MONTHLY ELECTRICAL INCIDENTS

ASP Manufacturing

April 2021

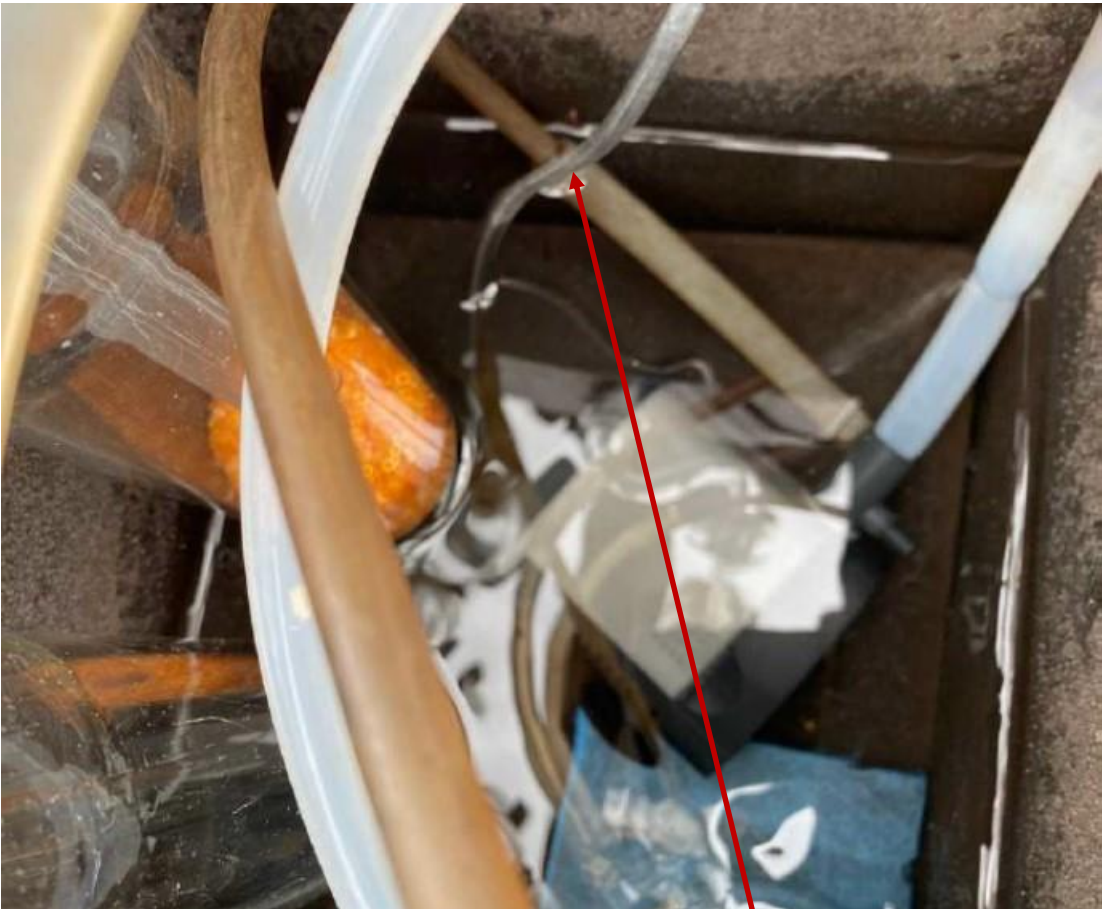
A technician working at the top of the Waste gas stack has received an **Electric Shock** to the hand whilst emission testing. When removing a small 240V ac pump from a container filled with water a shock was felt to the hand in the water. An investigation found the pump to be a standard domestic fish tank style pump which is double insulated and has a two core cable to it with no earth conductor. The cable was found to be damaged at the connection point to the pump with the neutral conductor exposed. The pump was RCD protected which did not trip as there was no current path to earth. As per Electrical Safety Manual 1.4.11.1 a visual inspection of the electrical article and lead should be undertaken to ensure the article has not suffered obvious damage, every time the article is used. Where possible eliminate the risk by using extra low voltage equipment (less than 50 volts ac or 120 volts dc) or battery operated equipment.

Pump submersed in water in the sampling container, with 240V lead

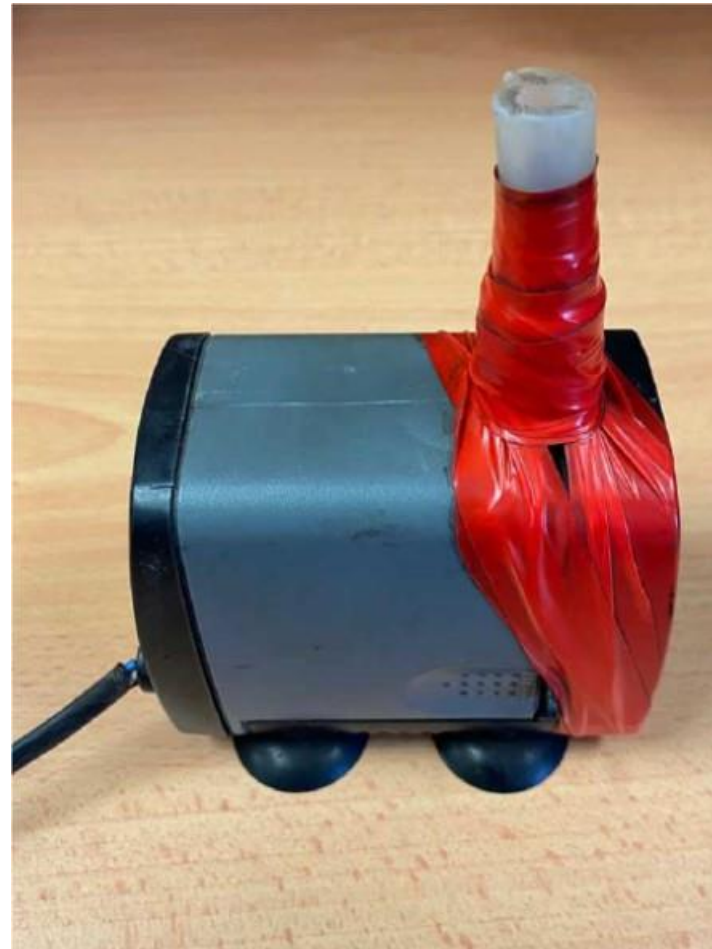
The fish tank style pump with damaged lead

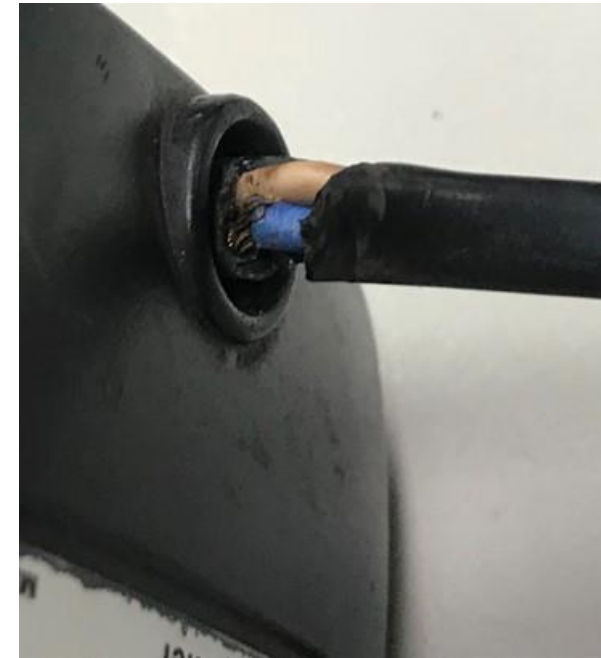
Close up view of the damaged lead and exposed neutral conductor

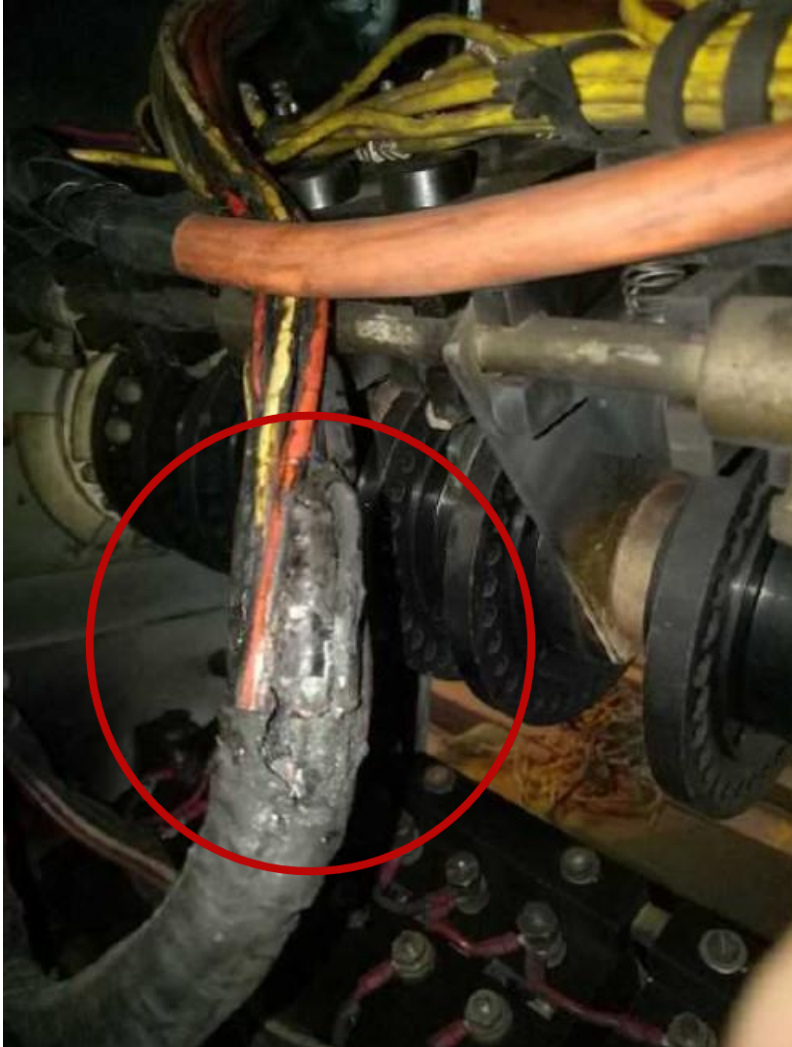
Electricians were called to investigate why crane F492 had no cabin or riding lights. A 16 amp fuse was found blown. Preliminary inspections of all the light fittings, switches and cabling found no obvious signs why the fuse had blown. Fault finding below the control switches on the operator control desk found all the lighting cabling had been loomed together and this loom showed signs of heat damage. When the loom was opened up it was found a lot of the cores had been joined with inline link lugs and one of these joins had developed a hot joint. As the cores were all closely wrapped together in the loom the hot joint has damaged a lot of the cores and caused short circuits.

The loom of wiring inside the control desk tapped together and showing signs of heat damage

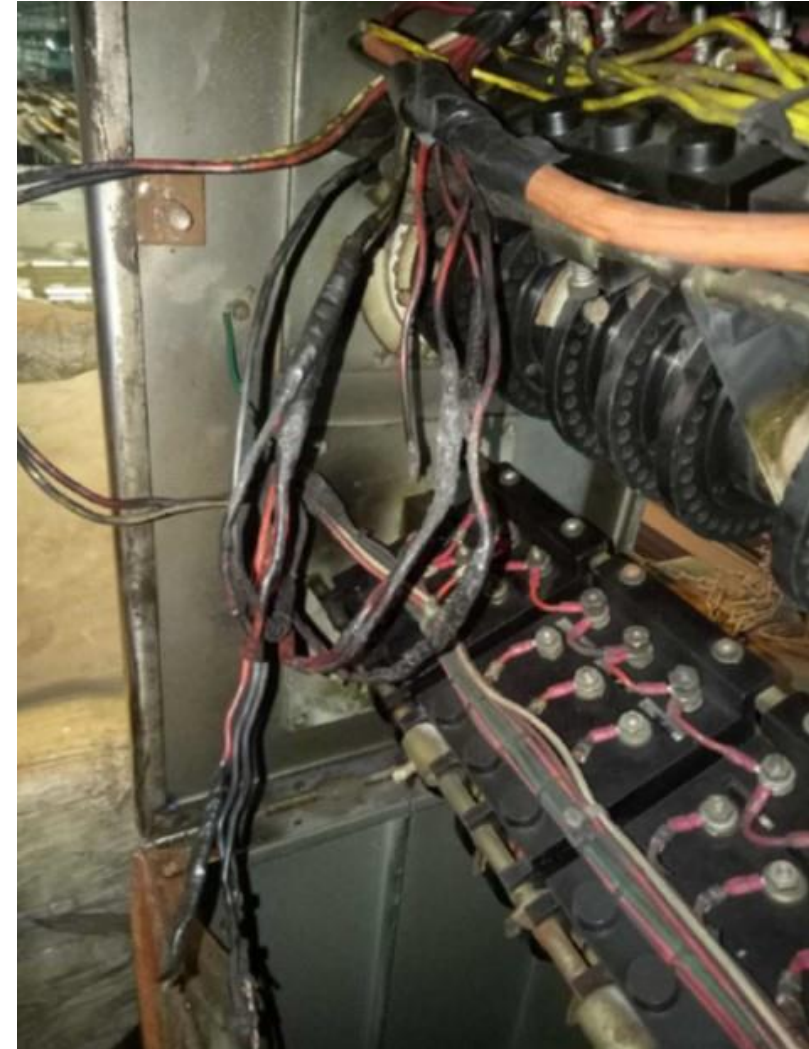
The loom opened up revealing the damaged wiring, damaged links in the cores and broken wires

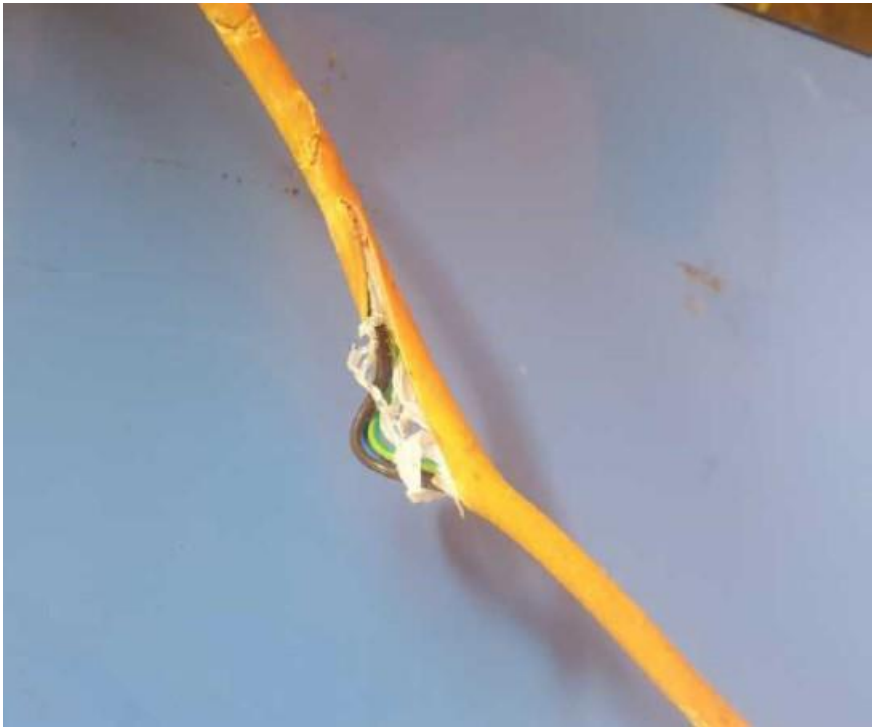
An electrician doing routine inspections has noticed the condition of the lead to the air cooler at the exit end of MCL5. The lead was clearly damaged with exposed live conductors. The assumption has been made that the lead has been run over by the cooler and not notice by the operators who had place the cooler in position. The lead was protected by RCD which had not tripped.

Close up view of the damaged cable

As per the electrical safety manual 1.4.22 incorrectly or inadequately maintained electrical installations can create a situation which exposes personnel to electric shock. All electrical articles shall be routinely inspected to ensure safe and satisfactory operation of the electrical installation.

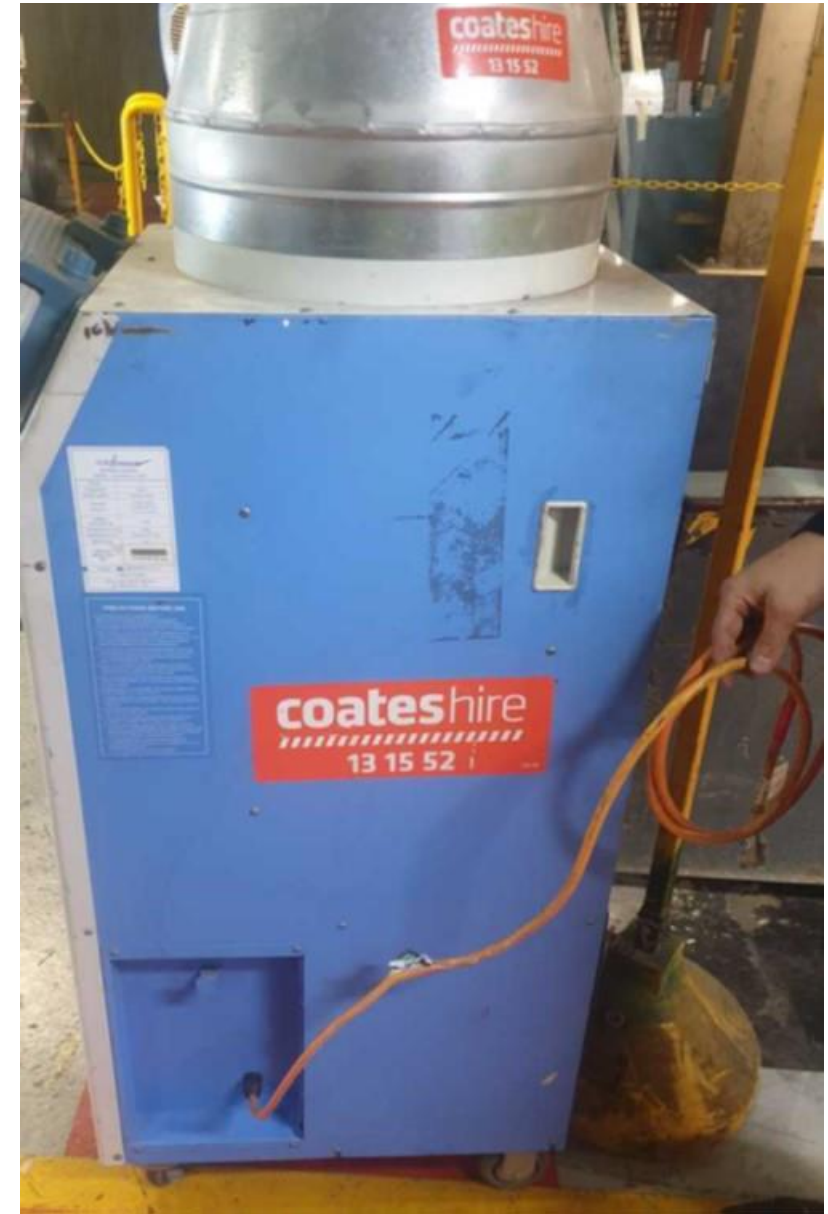
The portable air cooler with the damaged lead

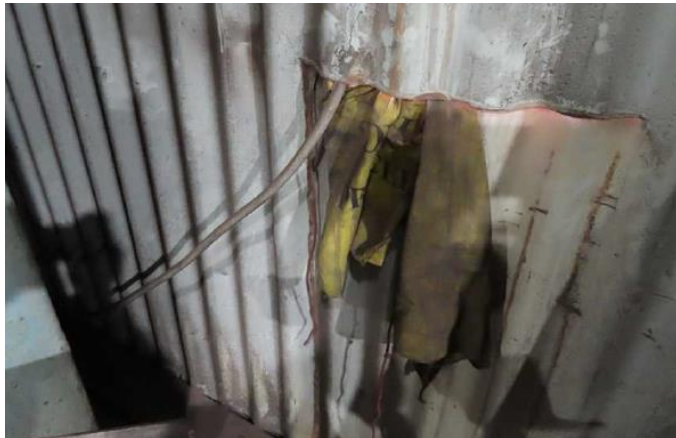
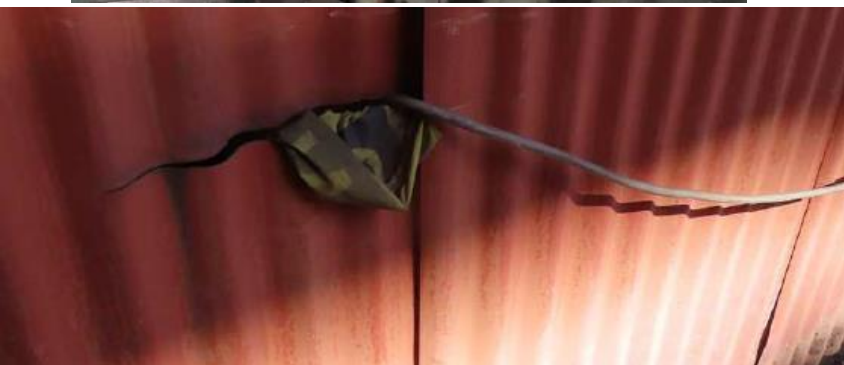
A very bad example of how not to run an extension lead was found. The extension lead had been run from an RCD protected outlet in the workshop up to the roof where a power board was being used for roof repairs. A gap had been cut in the workshop wall to poke the lead through with only an old caution flag protecting the cable from the sharp edges. The lead had been run up a wall with no supporting structure and was run over the sharp edge of the top roof sheeting with no mechanical protection. The cable did have a compliance tag on one end but the tag was blank and not filled out. Surprisingly the cable had numerous cuts and nicks in the outer insulation.

Back and front views of the cut in the wall sheeting with the lead running through it.

Note the old caution flag is only protecting the bottom of the cable, there is no protection from the top piece of cut wall sheeting.

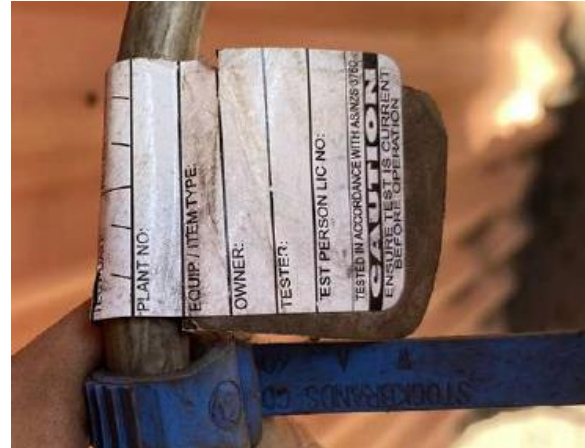
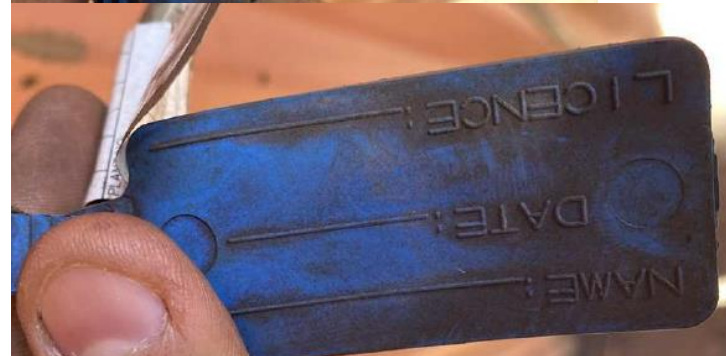
Two different tags with no details on them

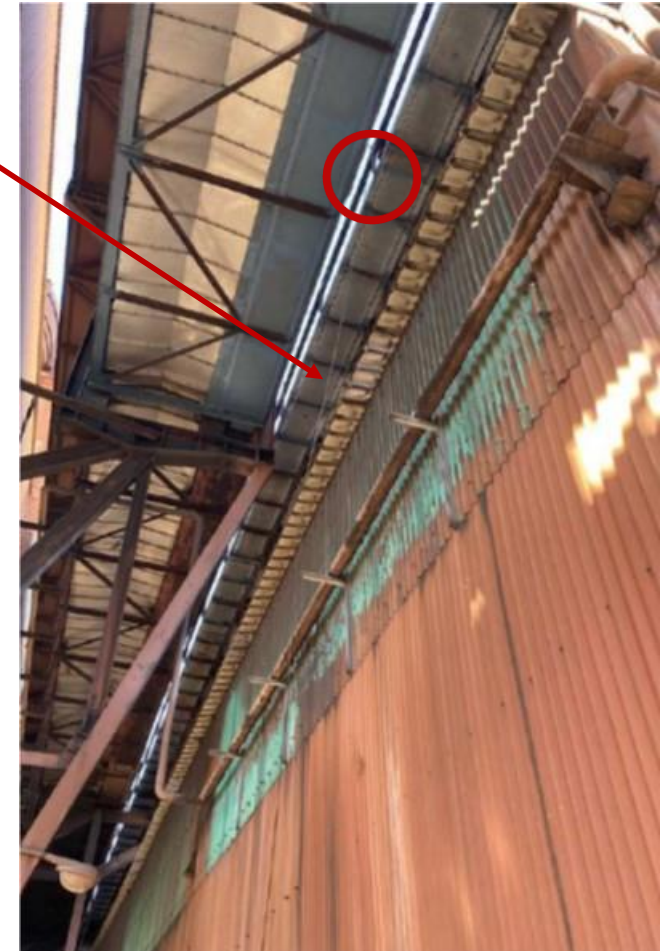
The lead run up the wall with no support, onto the roof and point where it is sitting on a sharp edge

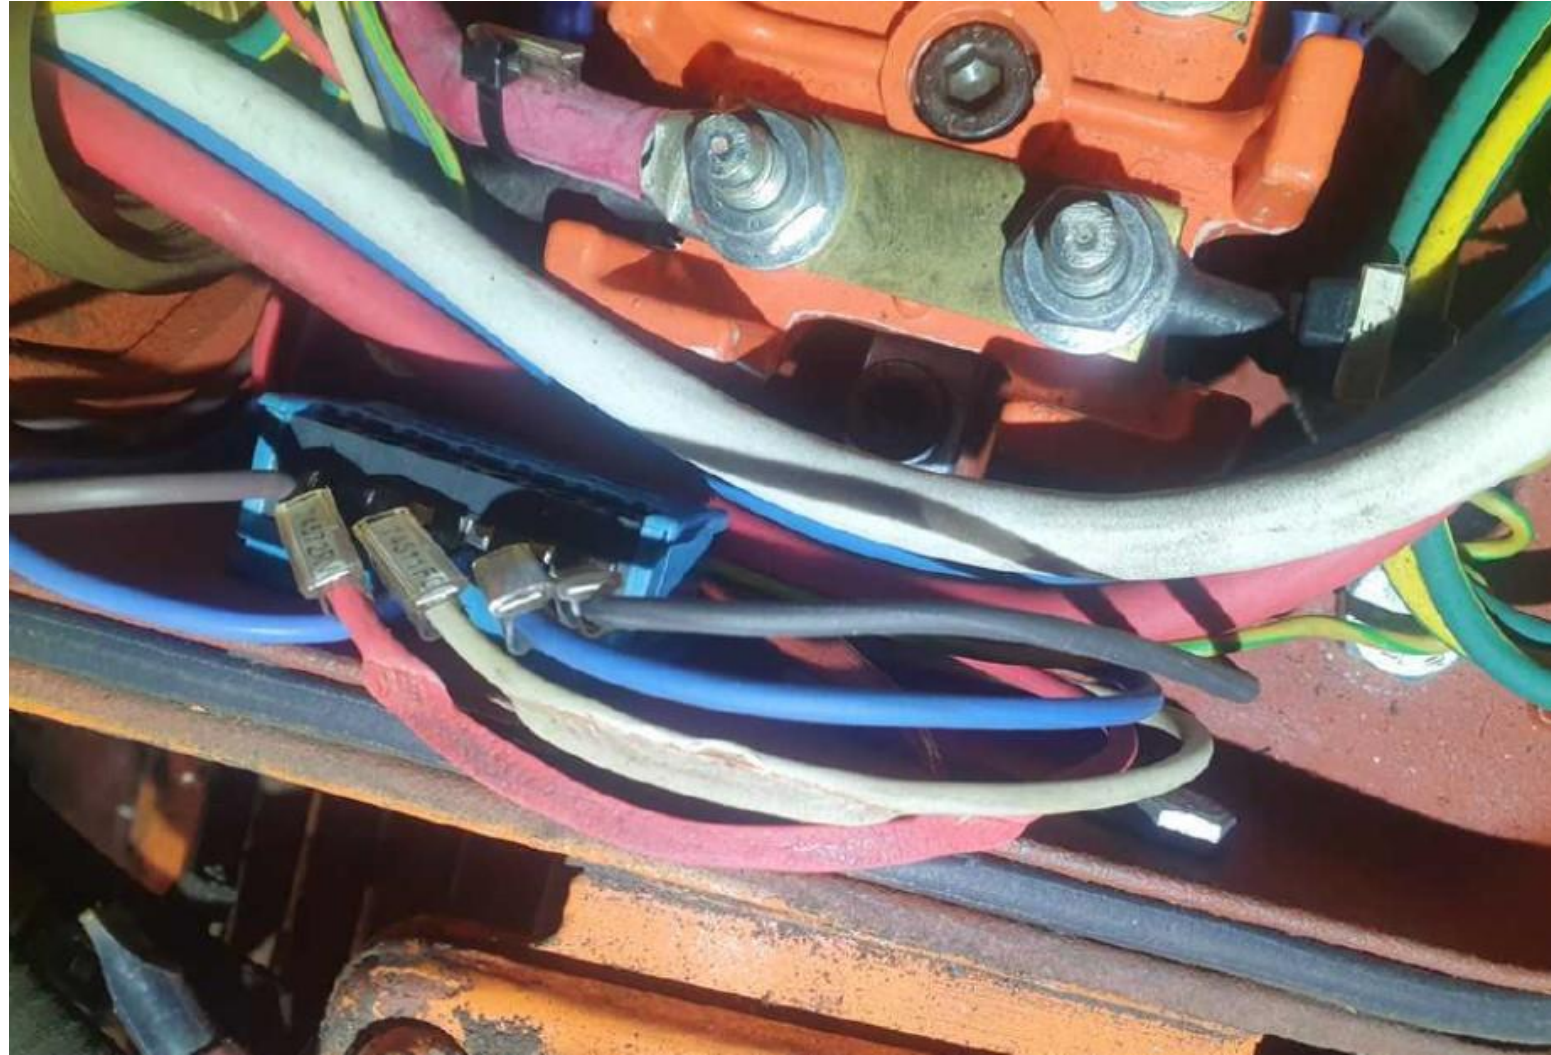
During start up on ZAL No.1 MCL process line the supply circuit breaker for the all the process AC brake supplies tripped out. An inspection of the individual beakers found entry bridle roll also tripped. Testing the brake circuit found the red and white phase cores were shorted to earth. The motor terminal box was opened to find the two cores had accidentally been squashed and the insulation damaged when the lid of the j-box had been screwed down and tightened. All care should be taken to ensure the integrity of a circuit is maintained when securing the lids or covers of electrical installations and the appropriate testing is conducted before power is restored to that circuit.

The two cores squashed by the terminal box lid

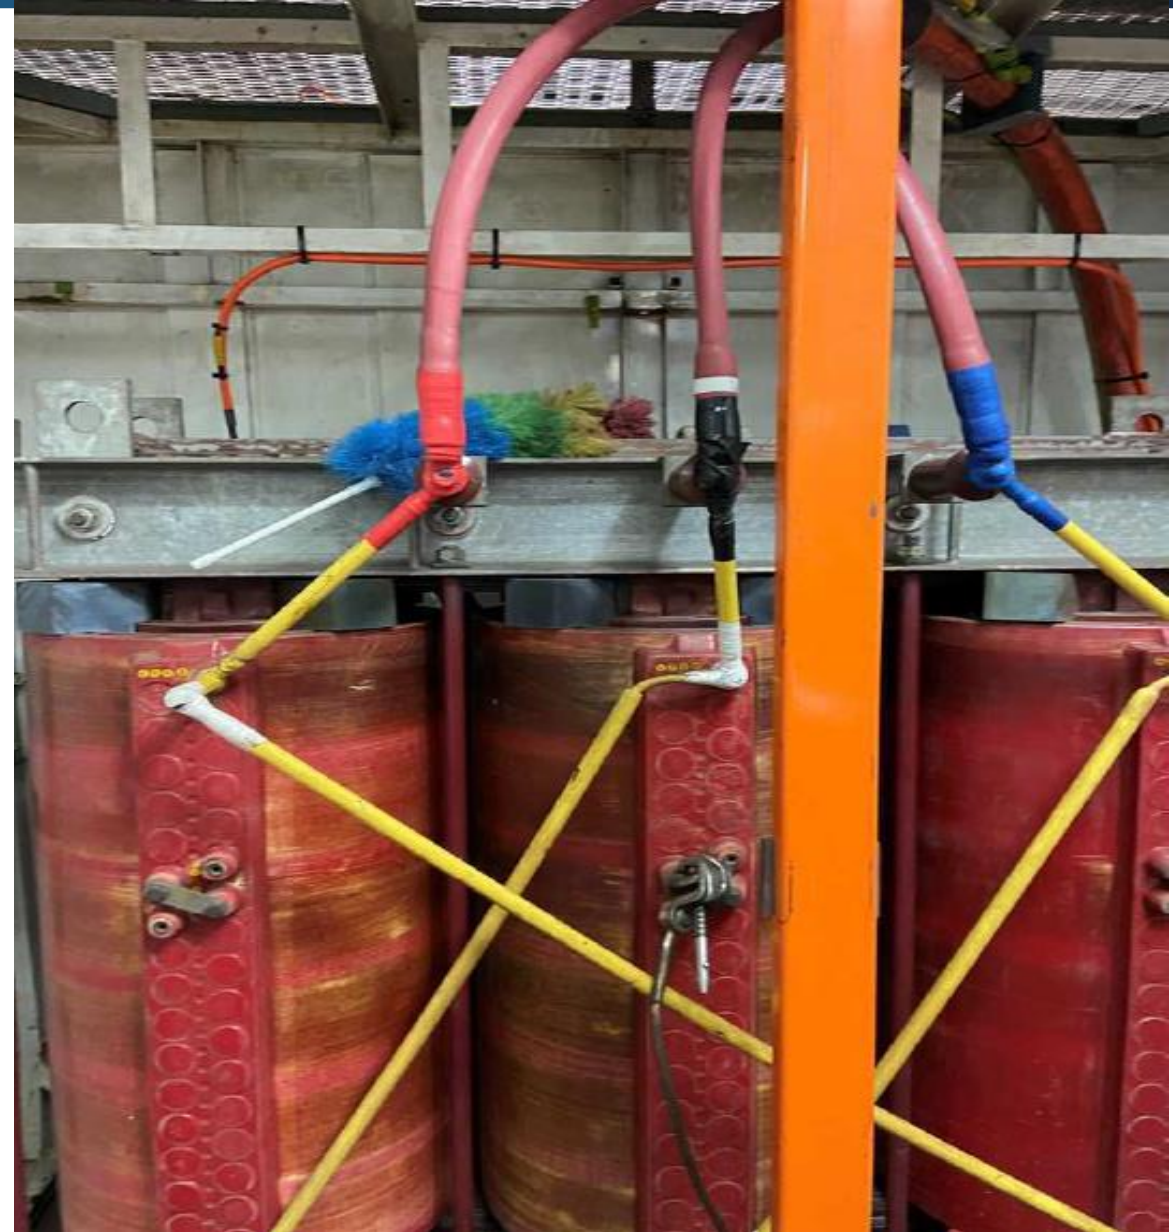
When 4-405 6.6kV dry type transformer enclosure was opened for routine maintenance a feather duster was found sitting very close to the 6.6kV terminations inside the locked enclosure. This circuit was last maintained in 2018.

The feather duster sitting adjacent to the red phase 6.6kV termination

After routine maintenance all electrical installation should be inspected to confirm the apparatus is in its original state and fit to go back in to service.
