MONTHLY ELECTRICAL INCIDENTS

ASP Manufacturing

June 2022

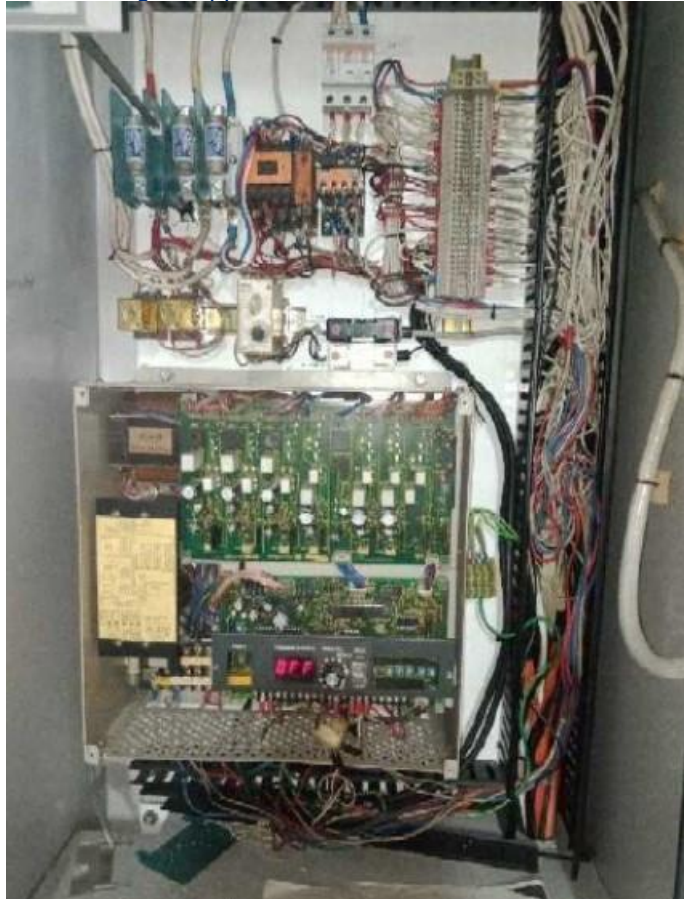
An electrician tasked to investigate why a VVVF drive was not working has received an **Electric shock** to the left hand when removing the VVVF. The drive was found to be internally faulty and needed to be replaced. After completing isolations and Test Before You Touch on all conductors terminated to the drive to ensure all conductors were de-energised, the drive was removed. With right hand at the top of the drive and the left hand at the bottom the electrician's left hand has touched one of the motor cable conductors and felt the shock. The conductors were again checked with a multimeter in normal setting and low-impedance setting, and found to be de-energised. This plant has a history of induced volts being recorded on isolated conductors due to the long cable runs. As a result of not initially testing with a low-impedance meter the induced volts have discharged into the electrician's hand wearing cut resistant gloves.

The inside of the motor starter with the drive cover removed before the VVVF was removed

In areas with suspected induced volts follow as per the Electrical Safety Manual section 1.4.3.2 "If induced voltage is confirmed greater than 25V ac apply earth bonding as close to the work area as practical using an approved method", a risk assessment should be conducted to confirm the most practical method.

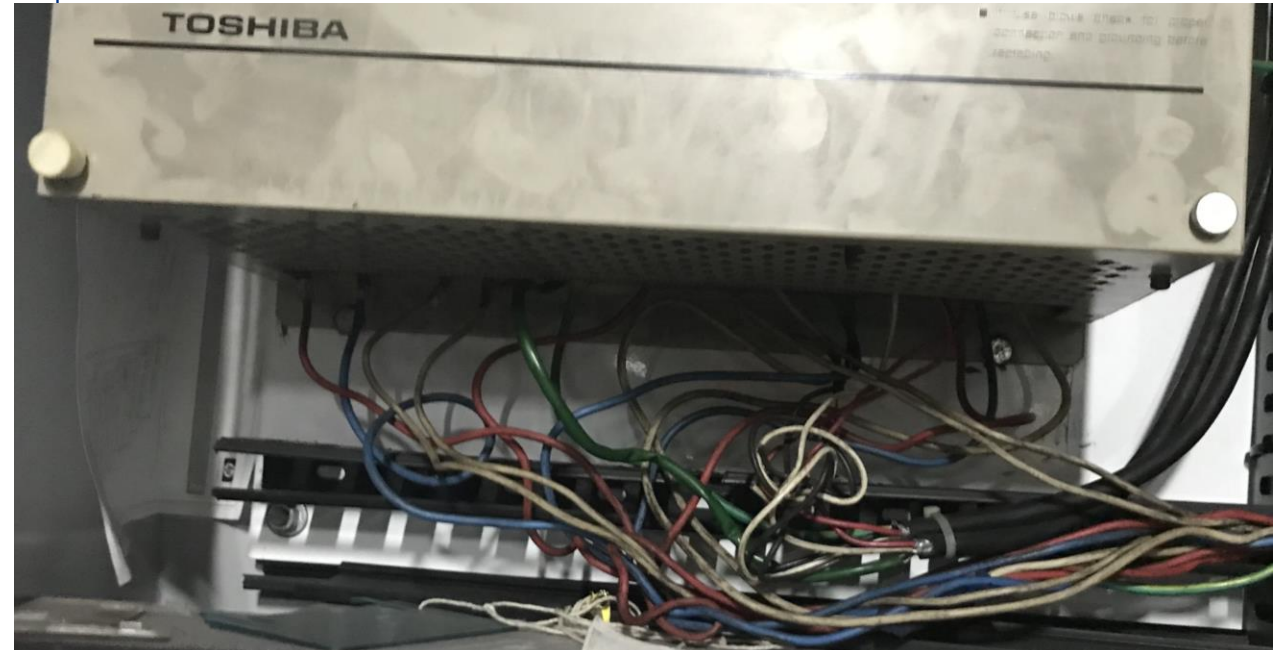
A close up of the wiring at the bottom of the drive where the electrician's left hand came in contact with the motor conductor

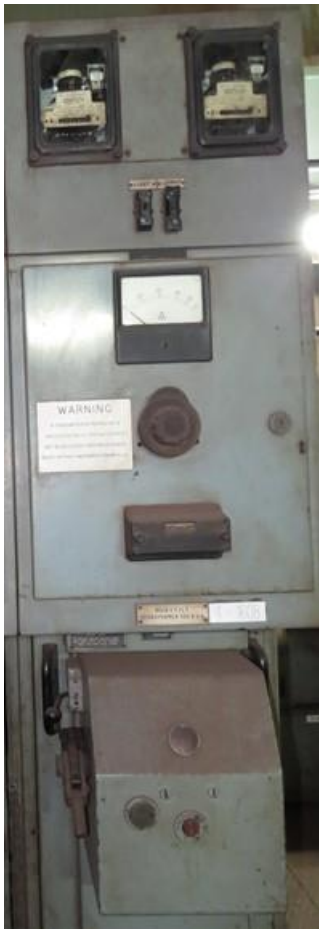
High voltage maintenance team completing routine maintenance have opened up the oil tank of an OCB to find the oil black in colour and very thick with floating particles. The moving and fixed contacts were found melted away and burnt. The 6.6kV 400amp OCB is used as part of a DOL starter circuit for a synchronous motor which has a full load current of 128amps. Due to reliability issues of closing this breaker it has been reported the OCB has failed to latch and retain on a number of occasions. Unfortunately as a result of this issue there has been many attempts to close this OCB each time the synchronous motor has been required to start. The number of attempts has far exceeded the recommended of 3 causing the contact damage and the oil to heat up.

The front of the OCB breaker

The starting of large motors DOL has to be managed correctly to ensure the starting equipment has adequate time to cool down before subsequent starting attempts are made. This is to ensure the starting equipment is safe and reliable to operate.

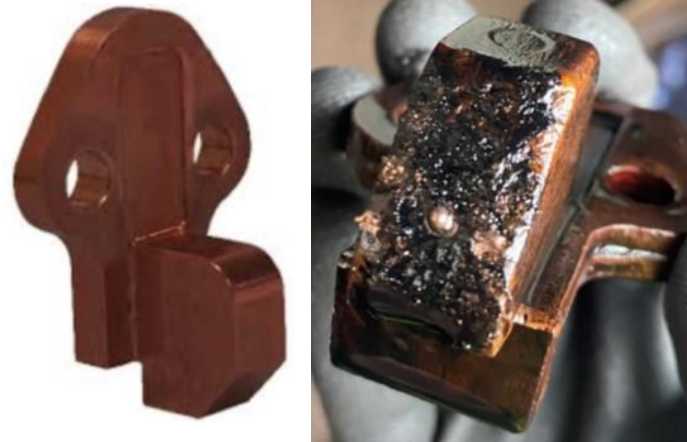
A new and the used arcing (or sacrificial) contact which is used to suppress any arcing during switching

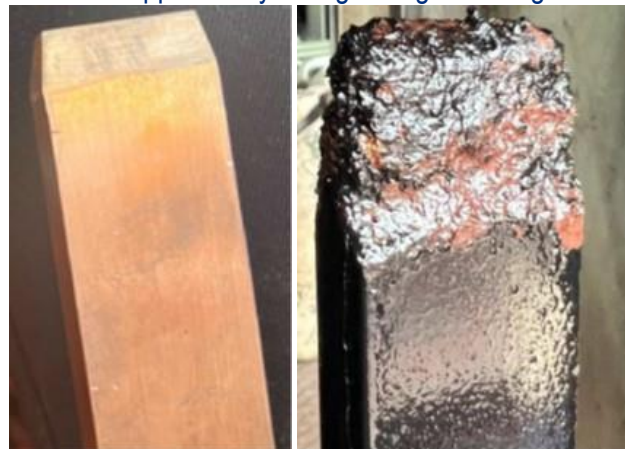
A new and used moving contact, note the amount of melted and missing copper which is not meant to happen to this contact

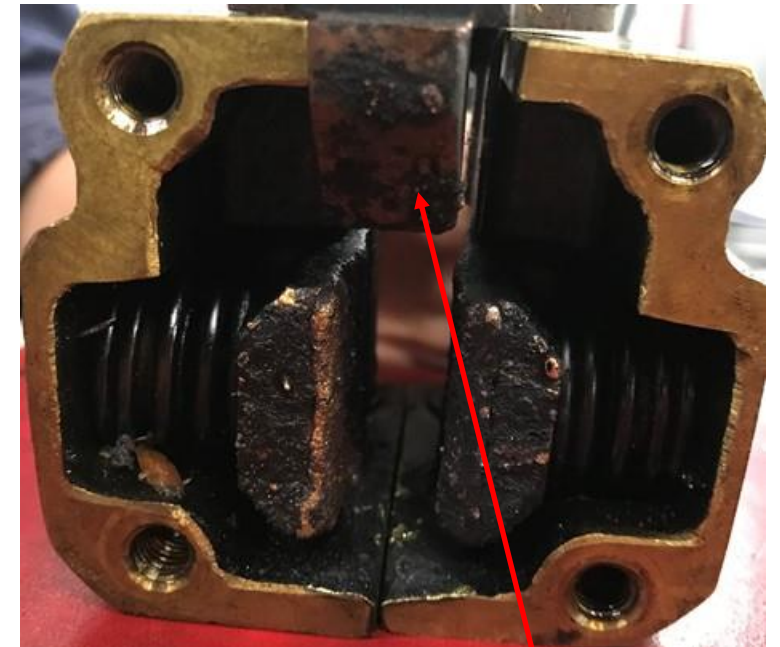
The main fixed contacts with the arcing contact mounted above.

Note the fixed contacts are meant to be curved but due to the damage are flat and would be making very poor contact with the moving contact which moves up inside.

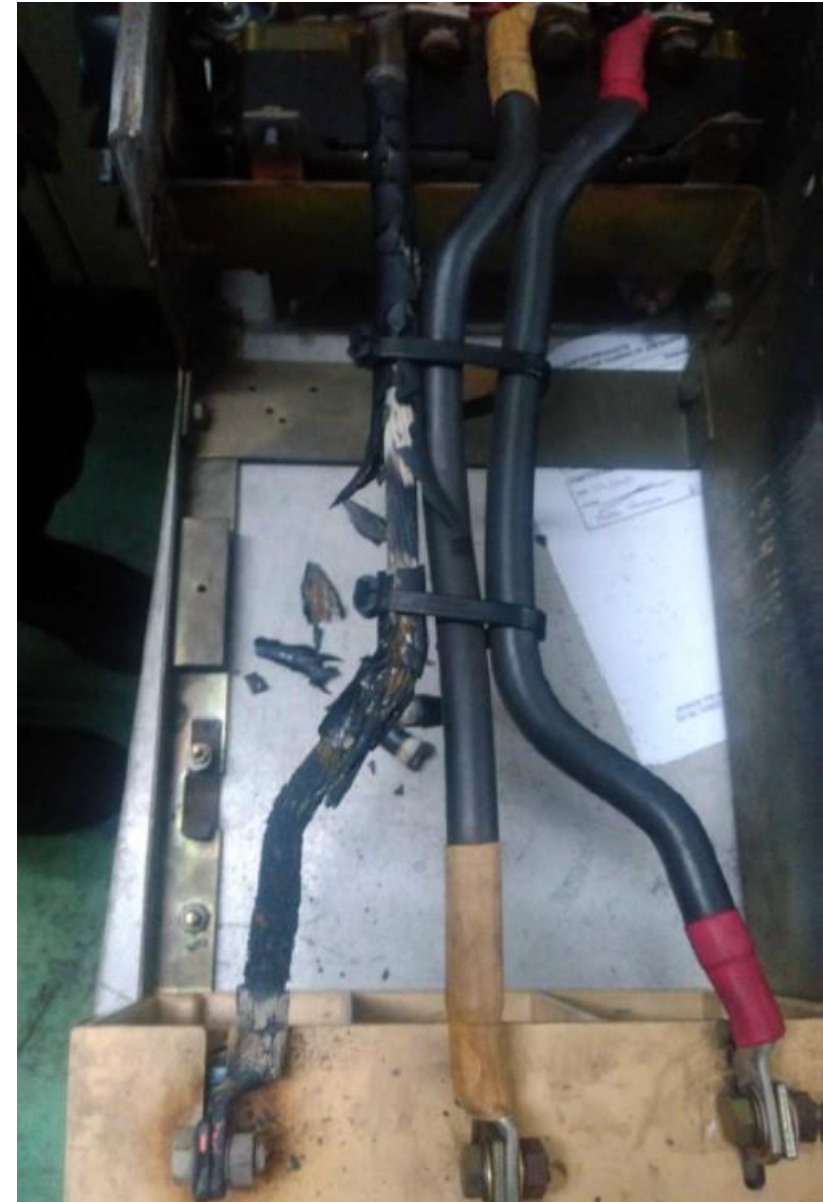
During scheduled maintenance of an MCC the main cabling inside a cell was found to be heat affected. One of the phase cores from the main fuses to the main contactor had all the single insulation, which has become brittle, falling off the conductor. The hot joint seems to have generated from one of the bolted connections of this cable. An internal investigation has found this 160amp removable starter had incorrectly been placed in the position for a 250amp starter, thus being under rated for the duty cycle of the 110kW motor. This MCC has inspections every 9 months on all its starters.

The brittle and falling off insulation on the blue phase conductor of the MCC starter

As per Electrical Safety Manual 1.4.22 all electrical installations shall be regularly inspected and maintained to the safety and satisfactory operation of the equipment. Equipment rating shall be taken into account when designing and installing to ensure the installation can withstand the duty cycle as per manufacturer's specifications.

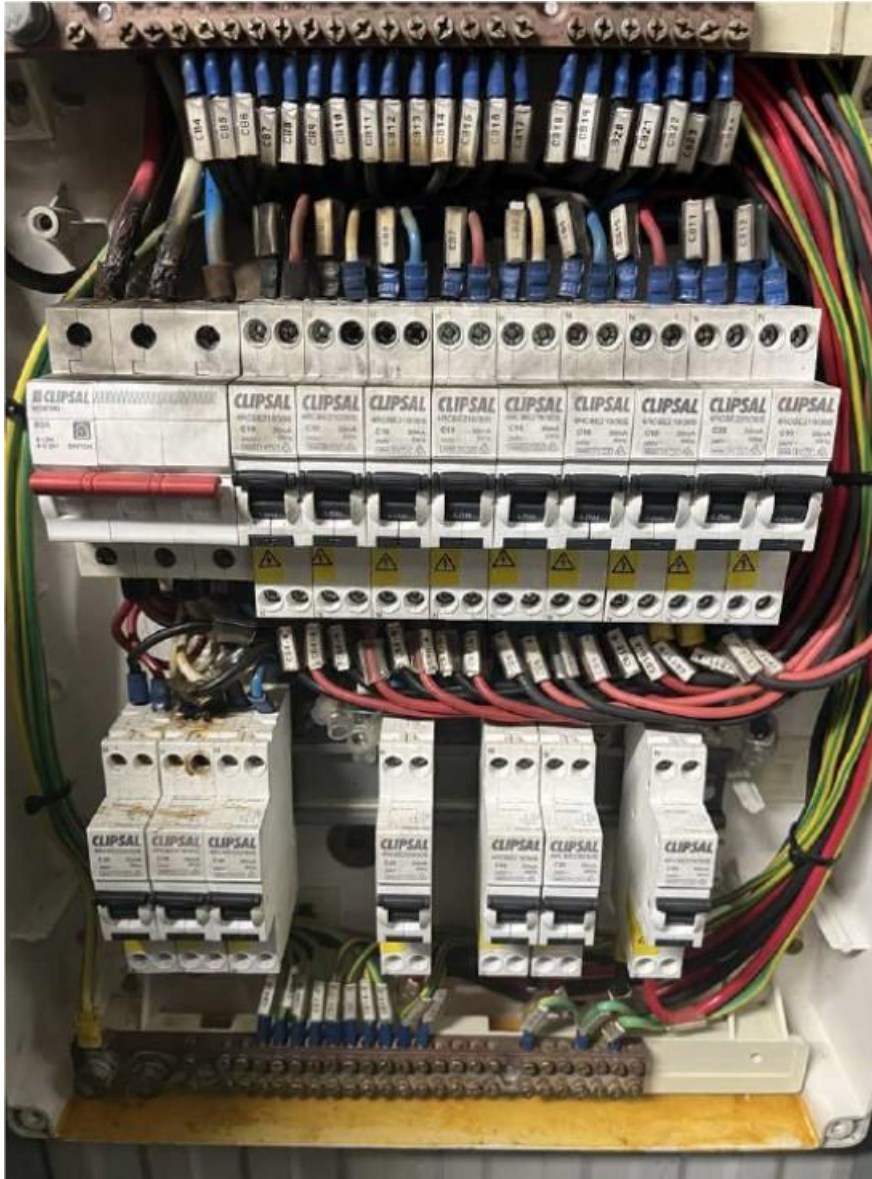
An electrician investigating why the gallery switchroom had lost its lights has found a damaged distribution board. Inside the board the cabling to the main isolator was burnt due to a short circuit between phases. Water ingress from a roof mounted air conditioning unit seems to be the cause, where the water has run down the inside wall of the switchroom into the board due to top entry cable penetrations.

Inside the distribution board with the burnt main incomer cabling to the main isolator

Ensure all electrical installations are suitable for the environment and have the appropriate IP rating. It is recommended that all cable entries are from the bottom. If the situation cannot avoid top cable entry all care should be taken to maintain the IP rating to eliminate water entry.

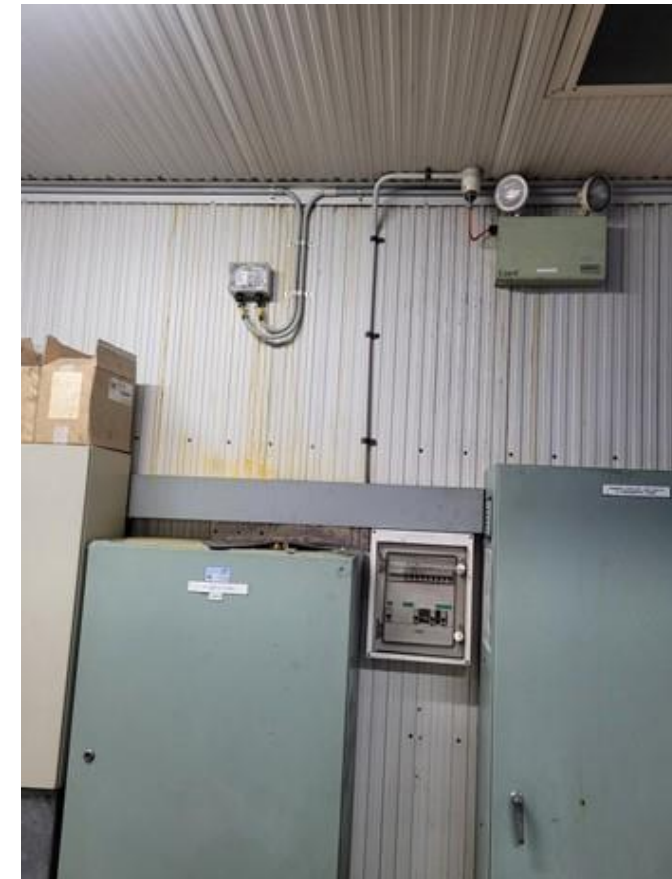
The position of the distribution board on the switchroom wall

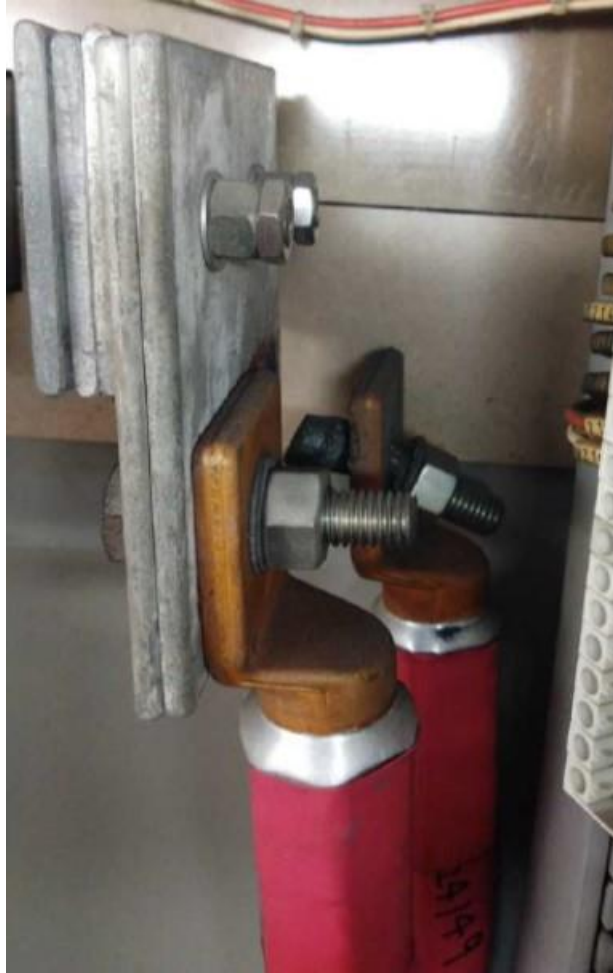
During a periodic inspection of terminations of the main connections from an ACB to the main pot inductors a hot joint was found. These inspection only occur every approximately 5 years. The 1600amp 415V ACB has 2 by 630mm² Al conductors run in parallel per leg. The hot joint had caused the bolted connection of one of these conductors to melt off the head of the bolt. This conductor has then become open circuited from the main busbar. Resulting in the other conductor carrying the full current of the inductor. This damage has been in this condition of a number of months.

The bolted connection clearing open circuited from the busbar by the weigh of the cable and head of the bolt melting off

As per Electrical Safety Manual 1.4.22 all electrical installations shall be regularly inspected and maintained to the safety and satisfactory operation of the equipment so that the installation does not become a significant potential cause of fire.

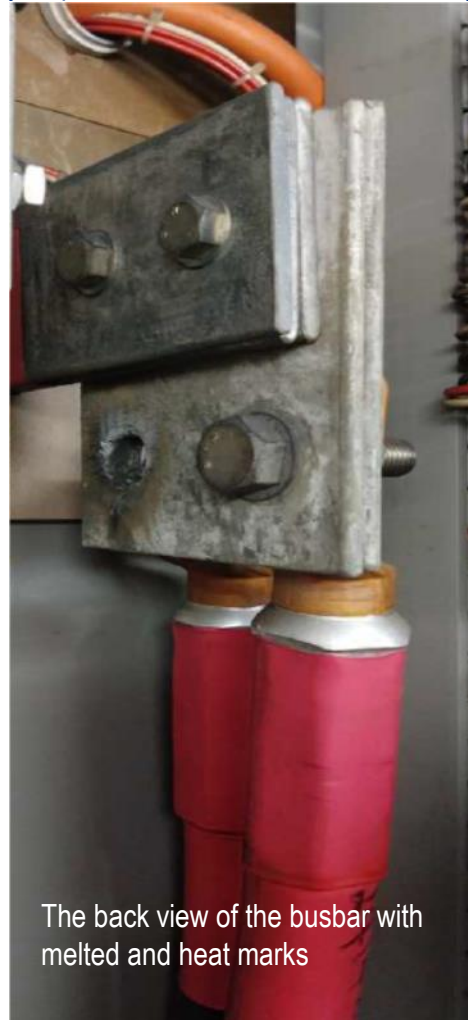
The back view of the busbar with melted and heat marks

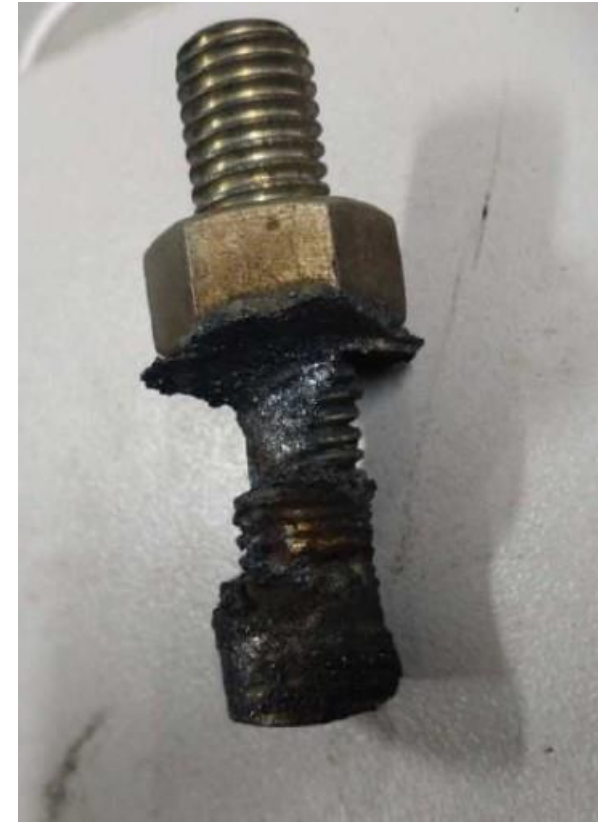
The heat effected bolt with the heat end melted round to allow bolt to come away from the busbar
