# MONTHLY ELECTRICAL INCIDENTS

**ASP Manufacturing**

**July 2022**

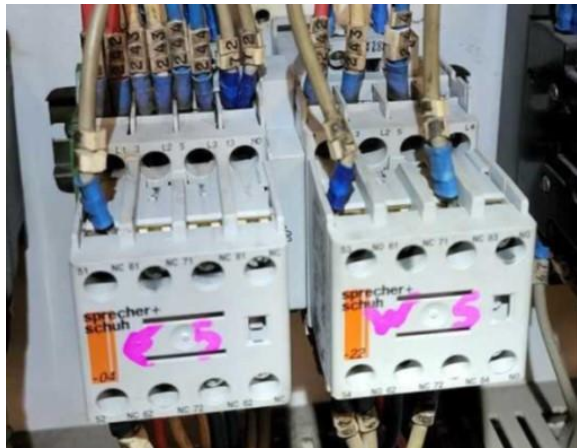
An electrician fault finding in a crane cross travel panel has inadvertently started a small fire on a contactor. Believing the contactor mechanical interlock to be jamming the electrician used CRC CO contact cleaner to free up the device. When the contactor was power tested a small fire propagated across the contactor and into wiring ductwork. Power was removed but the fire continued for about 10 seconds. The duct lid and sides were slightly burnt and melted but none of the wiring was effected. CRC CO cleaner can be flammable for up to 30 minutes after it has been used on any surface. Unknown to the electrician the usual contact cleaner can CRC NF which is not flammable looks identical to the CRC CO can.

The cross travel contactors

This is a timely reminder to use the correct equipment and products for the job and ensure they are fit for purpose. Always read the MSDS sheet of any substance being used to understand the risks involved.

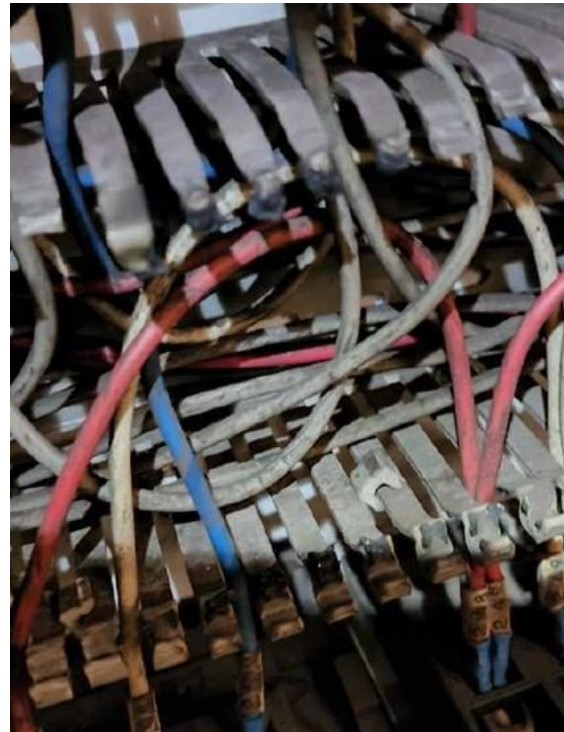
The cabling below the contactor is all fine, but the sides of the duct has been burnt and melted

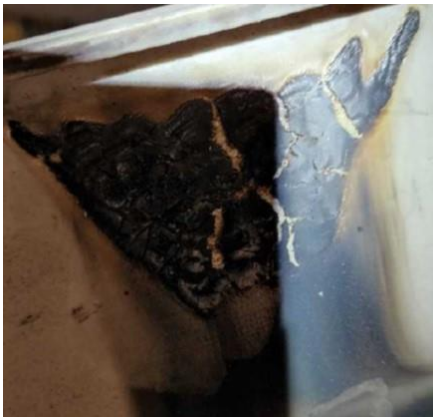
The burnt cable duct lid

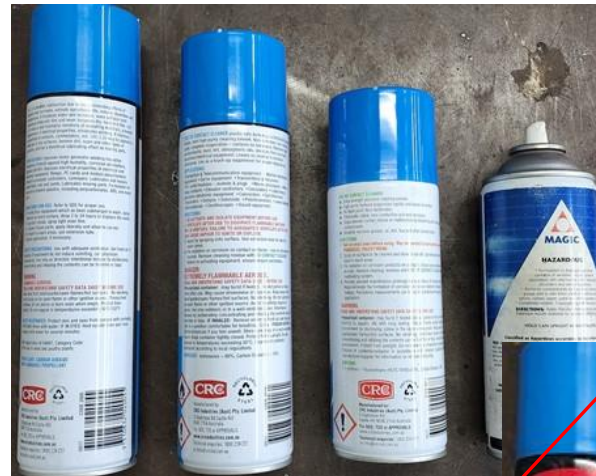
The front and rear view of the contact cleaners used at the Western Port site

Note the CO can and the NF can look similar. The details at the rear of the CO can clearly states it is highly flammable. The NF can states it is not flammable

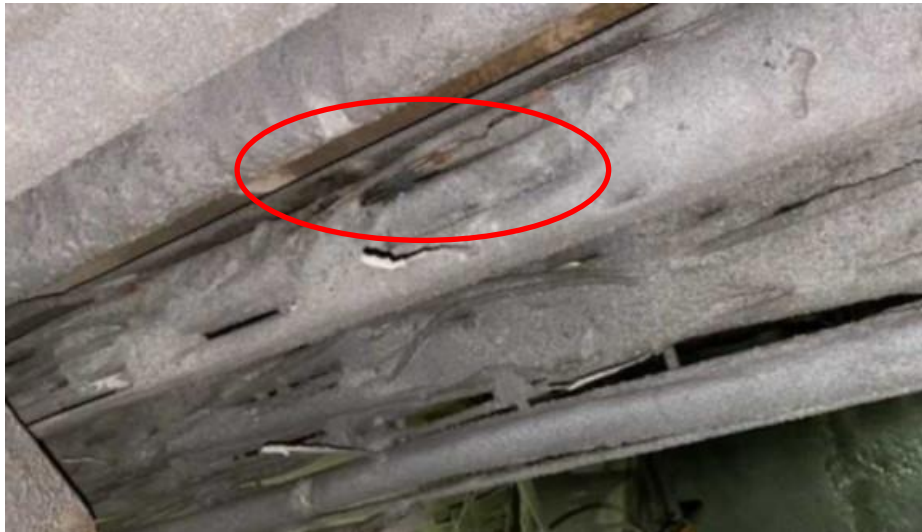
A 6amp 230V dc fuse was found blown while fault finding sub lance control. Without a correct replacement fuse available the shift electrician used a 16amp fuse which at first appeared to get the lance to move, however the lance moved by itself due the PLC 24V dc input card having 230V dc on it due to a cable fault that was not identified before the fuse was replaced. The cable route up to the lance was traced, burn marks were found on the cabling and another cable had melted. The lance emergency stop 2core TPS cable was found to be severed and was arcing. It had melted the insulation of the 24V dc control cable it was sitting on, resulting in transferring 230V dc to the 24V dc circuit. The immediate area is heavily covered in dust and Kish which had been deluged with water from the previous rains. Circuit faults must be carefully investigated before replacing fuses or resetting circuit breakers and protection. The correct protection settings and fuse sizes must be maintained to ensure circuits remain protected correctly.

The cable racking where the damaged cables were found.  
Note 1, the burn marks on the rack noticed

Note 2, the grey covering is a mixture of dust, Kish and water making a grey mud

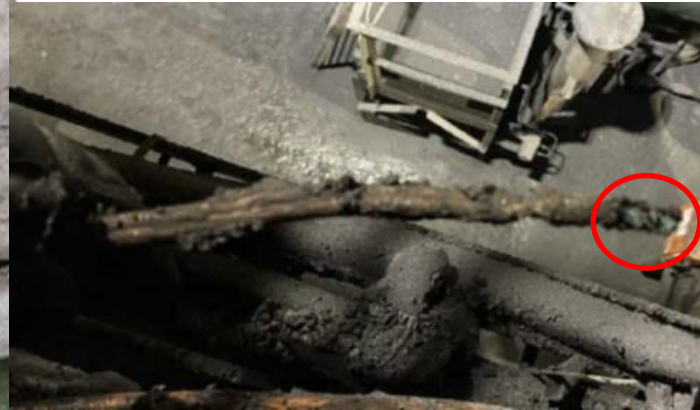
The two severed ends of the emergency stop cable

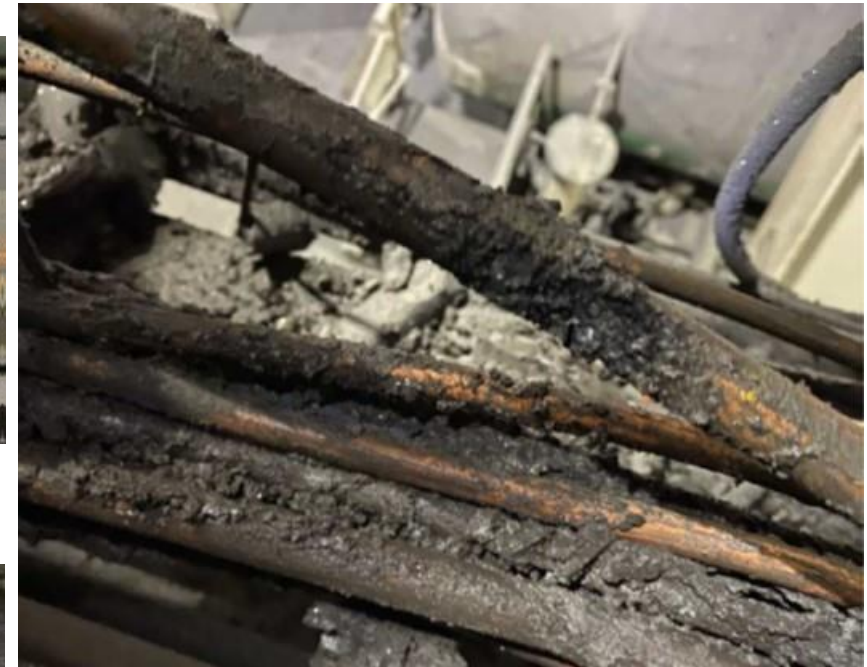
The other damaged control cable with outer sheath and inner insulation melted exposing conductors. Covered in Kish mud.

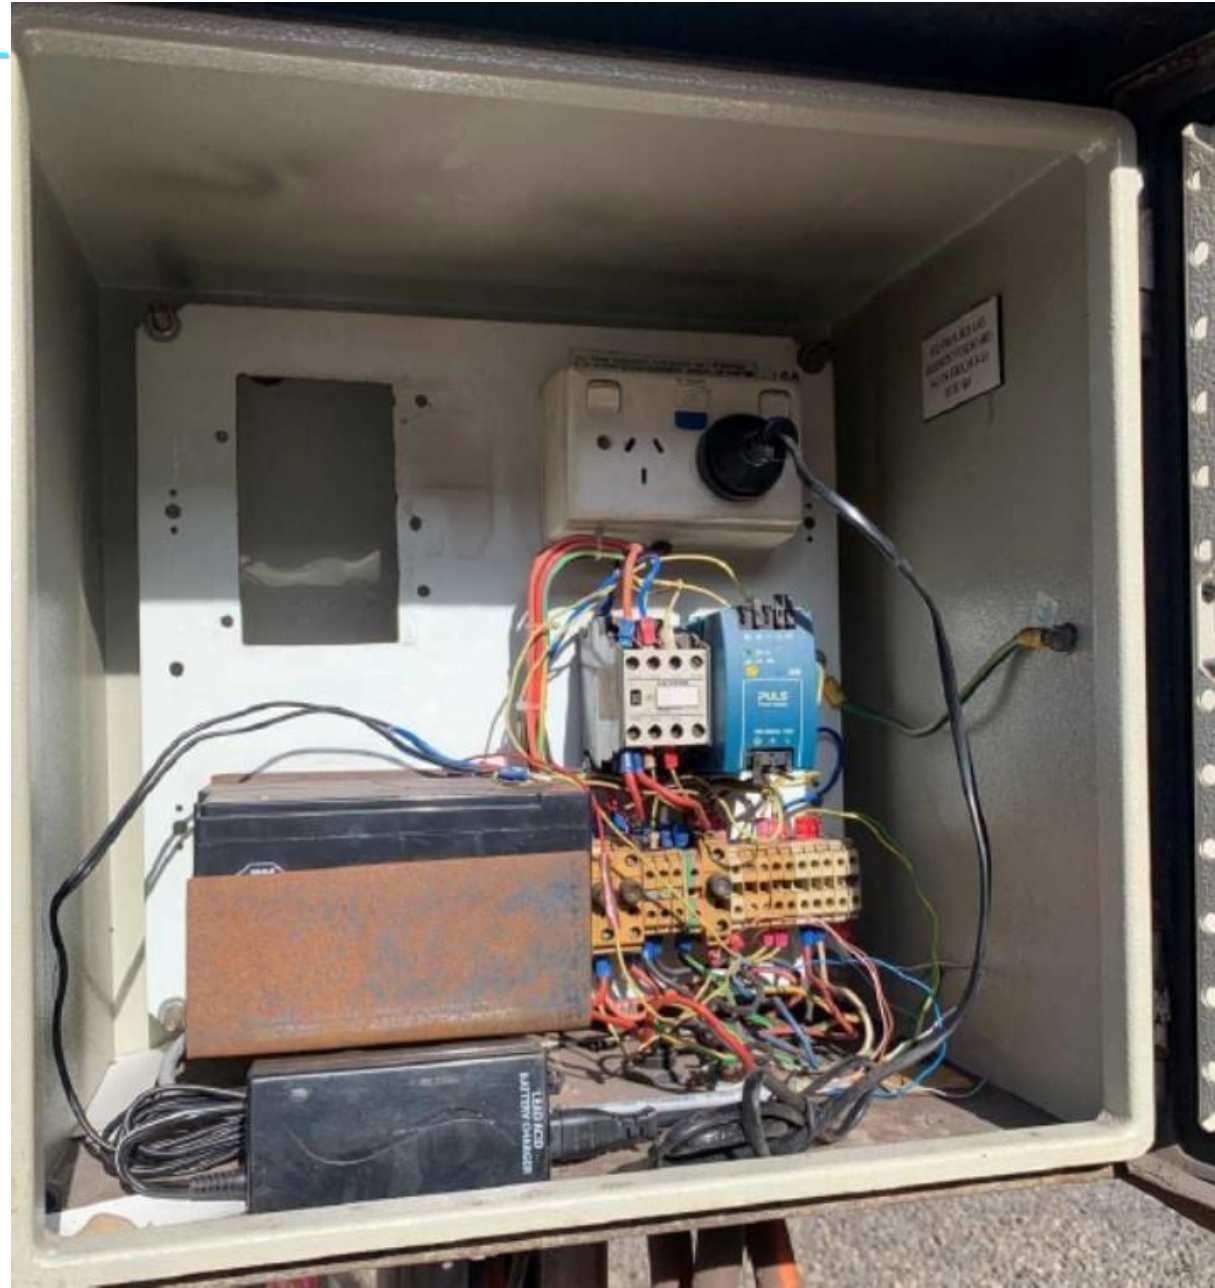
An electrician was called when an outlet supplying power to a fixed CO gas monitor j-box have no volts. The outlet with integral RCD unit was fed from a 1amp terminal strip fuse which had blown. Contractors had attempted to use this outlet with a power drill, where as the outlet is only intended for use with the gas monitor battery charger.

Inside the CO gas monitor j-box which was accessed by unauthorised people

Socket outlets intended for specific functions must be secured to prevent incorrect use and be labelled accordingly.

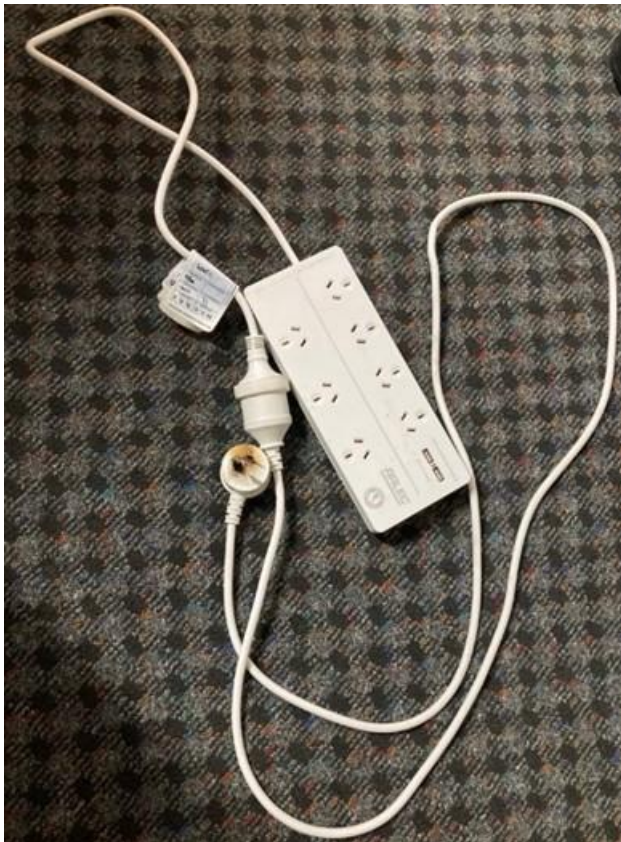
The plug of the board

As per Electrical Safety Manual 1.4.14 power boards should have the appropriate construction, IP rating and overload protection for the environment where it is being used. Power boards should not be plugged into extension leads.

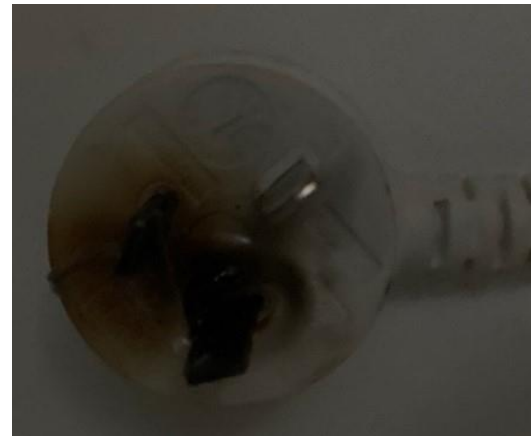
An operations staff member noticed loss of power within their work station and could smell burning plastic. An electrician has found the upstream 16 RCD had tripped. At the work station a 7-way power board was found heavily loaded, plugged into a short extension lead and when its plug was removed from a standard 10amp outlet it was found to have burn marks on both active and neutral pins. At the back of the outlet a hot joint on the neutral wire connection was found. Also the outlet was poorly wired with the terminating screw actually being secured to the insulation of the wires.

The 7-way outlet board with the short extension lead, which does not have overload protection

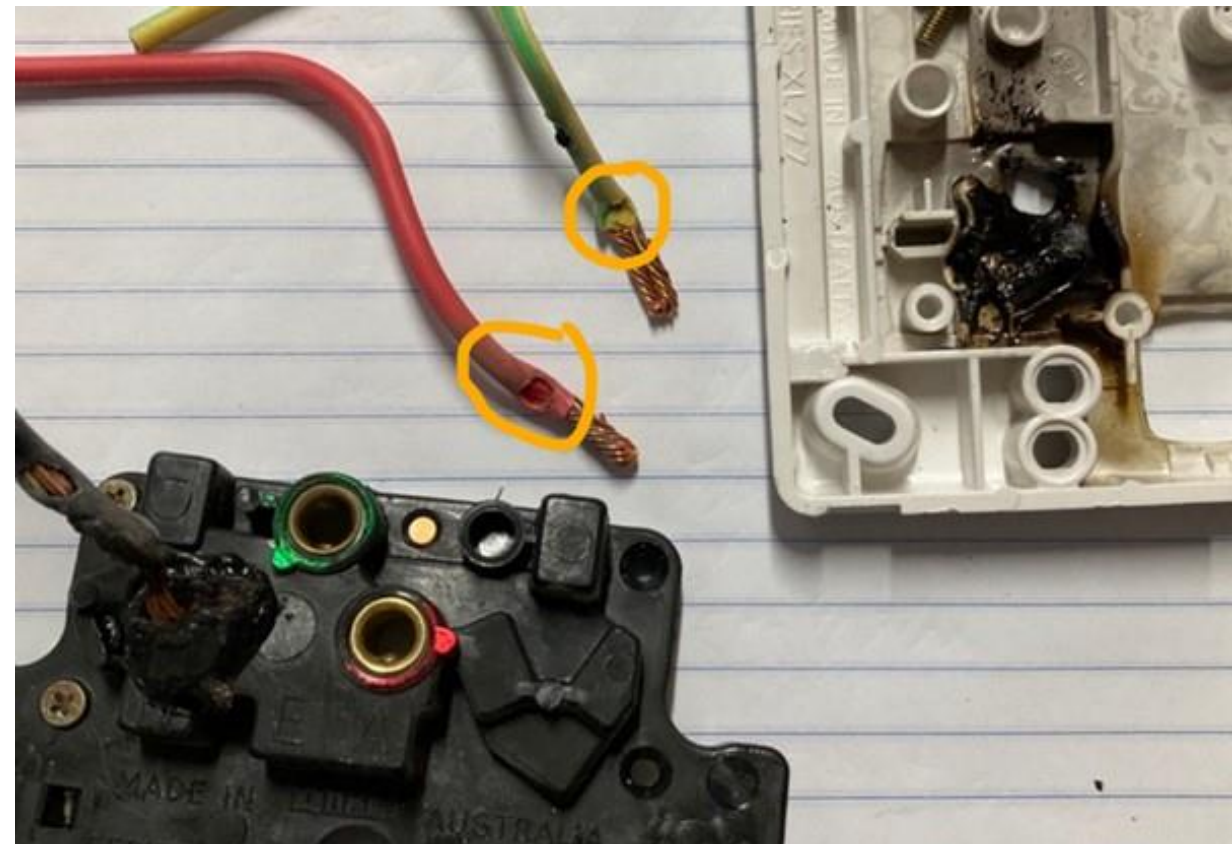
The back of the 10amp outlet with the melted connection of the neutral conductor from the hot joint. The terminating screw marks on the insulation of the wires

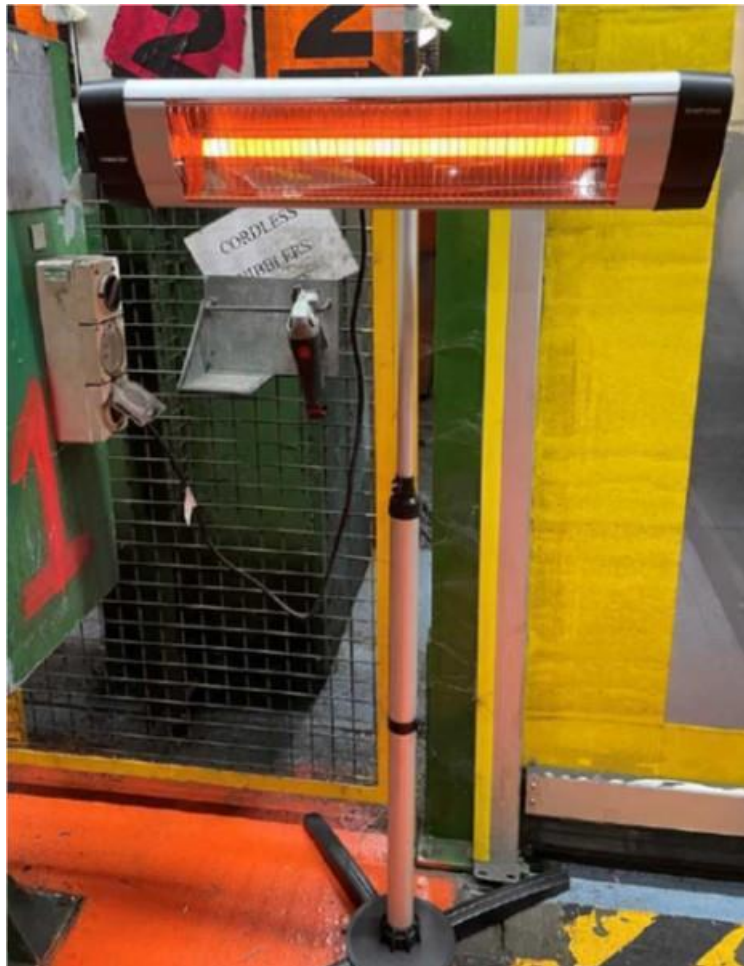
An operator complained when a portable heater made a loud bang and then had smoke coming out of it. An electrician found the RCD outlet the heater was plugged into did not trip but the upstream 16 amp fuse had blown. The heater internal wiring appeared to have a suffered hot joint on the neutral conductor, this had then burn through the heat protection sleeve of the active conductor and created a short circuit. Note the active conductor is a heat rated cable with an extra heat rated fibreglass sleeve over it, where as the neutral conductor had only PVC insulation.

The portable heater plugged into an RCD protected outlet

Ensure all electrical equipment installed is rated for its environment as per manufacturers specifications.

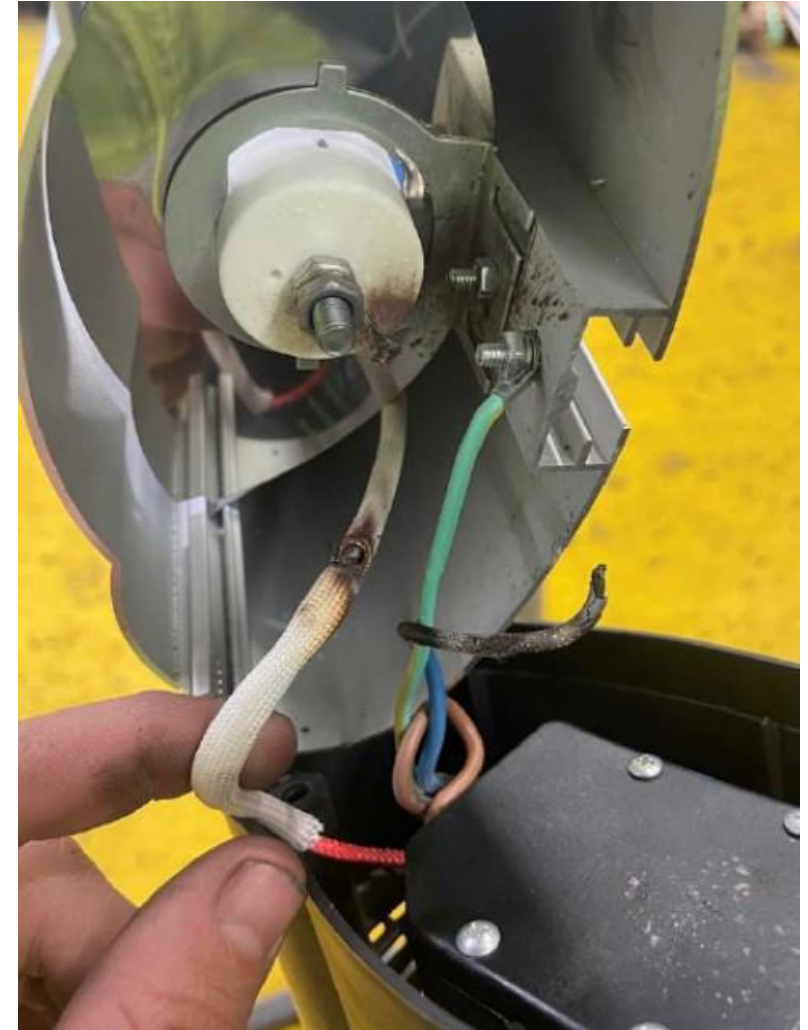
The internal damage of the heater. Note how the PVC rated neutral conductor has burnt through the fibreglass sleaving to create the short circuit.

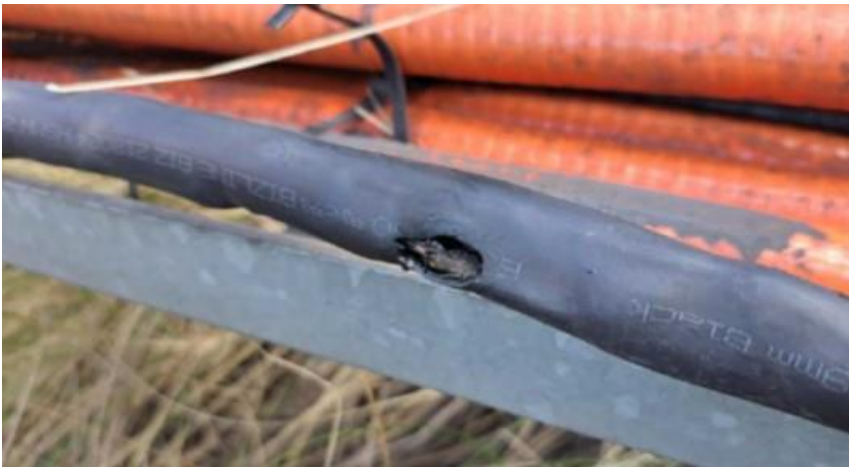
A 32amp circuit breaker and 100A fuse supplying power to the cutting shed had tripped. Inspection of the supply cable found it had previously been repaired when a failure had blown a hole at a joint. The cable joint was not rated for an outdoor environment, only standard heat shrink had been applied over the cable connections which did not provide a water proof joint. Water has run inside the cable joint, compromised the insulation and created a short circuit between phase and earth.

The blowout in the heat shrink cable joint

All equipment used in outdoor environments for the connection to electrical installations should be rated minimum IP42, be bottom entry and be mechanically protected to prevent moisture ingress. As per electrical Installation Manual section 4.3.7 for hostile environments and section 4.5.1 for field panels.

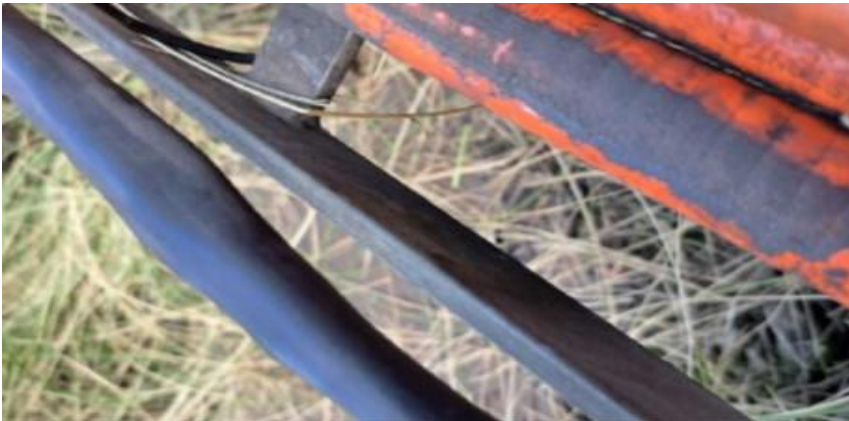
Evidence of arc marks on the side of the cable rack

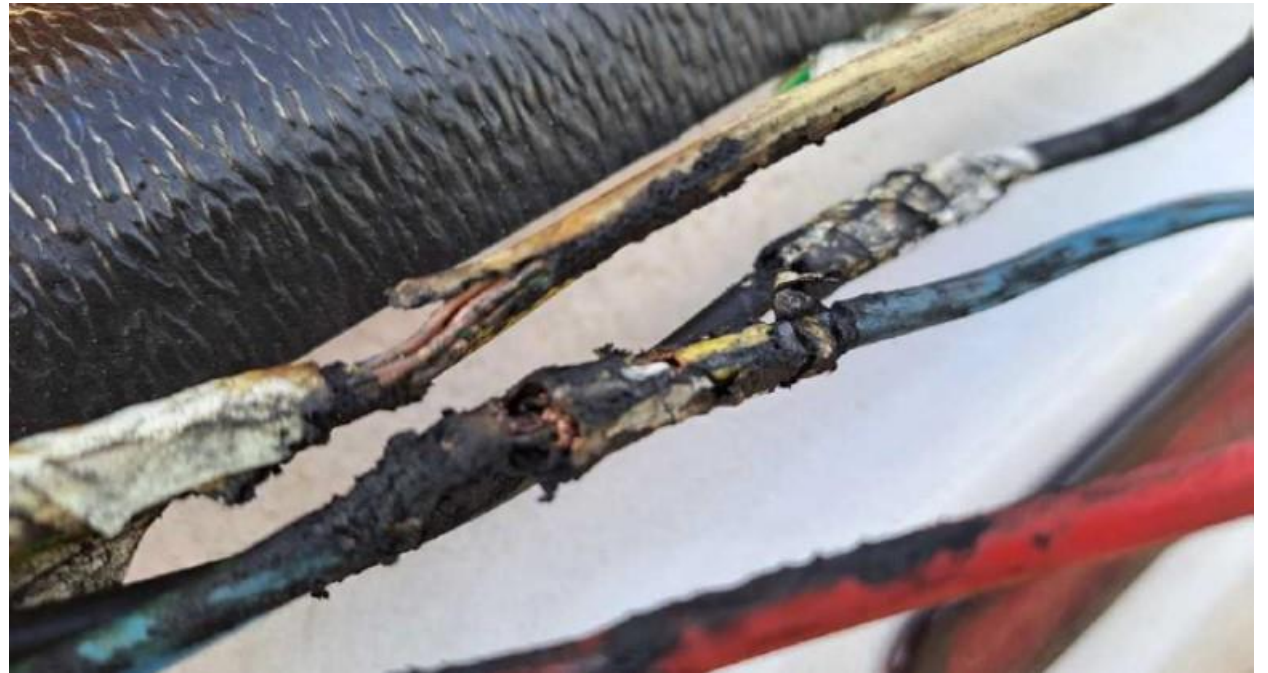
The internal view of the cable joint.  
The blue phase has shorted to the earth conductor.  
Note only standard PVC tape has been used on each of the connections to insulate each phase from the earth
