July 2022

Serious incidents resulting from the use of live polarity testing

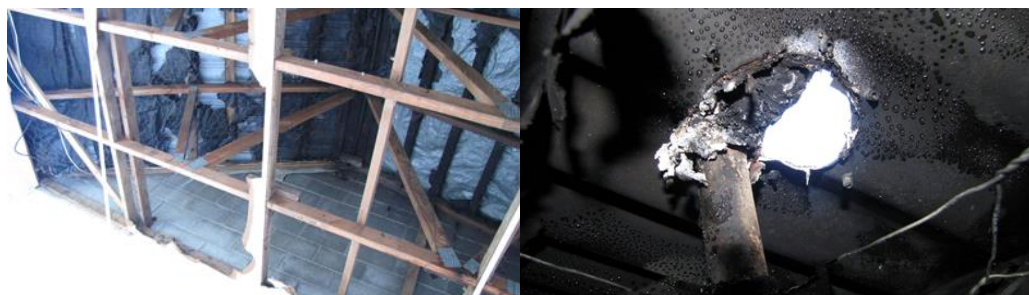
The transposition of the mains livened any electrically earthed connections, such as the hot water vent pipe.

Because the hot water vent pipe in this installation was equipotentially earthed, this caused a current to flow between the vent pipe and the iron roof. This resulted in intense localised heating and/or

arcing which in turn caused the building paper to ignite. This resulted in significant fire damage to the roof space of the residential dwelling.

Images showing fire damage in the roof space and the hot water vent pipe that was livened.

- These incidents would have been prevented by using the correct method of polarity testing. The polarity test that **must** be carried out is a deenergised polarity test. This polarity test method should be done after the connection has been carried out and before the installation is livened.

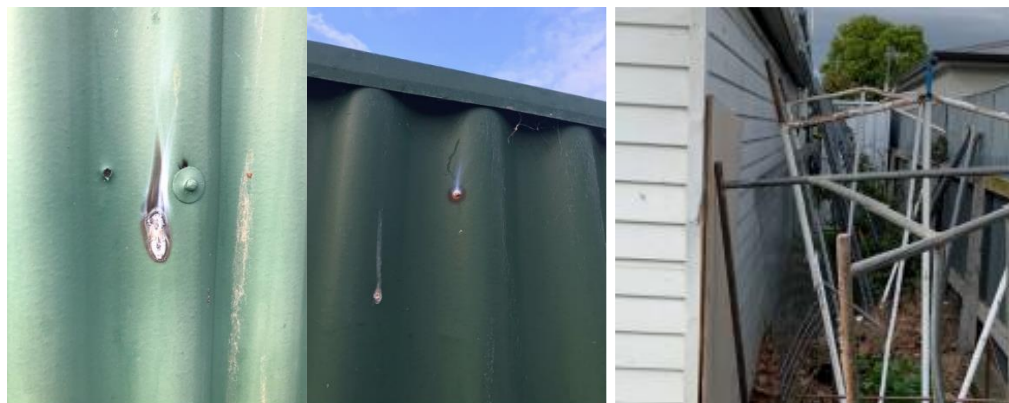
Turning the power on to conduct the polarity test, created a fault situation in which the transposition of the mains livened the electrically earthed connections. In this case the iron cladding of a storage shed on the school grounds was livened.

There were several iron poles leaning up against the shed which were in also contact with the neighboring iron fence. This resulted in a flow of electrical current between the storage shed and the neighboring fence causing arcing to the fence.

Images showing arcing on the iron fence and poles that were making contact between the fence and the storage shed.
