MONTHLY ELECTRICAL INCIDENTS

ASP Manufacturing

August 2022

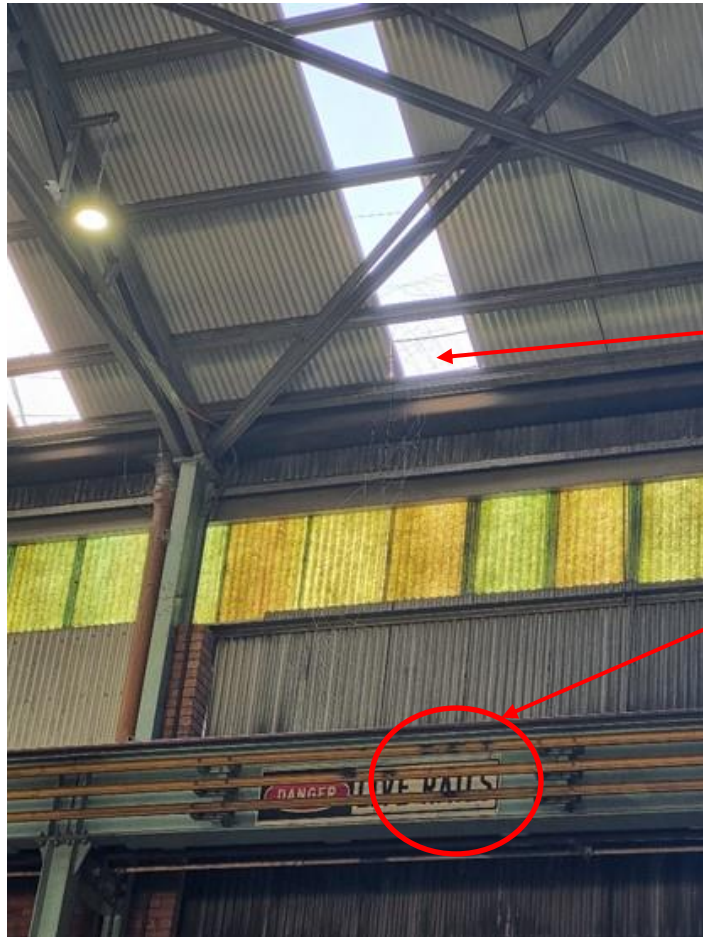
Roofing contractors lost control of a wire mesh coil while replacing Alsynite sheeting on a roof above energised 415 Vac live rail conductors. The coil unrolled as it fell through the roof opening and then contacted the live rails causing the 315 A supply fuses to blow before finally landing on the ground below. The fault left burn marks on the live rail conductors and parts of the roof the mesh had been in contact with.

The opening in the roof for the installation of Alsynite sheeting. The wire mesh has fallen through this opening onto the live rails below

All work near live rails must be assessed for adequate clearance and risks of encroaching the live conductor exclusion zone. Controls must ensure the exclusion zone will not be infringed or rails must be isolated. Isolation provides the most effective hazard control.

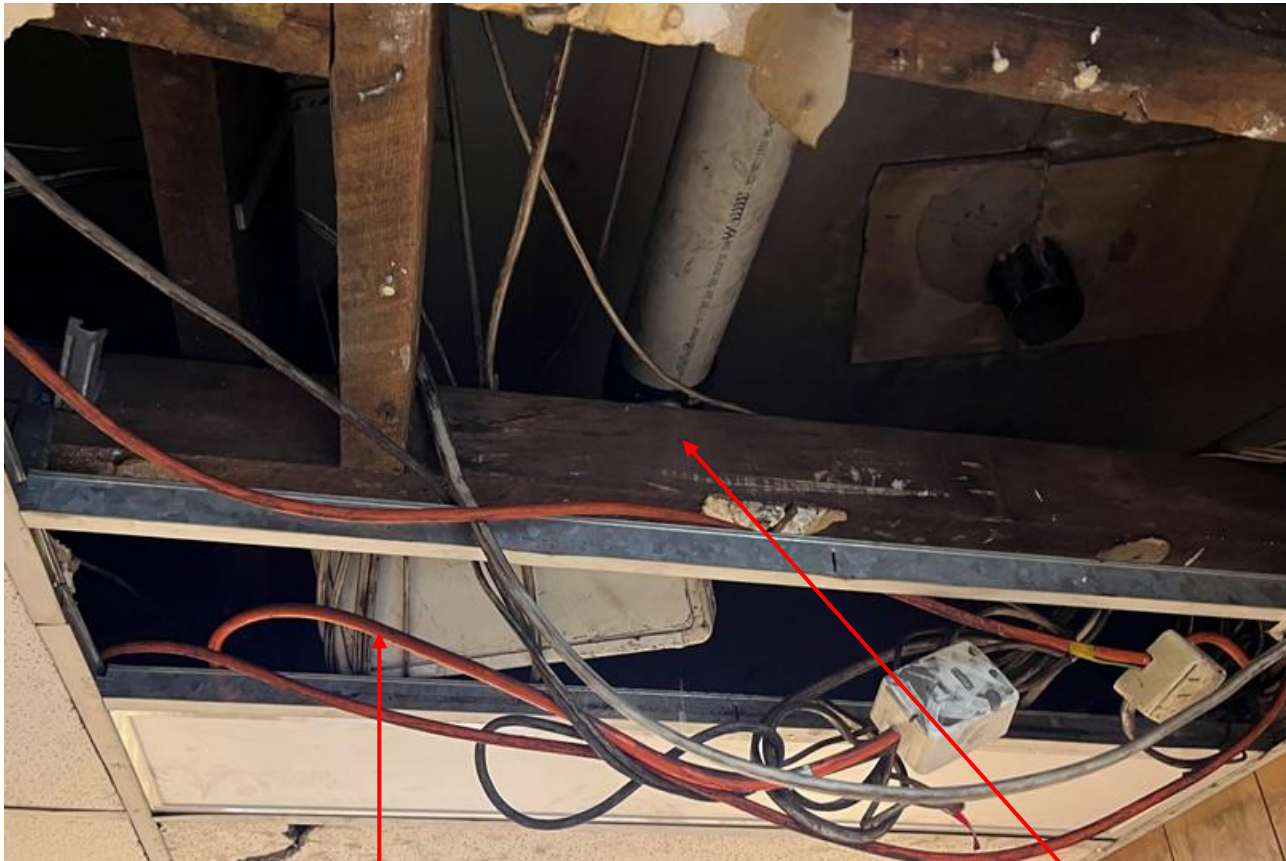
An apprentice plumber received an **Electric shock** while repairing a leaking pipe in an office ceiling. The leak was located above electrical cabling and a redundant emergency light fitting which had been left in the ceiling space. Power to other working light fittings had not been isolated before commencing work. Tests could not identify live voltages on cables in the area despite some being wet, however the emergency light fitting was found to still have 240 Vac on its terminals despite being redundant. Water has potentially resulted in leakage current from the terminals to the metal frame which the apprentice may have contacted.

The emergency light fitting with supply cable wrapped around it

It is essential electrical equipment is isolated before commencing work in areas at risk of contact with live parts. Water increases the risk of contact with electricity, hazards must be identified in job planning and risk review. Redundant electrical equipment must be made safe by removing all sources of supply. Redundant cables and equipment should be removed wherever possible.

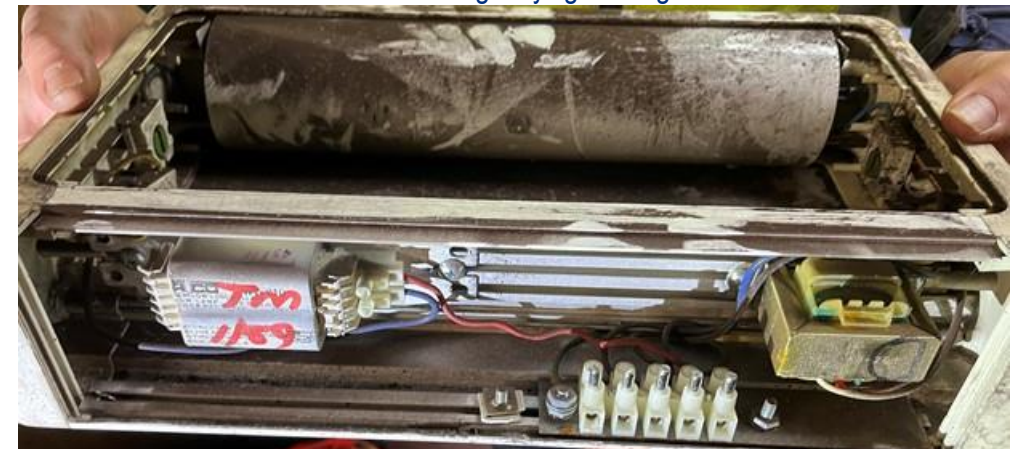
Energised 240V ac terminals inside the redundant emergency light fitting

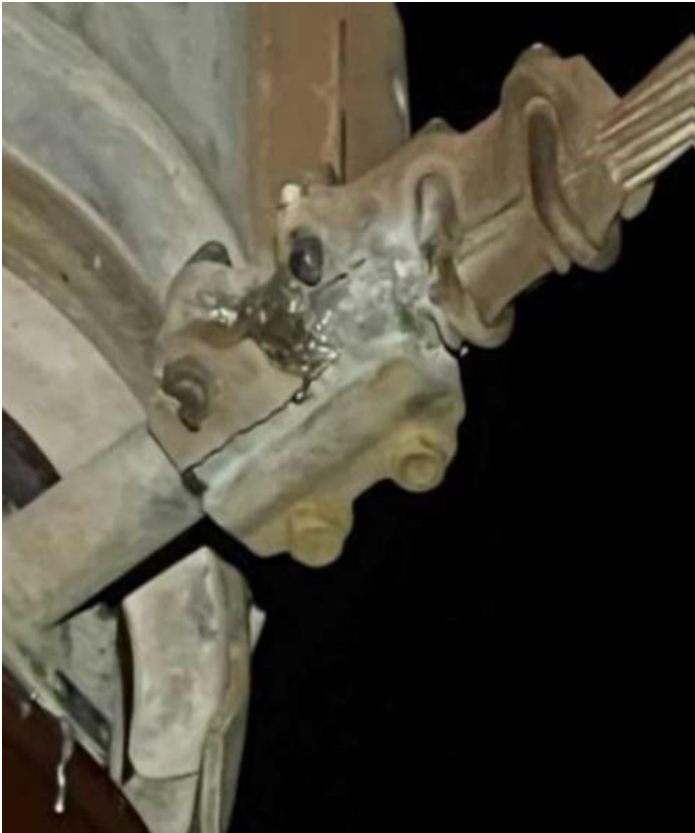
Cold Reduction personnel noticed a glow and flashes in the 33kV outdoor switchyard and contacted the High Voltage supervisor. The supervisor identified a bolt on a CT connection was glowing hot and molten aluminium was evident on the ground below. The FSM stopped rolling to reduce load and the site electrical engineer was informed of the problem. A switching instruction was prepared to complete investigations and repair. A thermal image scan found the joint to be at 212 degrees Celsius. The maintenance strategy is being reviewed.

A close up of the aluminium CT connection with melting damage due to the hot joint evident

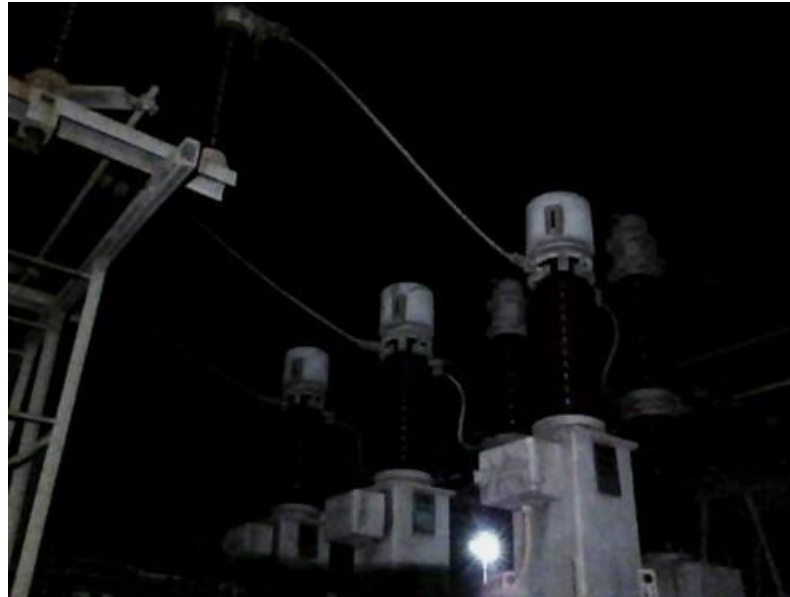
The incoming aerial supply CT connections at night when the hot joint occurred

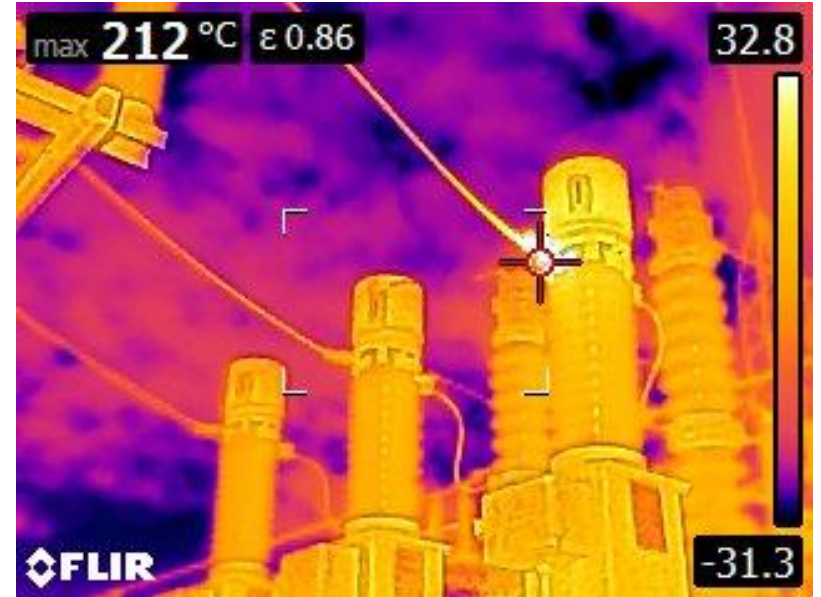
The thermal image scan clearly showing the hot joint

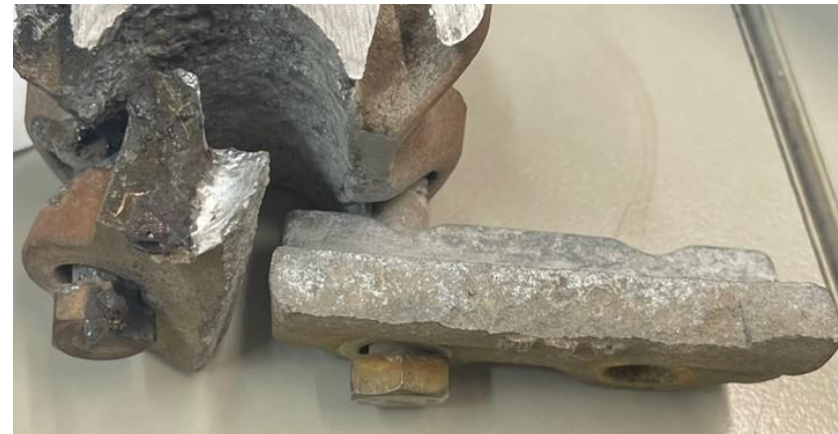
The aluminium connector after the event, showing a fault line which could be the cause of the hot joint

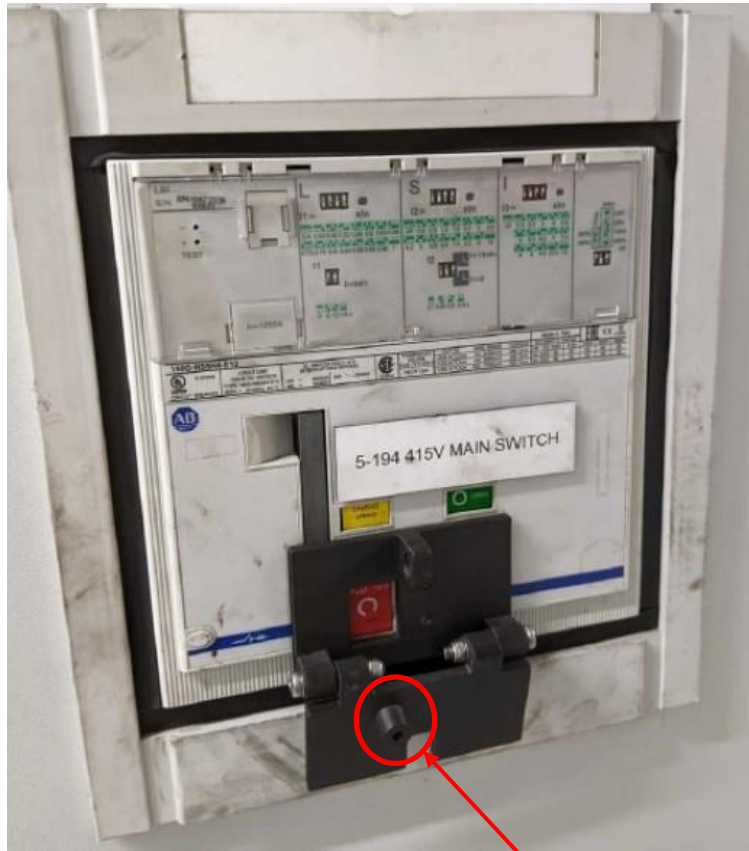
The isolation padlocking mechanism of the main ACB may not adequately secure the breaker in the isolated state depending on the type of multi-lock hasp used. The locking mechanism engages the breaker open button. Wear of the locking mechanism prevented a plastic multi-lock device from engaging the operator sufficiently to maintain disconnection and allowed the breaker to be closed with the remote close push button. The locking arrangement is not suitable for isolation purposes and will be replaced.

The locking mechanism at the front of the ACB. The lower flap closes onto the top section with the raised section depressing the open pushbutton

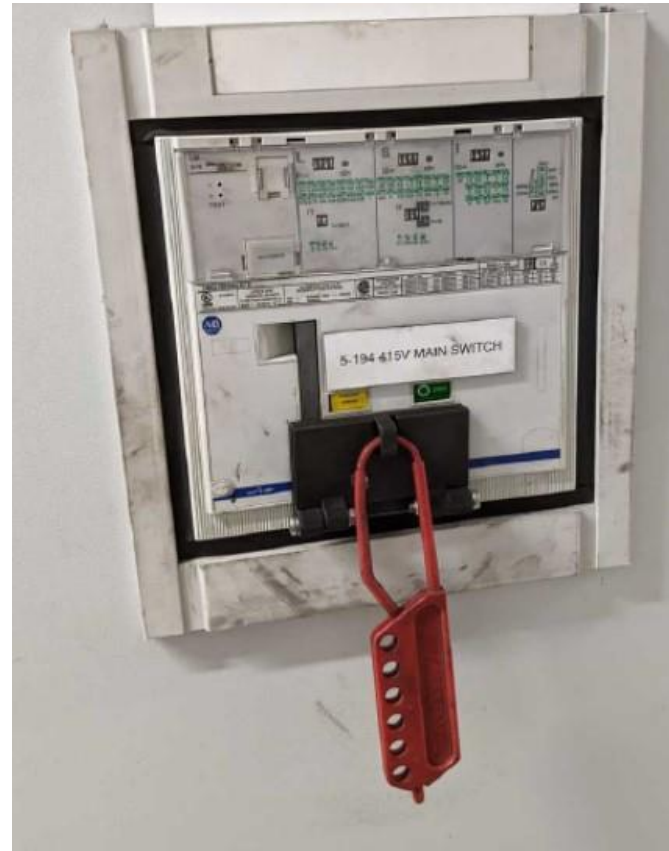
The ACB in the locked out position secured with a red plastic multi-lock device. The multi-lock does not engage the locking mechanism sufficiently to inhibit breaker close operation.

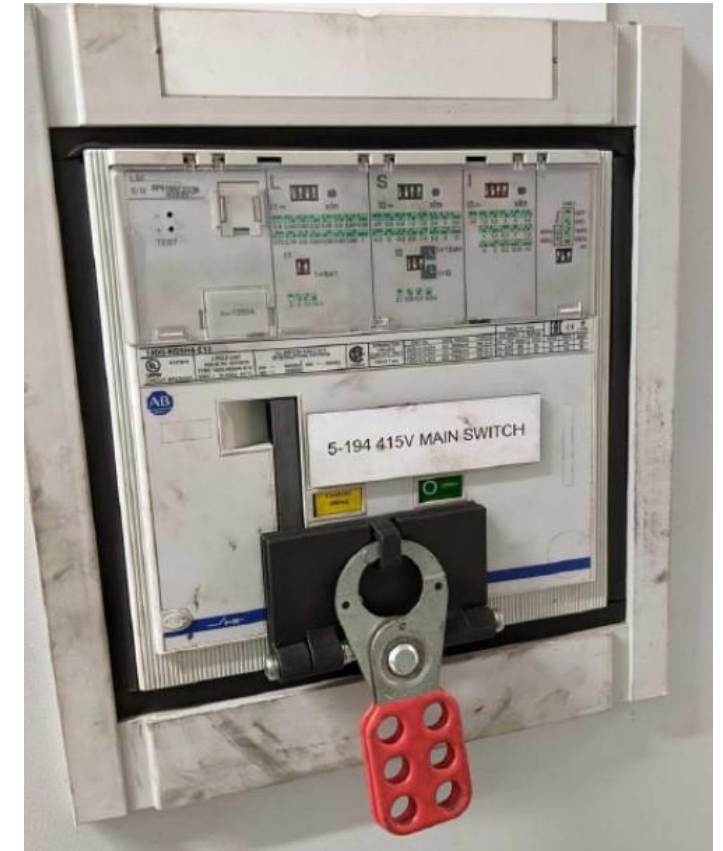
A metal jaw style multi-lock device presses the locking mechanism closer together ensuring the open pushbutton is sufficiently depressed to inhibit ACB operation

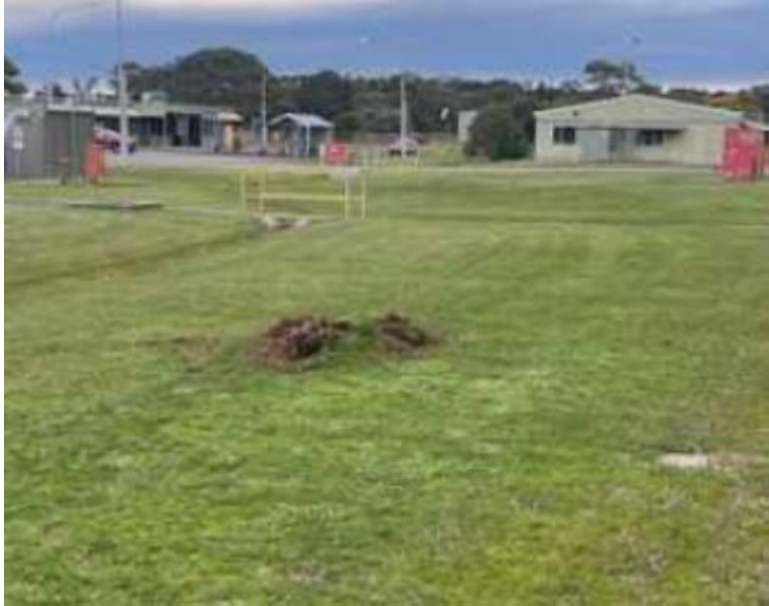
A 6.6kV underground cable tie between the HSM CR-6.6-107 and OFD CL-6.6-104 failed at a cable joint in a section buried approximately 1000mm below the surface. The location was easily identified with a large hole created on a lawn. The direct buried cable had a 100mm concrete cover. The fault explosion impacted the surface despite this.

The site of the cable damage and the hole in the grass

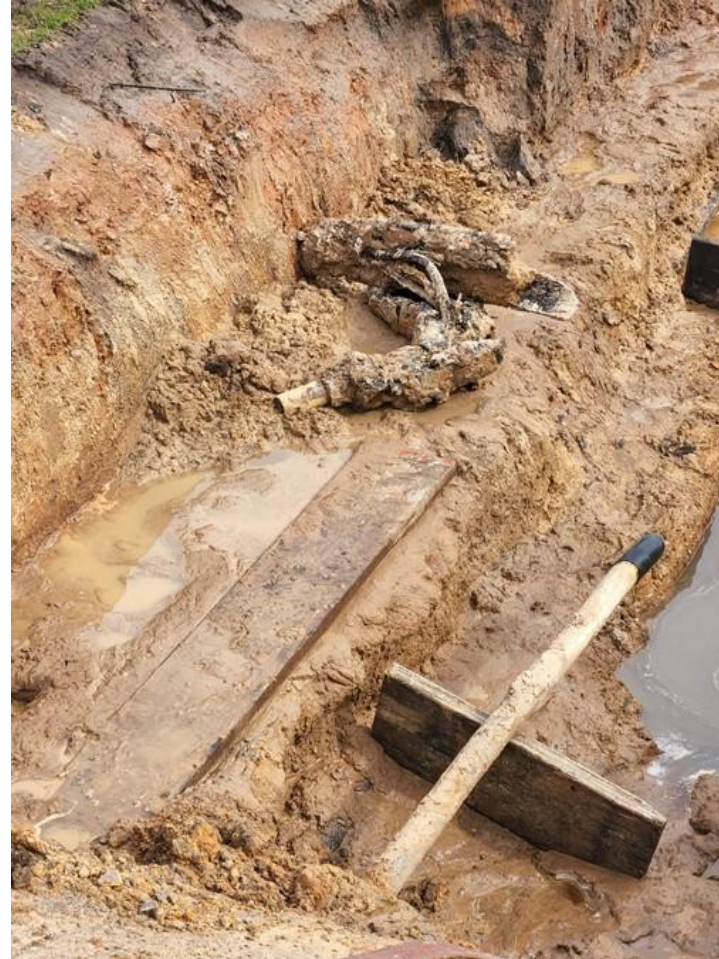
The remnants of the cable joint after it was dug up.

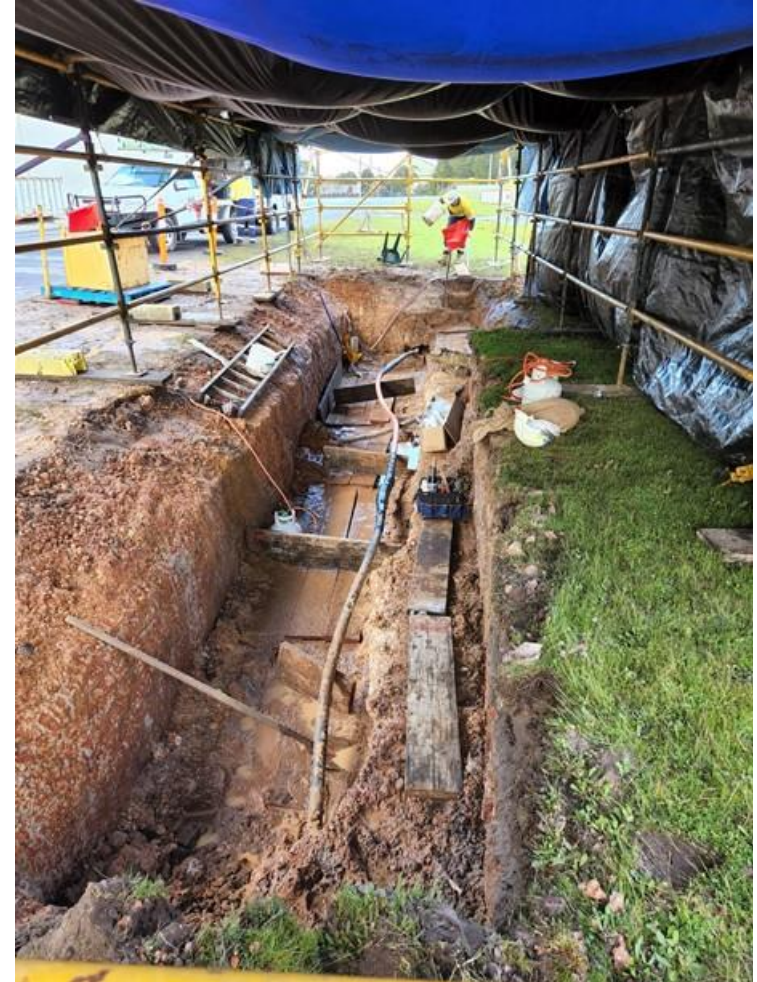
The excavation site of the new cable joints
