MONTHLY ELECTRICAL INCIDENTS

ASP Manufacturing

September 2022

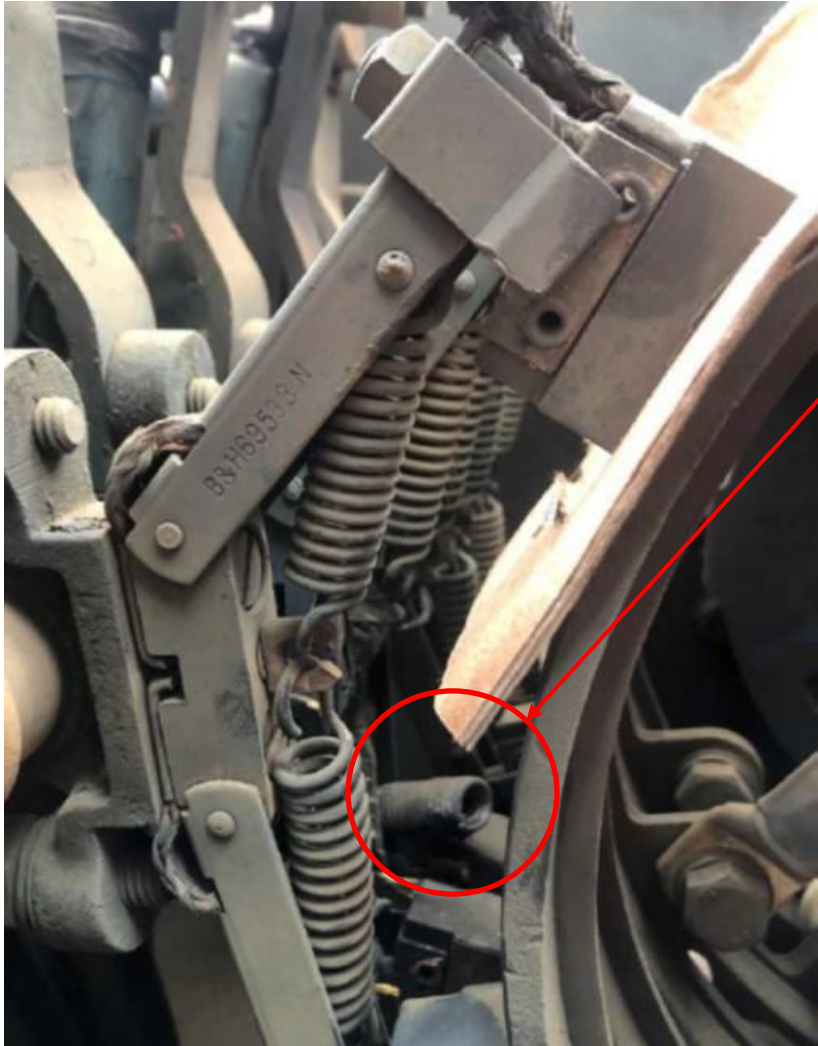
Operators of the Stacker/Reclaimer reported the machine had lost power and stopped by itself. Power Control found the white phase 63amp fuse of the 6.6kV trailing cable had blown. Further investigation found the tension spring of a 415V ac slip ring brush arm had failed resulting in a short circuit between the white and blue phases. The white and blue phase 500amp fuses of the 415 V ac supply were also found to have blown.

The arrangement of the 415V ac slip rings.
The failed spring after it has caused the short circuit

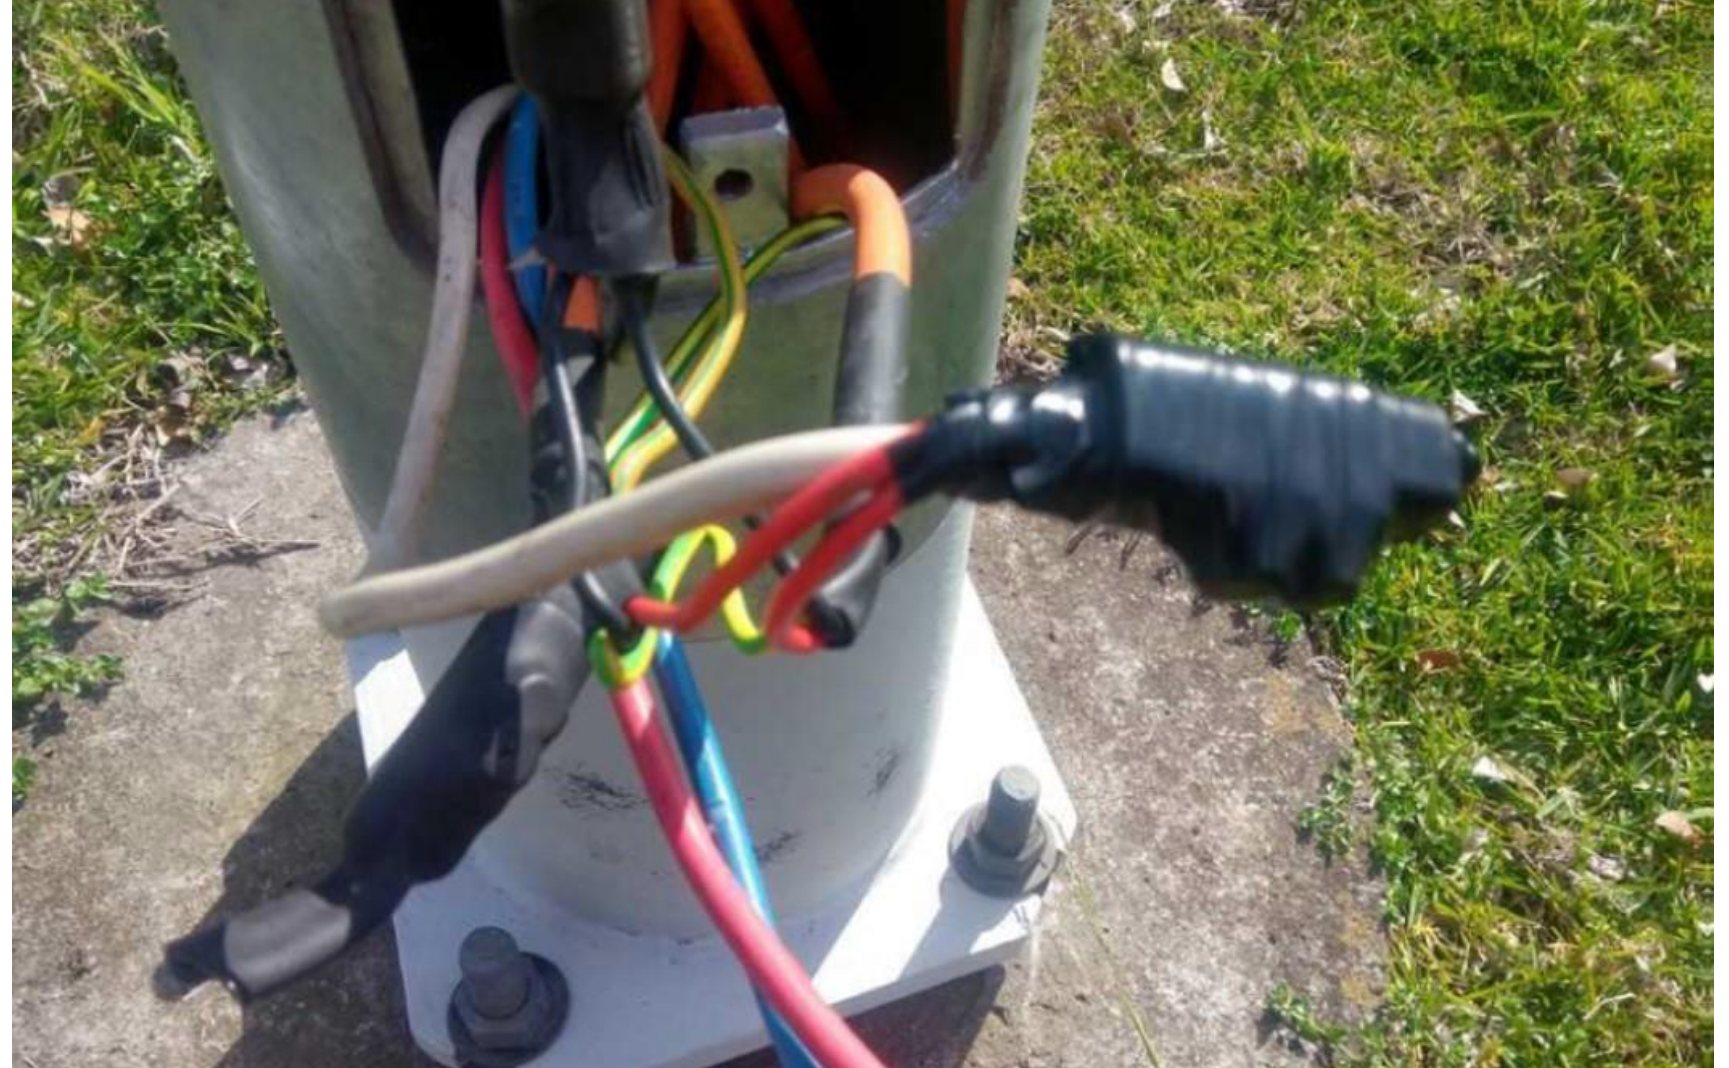
An electrician had to open the electrical access points of a number of lighting towers while fault finding. A tower which had recently been replaced was found to have wiring installed that does not comply with AS3000 protection requirements. A 50 A circuit breaker provides supply to a 16mm² 4C+E supply cable which loops in and out of each tower pole. At one of the poles, the 2.5 mm² single insulated cables to the lights at the top of the tower were BP connected directly to the 16mm² cores of the supply cable without additional circuit protection to suit the reduced conductor size.

The two 2.5 mm² red active conductors connected via a BP connector to the white phase 16 mm² supply core with no short circuit protection.

Licensed electricians are responsible for ensuring the safety and compliance of electrical installations satisfy the requirements of AS3000 to protect persons from electric shock.

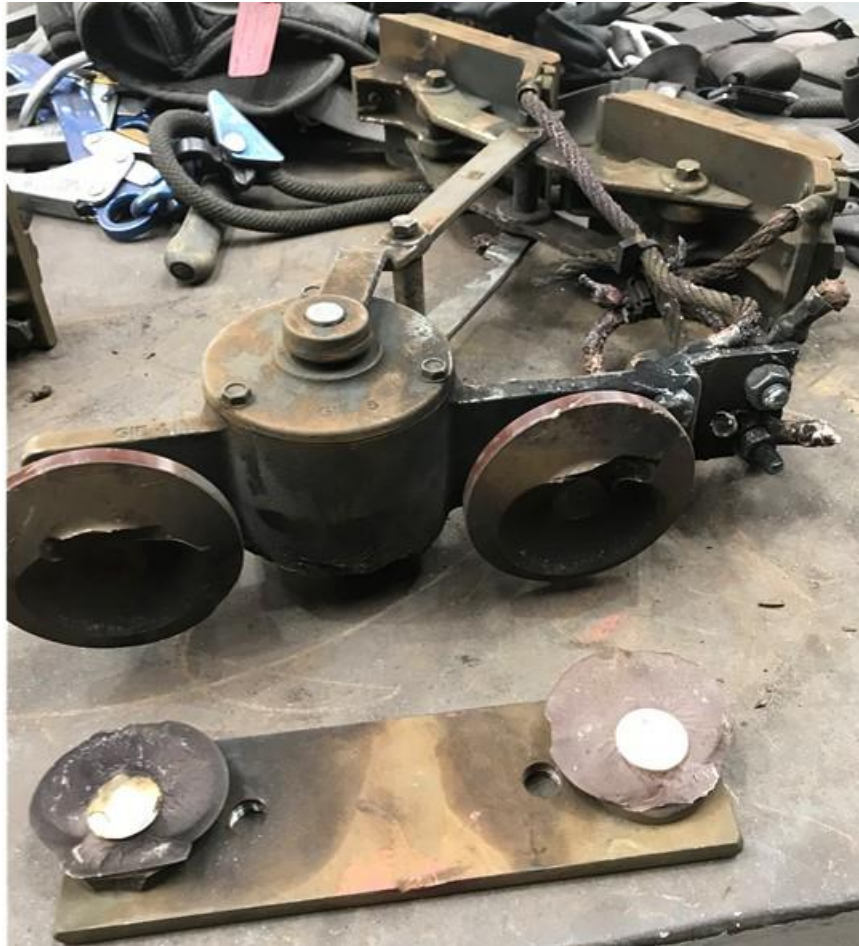
A crane driver witnessed a large arc flashover from the live rail collector gear when travelling west with No.1 Turntable crane. The top collector had broken off the insulator mounts allowing the collector shoe to contact the phase below and create a phase to phase short circuit. The fault was temporary as the collector fell free and the 500 A live rail supply protection did not trip. The top and middle rails and collector shoes were extensively damaged. The fault occurred near a joint and the rail was bowed. The mounting failure is being reviewed with the collector manufacturer.

The middle phase collector shoe with both supporting insulators cracked and failed. Note all the melted pig-tails and burnt arms

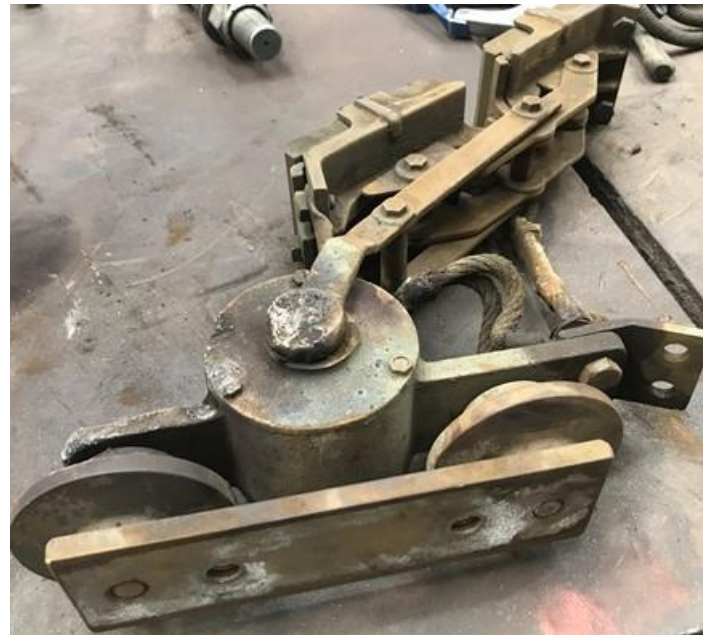
The bottom phase collector shoe and arc marks

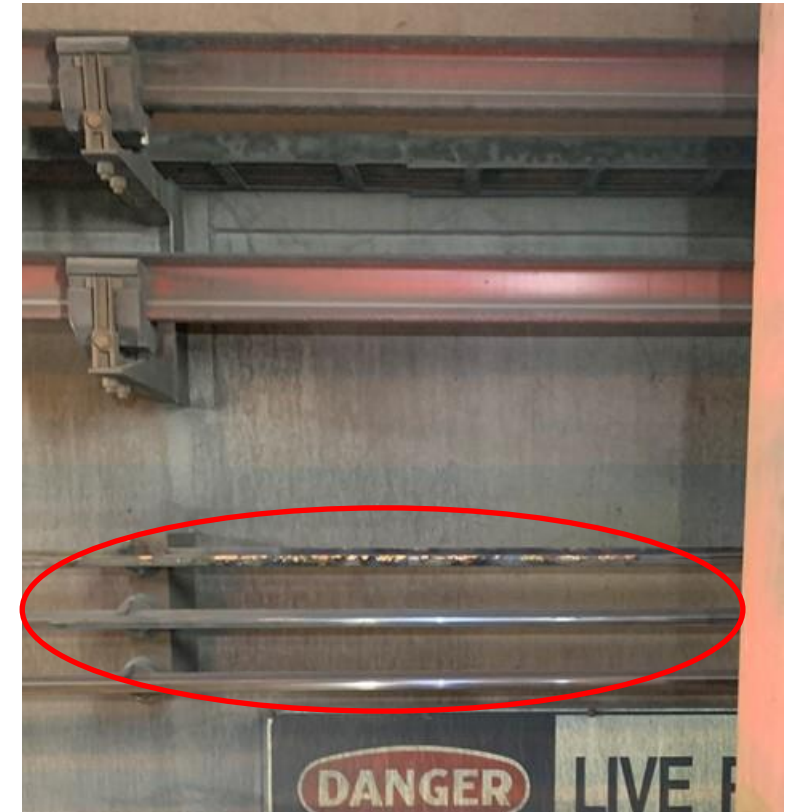
The damaged AC live rails

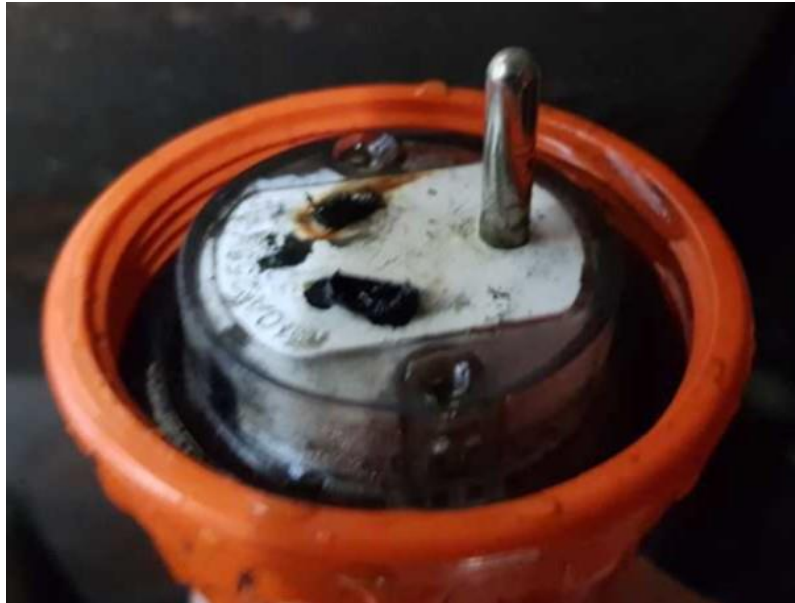
An electrician investigating the loss of basement lighting found one of the lighting outlets had water dripping from it. An IP56 rated socket outlet and plug are mounted on the ceiling with side entry cable conduit. Water has leaked into the basement and tracked across the ceiling to the outlet, eventually making its way into the outlet and plug connection. This created a high resistance short circuit between the active and neutral pins, damaging the connections and eventually tripping the 10 A RCD circuit breaker supply.

The IP56 rated plug with both the active and neutral pins missing, showing the heat affected areas

Suitably IP rated equipment must be selected and correctly installed in environments subject to water. This includes securing locknuts, conduit/cable entry points, mounting screw and covers so that the integrity of the IP rating is maintained for all components of the installation.

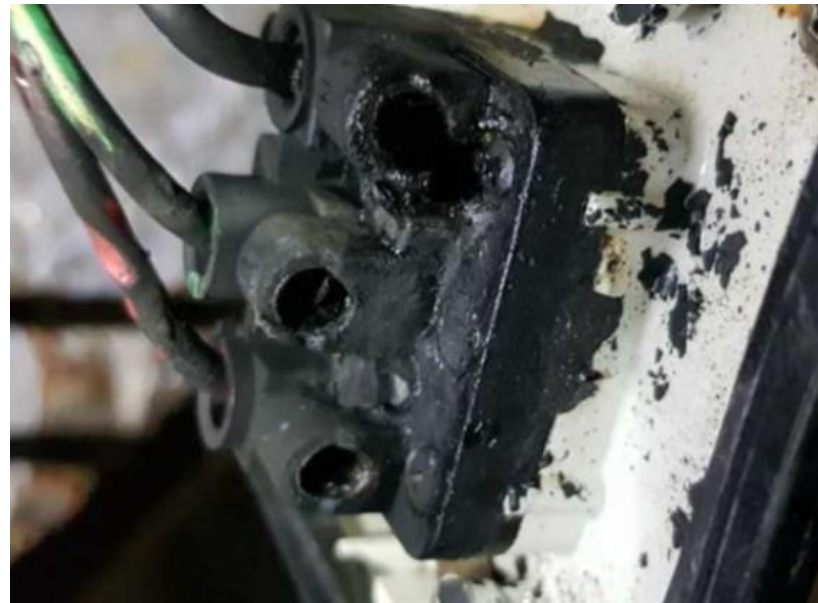
The inside of the socket outlet where the water has created a short circuit and hot joint between the active and neutral connections

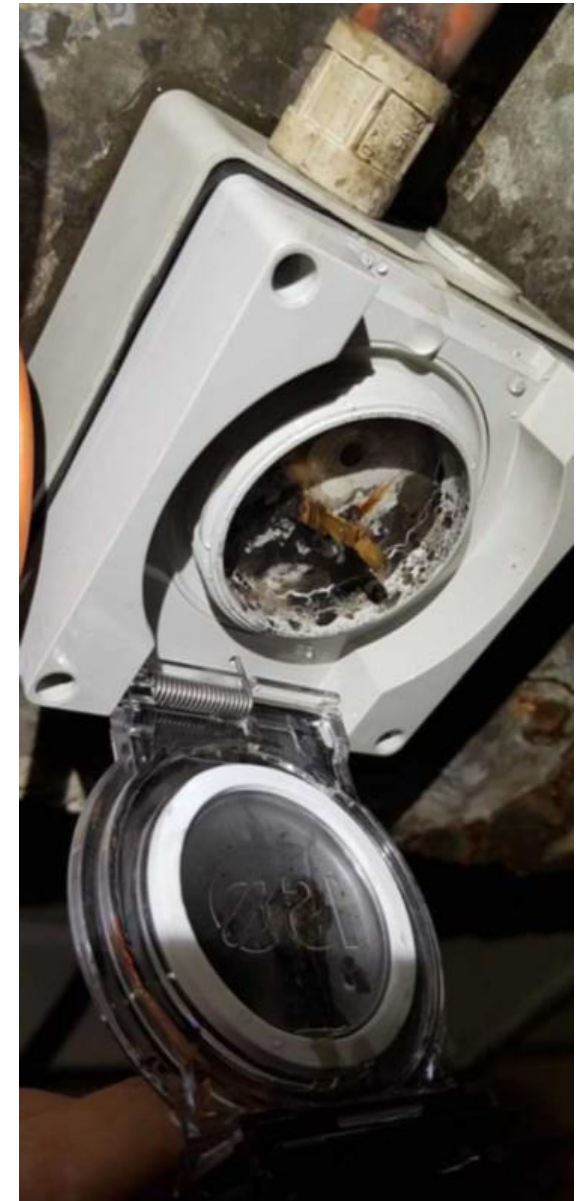
The ceiling mounted IP56 rated socket outlet showing signs of water. The pins of the plug are still embedded into the socket.

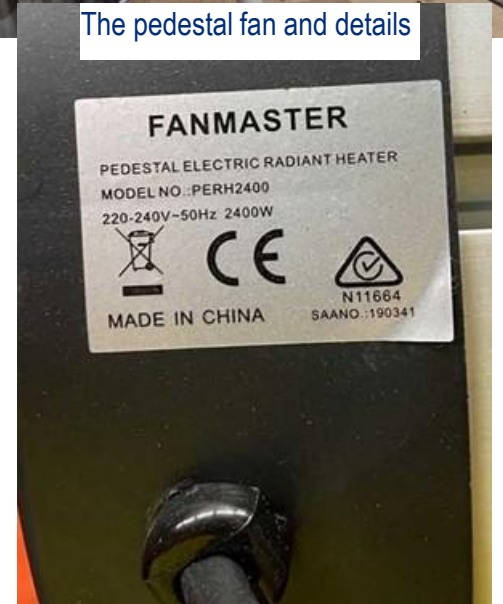
A follow up audit to incidents I2142440 and I2164101 identified two additional heaters with insufficiently rated or protected wiring for the internal operating temperature. One neutral had been completely burnt off, the second was in very poor condition. Three other units were found with high temperature wire and heat resistant sleeving installed on the active and neutral conductors. These modifications had been made either by the manufacturer or supplier, however a product recall notice has not been issued for the defective model. All units have now been removed from service at Western Port and the incident is being reviewed with the supplier (Blackwoods).

Examples of heat damaged neutral conductors on two different heaters:

1. The neutral reached a temperature where it has burnt through the active conductor insulation, created a short circuit and become detached from its connection point.
2. The heater has been opened up before the wiring has failed to find the neutral conductor already heat effected.

Anyone owning these heaters should either remove the unit from service or have it inspected by a licensed electrician to confirm if the unit is safe for use.

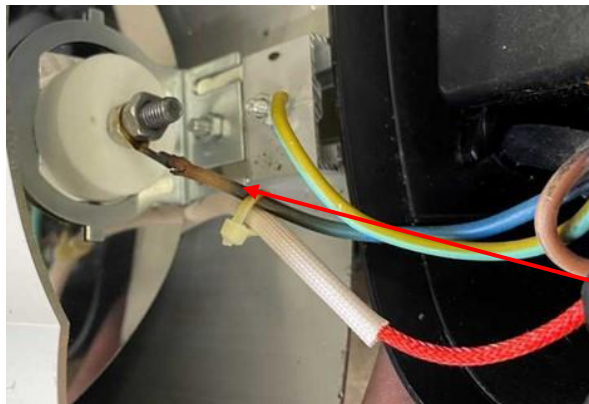
A heater with modified wiring.

Note 1, both the active and neutral conductors have high temperature rated insulation and additional heat resistant sleeves.
Note 2, the incoming PVC neutral conductor is kept clear from the heat source with the use of an inline connector

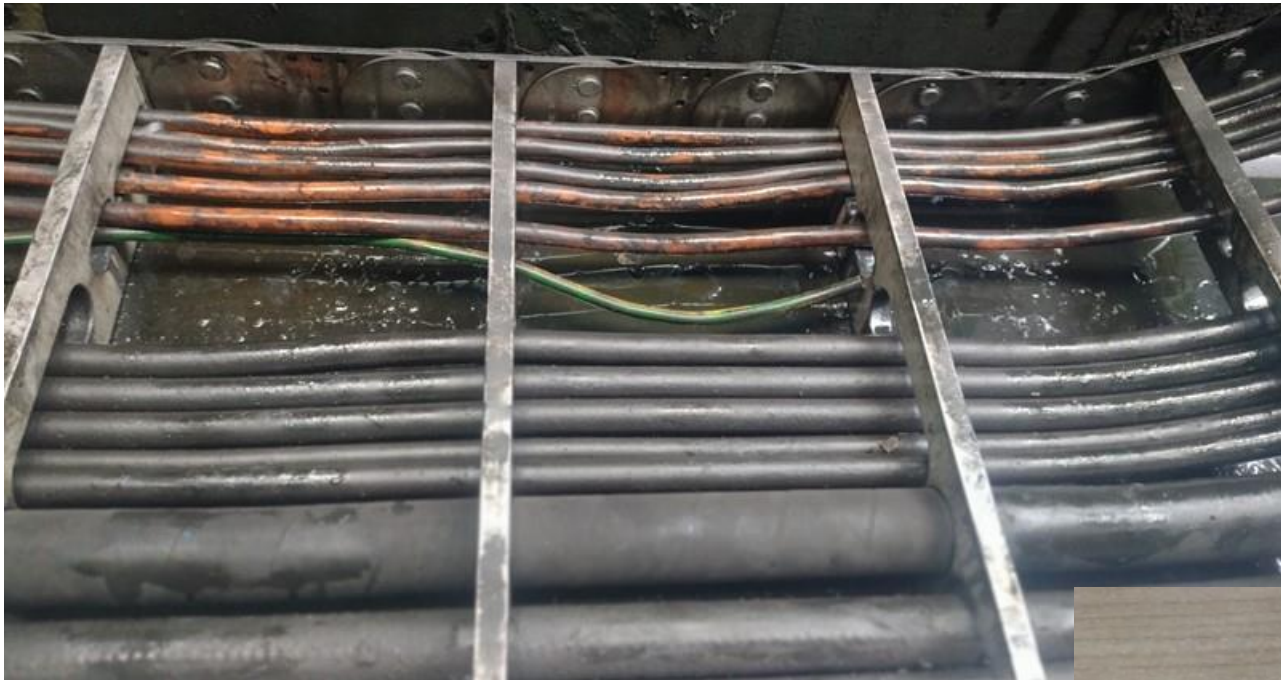
A damaged earth cable was found during routine maintenance inspection of a metal cable chain used on a roll grinder. The PVC insulation had become rigid and brittle, cracking in localised points, which then caused acute flexing at those points along the cable and eventually leading to conductor breakage. The insulation of other cables installed in the chain was found to be in good condition. These were correctly rated for flexible use and the oily working environment. The earth cable while flexible was constructed from standard PVC insulation which is not suitable for oily environments.

The metal cable chain, power cables and hydraulic hoses (bottom).
Cables installed in the chain are normally exposed to oil.

Cables must be selected and installed to suit the operating environment. In service inspections are required to ensure safety and integrity of the installation is maintained. This inspection restored the equipment protective earth, very important pick up.

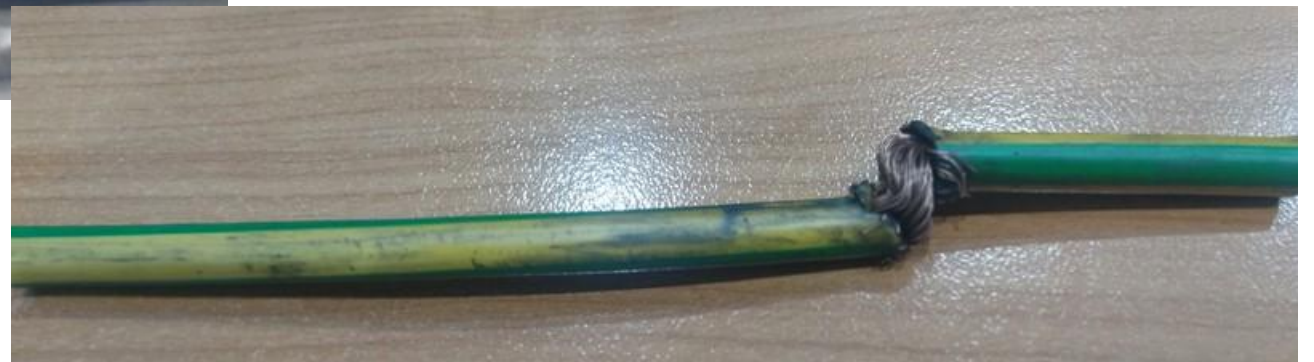
A section of the earth cable with failed insulation.
The cable is regularly flexed, insulation failed after becoming brittle.

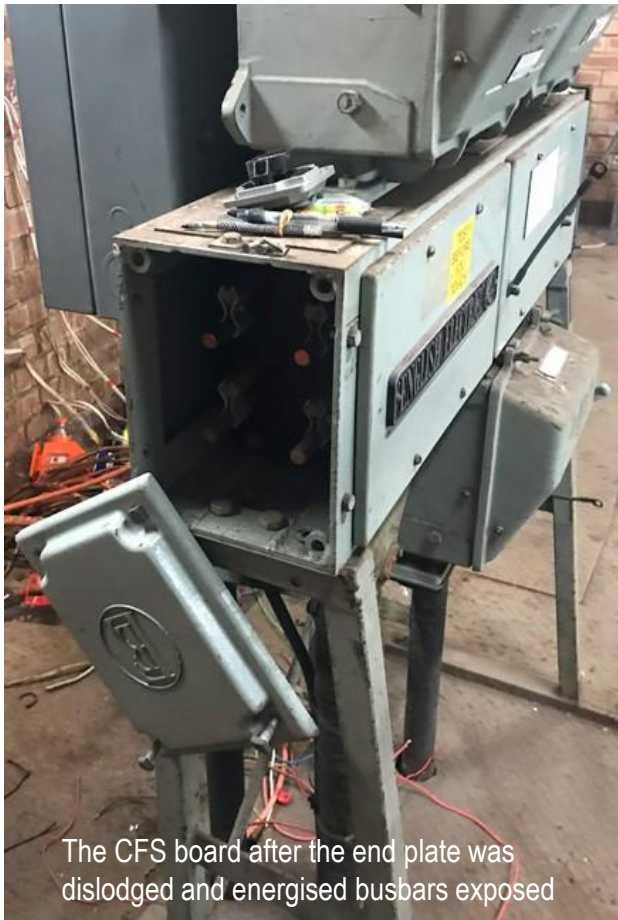
An electrician walking through switchroom A-11 brushed against a CFS board causing the end cover to dislodge. The cover was only retained by a single bolt and the high fault level busbars were exposed. Further inspection of the CFS board found the securing bolts of both end plates to be either very loose or missing.

The CFS board after the end plate was dislodged and energised busbars exposed

Incorrectly or inadequately maintained electrical installations and articles can create situations or conditions, which expose personnel to electric shock or arc blast and flash risks. Undertaking certain work on live LV distribution equipment may introduce the risk of electric shock or arc blast and flash burn injury from inadvertent interference with the high fault level busbar system. Isolate and verify the isolation before removal or reinstating busbar covers, bolts or screws. Refer to Electrical Safety Manual clauses 1.4.3.6 and 1.4.22.

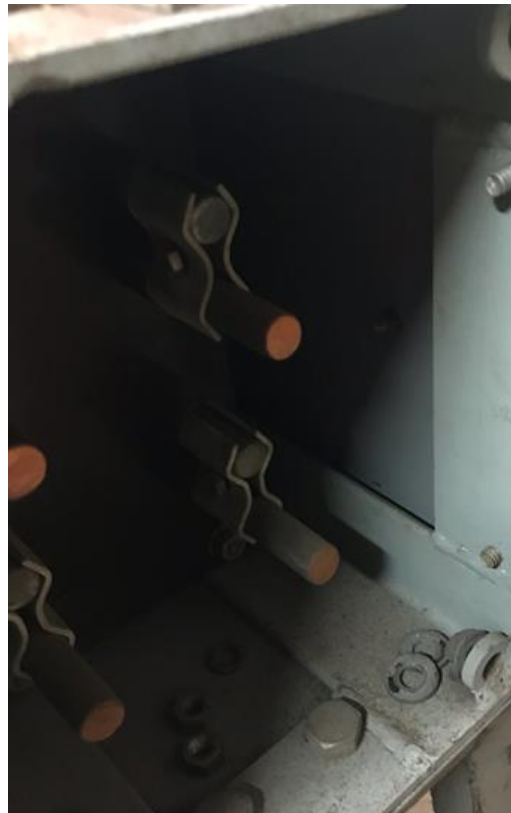
A close up view of the energised busbar and how close to the end plate they are.

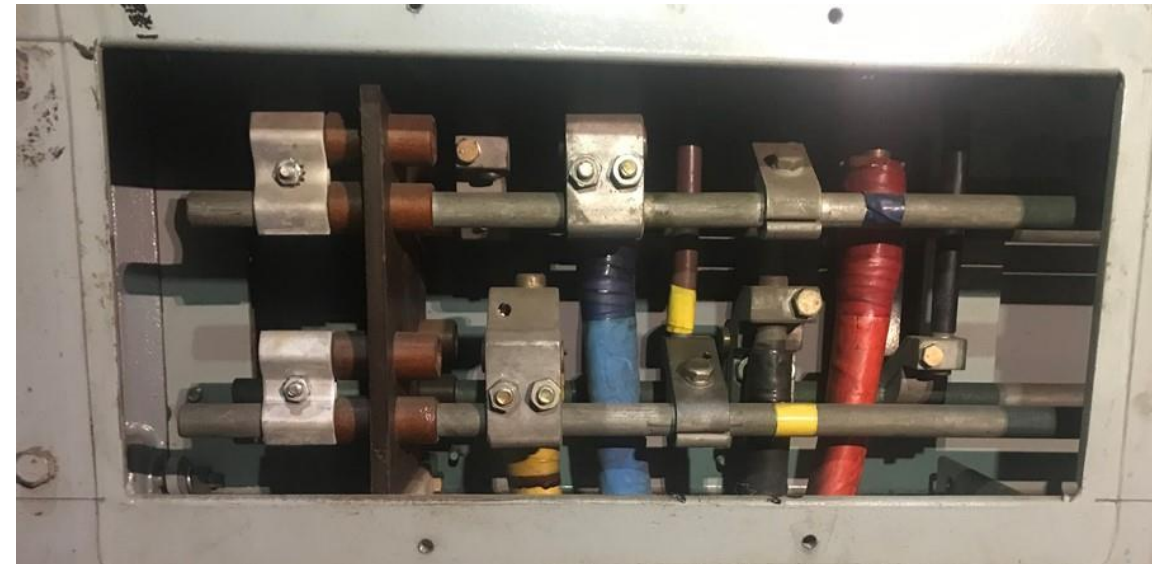
A side view of the CFS board busbar after isolation and covers were removed to secure the end plates
