# MONTHLY ELECTRICAL INCIDENTS

ASP Manufacturing

July 2023

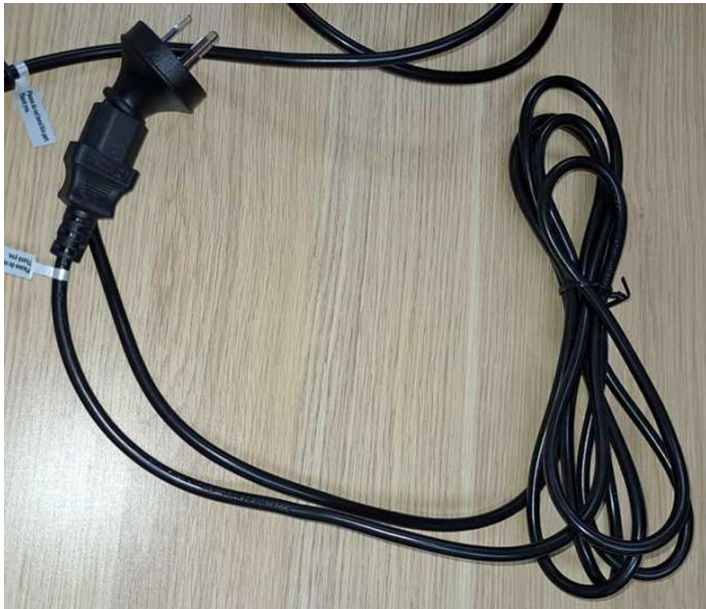
During electrical testing and tagging of new motorised office desks, it was discovered that the 240 Volt, 3 pin appliance leads of some failed the earth continuity test. The manufacturer of the leads had made them without an earth wire between the plug and connector earth pins. The desk was a double insulated appliance, so technically did not require an earthing conductor. However, there is a risk is the leads could be unplugged and used on other equipment that requires an earth conductor (e.g. test equipment or office printers with metallic parts). The supplier replaced the leads, and confirmed all other desks ordered have correctly earthed leads. It is important new appliances are tested before they are put into service, especially if they have 240 Volt detachable leads. Potential problems like this can be avoided by regularly testing and tagging our electrical equipment on site.

Common 240 Volt Appliance Lead

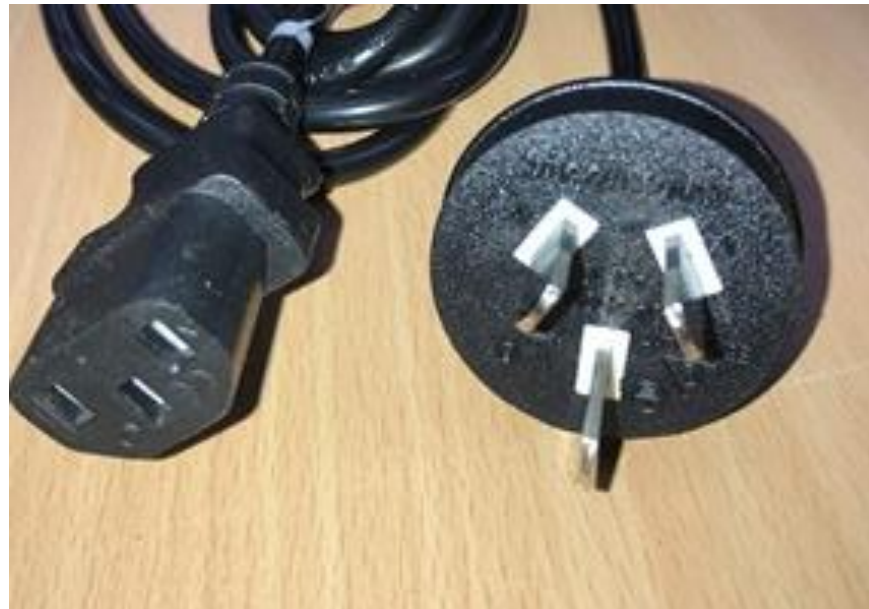
Earth Pins at bottom of both Socket and Plug

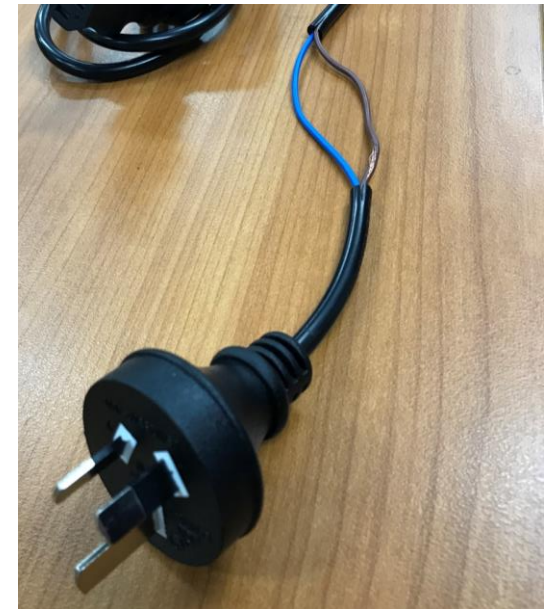
Only 2 wires in cable, no Earth conductor

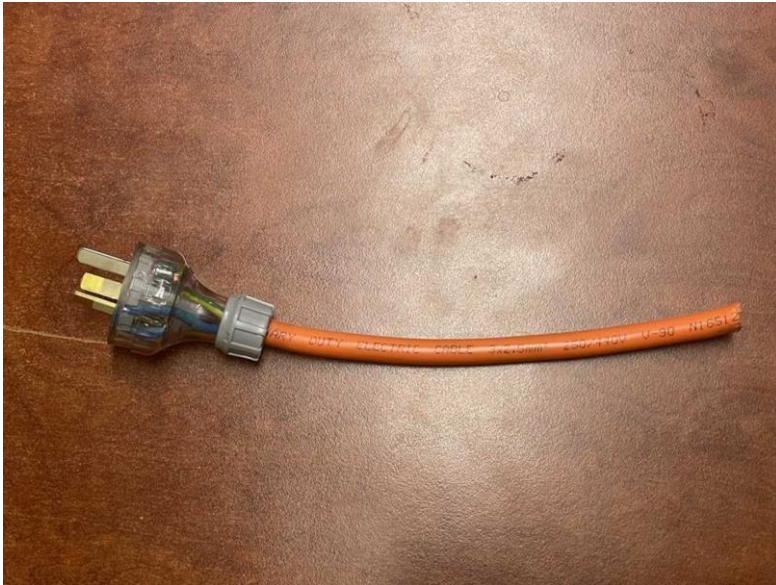
A 240 Volt plug and severed cable was found in a loading dock area where forklifts operate. The switch of the power point it was normally plugged into was still in the on position. The cause of the damage could not be identified, however the installation provided limited protection to damage from moving machinery and operations in this area.

240 Volt plug and severed cable

The movement of machinery, people, wheelbarrows, trolleys etc. needs to be considered when installing electrical equipment, and appropriate mechanical protection used. A mechanical barrier such as fixed bollards in front of this area would reduce the risk of this happening.

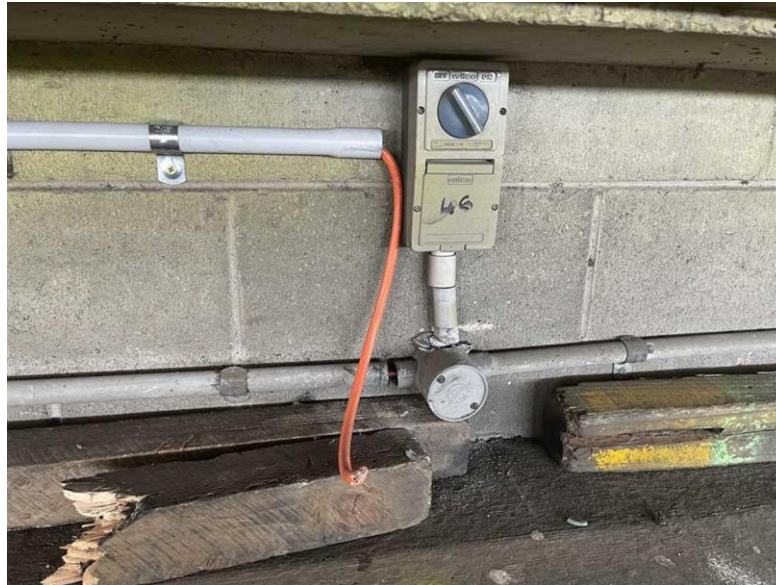
Power Point it is normally plugged into

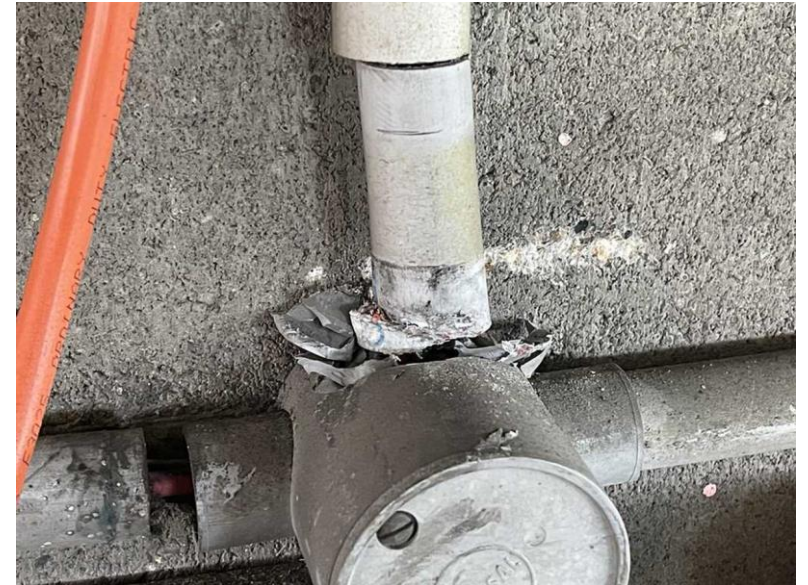
Damage to conduit and junction box below

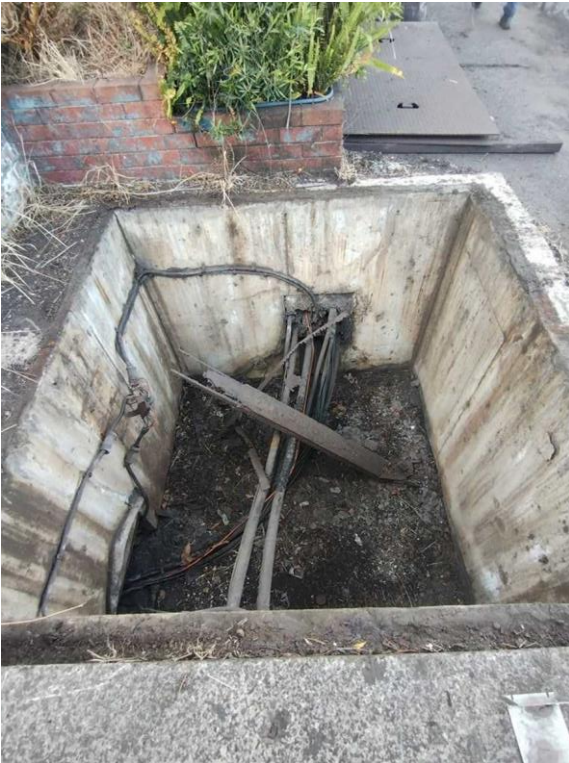
Pit with lid removed

When inspecting outdoor cable pits or enclosures, care should be taken when removing lids to look for corroded steel and exposed or dislodged wiring. Consider isolation before removing pit covers if there are concerns with the condition of the installation or the condition is unknown.

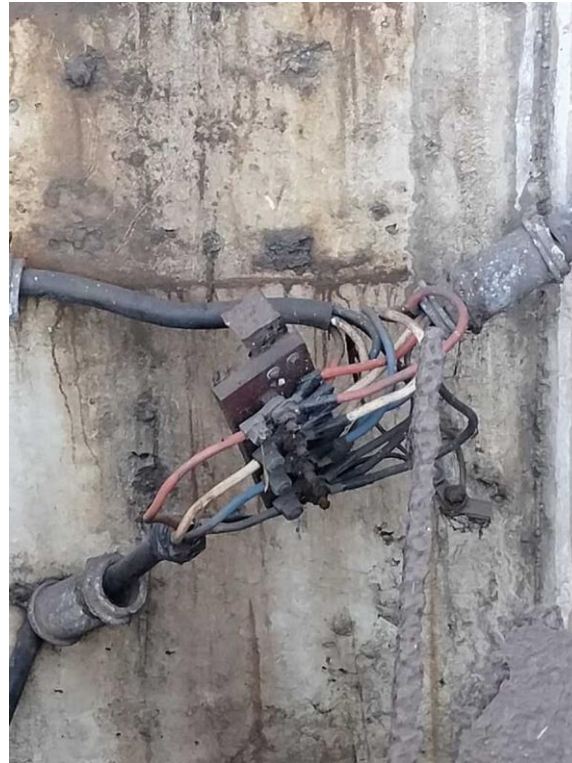
Exposed conductors were found in a pit after the lid was removed during cable installation work. The wiring had originally been enclosed in a steel box that had since rusted away. There was also a rusted steel beam that had fallen across the cables inside. After further investigation of the area, other steel junction boxes were found to be in a similar condition. The steel junction boxes and lids had deteriorated from exposure to the outside environment.

Exposed wiring inside pit

The use of stainless, galvanized steel or aluminum would prolong this decay. IP rated PVC enclosures, if suited to the environment, would eliminate the issue of rust too.

Electrical installations must be adequately inspected and maintained to ensure integrity and safety.

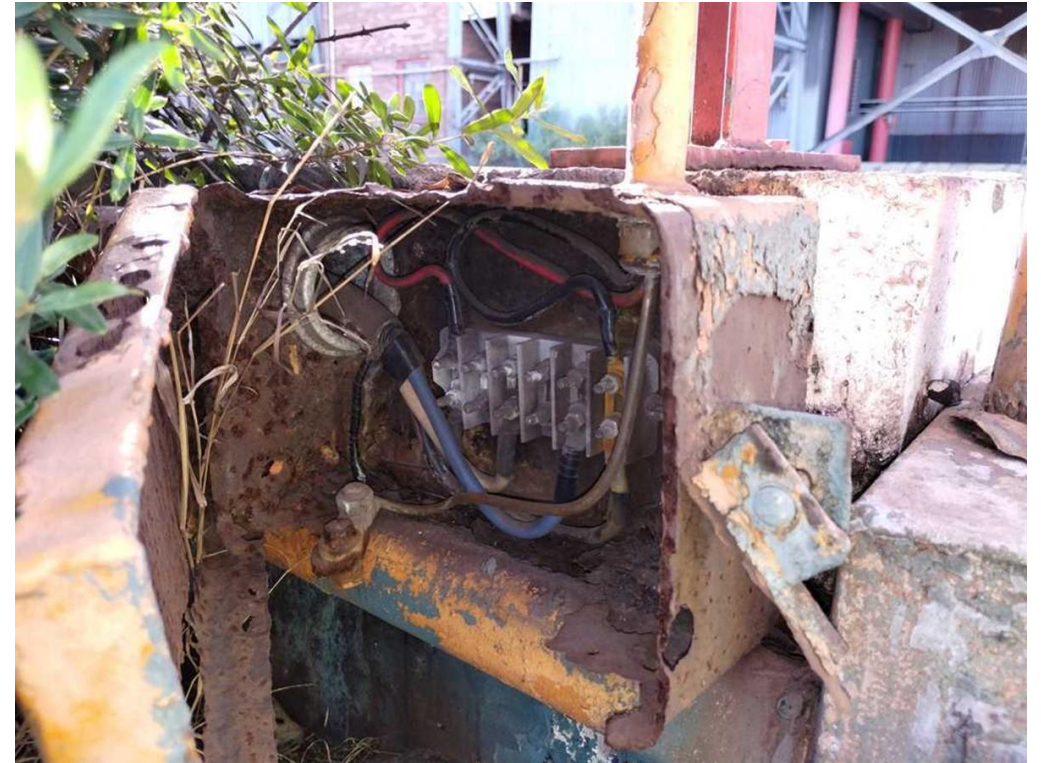
Nearby Steel Junction Boxes

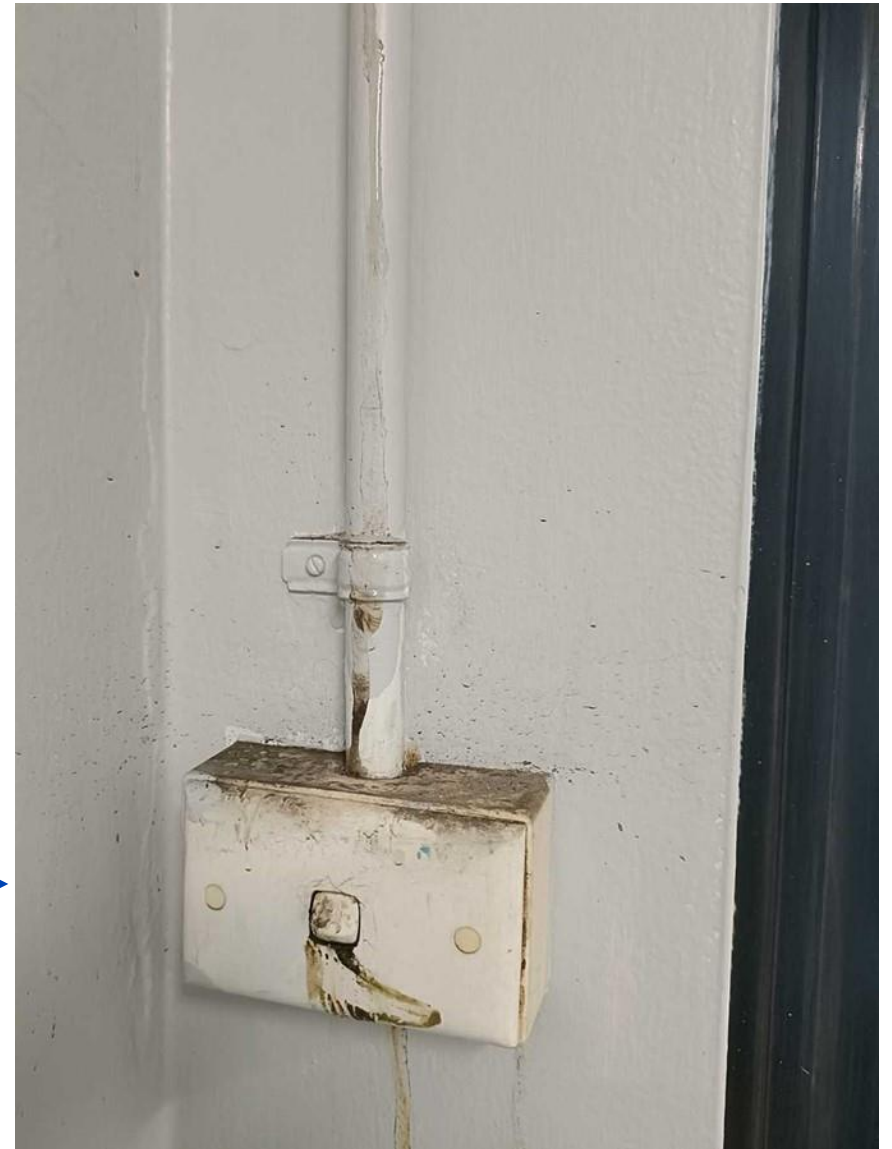
Water had been leaking from the ceiling of a bathroom for several days. The leak was notably getting worse on the 4<sup>th</sup> day, and then by the 7<sup>th</sup> day, a crackling or buzzing noise was heard from the electrical switch on the opposite wall. By then, water was running down the ceiling, through an electrical conduit, and into the switch. Discoloured water and smoke was coming out of the switch, and by the time electricians arrived the smoke was denser, and a burning smell present. Power was disconnected and isolated at the point of supply, for future repair.

Failure to fix a water leak straight away allowed water to find its way into electrical equipment.

Electrical Switch showing signs of water ingress →

Water leaks need to be reported and fixed as soon as possible, especially if near electrical gear.

Electrical equipment should be installed to prevent water ingress. Some examples include bottom cable entries, sealing existing top entry conduits, positioning ends of conduit in such a way they cannot fill with water, drainage points or holes.

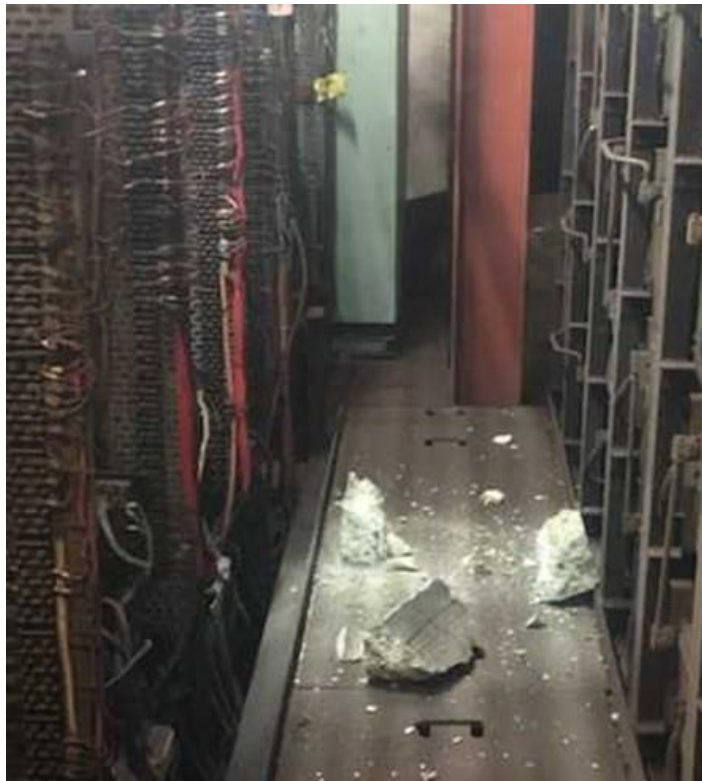
Pieces of concrete were found on the floor of a switch room (“contactor house”). Upon further investigation, up to 3 spalling areas were identified. Due to affected areas being out of normal thoroughfare, they were not spotted earlier until the area was searched. The area was barricaded, and a civil contractor contacted to assess and make safe.

Concrete pieces behind electrical panels

- Inspections of the switch rooms generally concentrate on electrical hazards, and not always the structural integrity of the building around them.
- Concrete can deteriorate with age and fall unexpectedly.
- Regular assessment of buildings and concrete will help us find warning signs before they become a hazard.

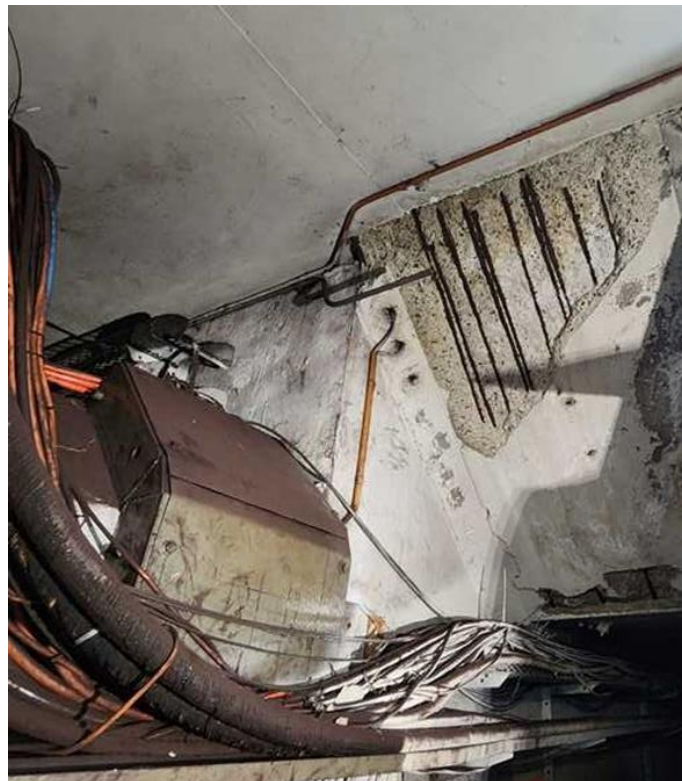
Roof above cable trays deteriorating

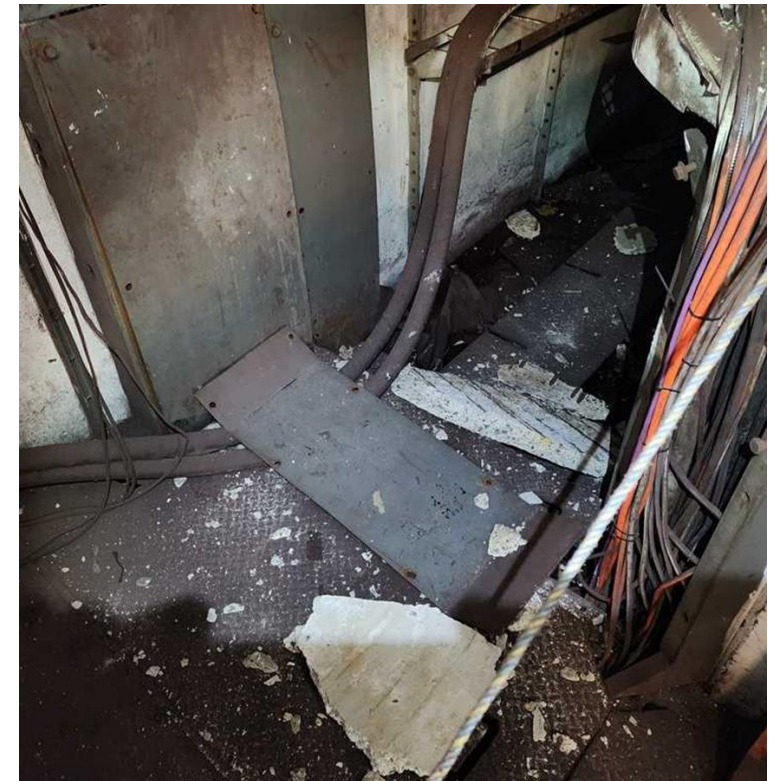
Concrete falling near cables
