# **Electrical Incidents**

# Key Learnings

**ASP Manufacturing**

September 2023

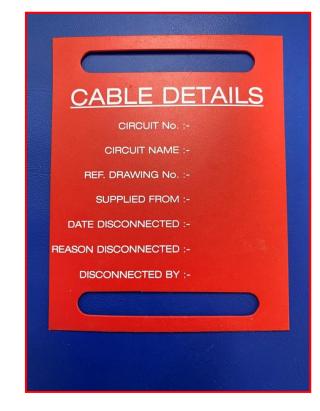
Polypropylene 100mm x 80mm tags

BlueScope – SAP Material No. 10100968

Refer to this for details on isolation, bonding of conductors, tagging and capping of cable ends.
- Following the Test Before You Touch process on any exposed conductors in the work area will help us find traps like this.
- To help identify redundant cables that have not yet been removed, use a "Cable Details" tag filled out using a permanent marker pen, include all relevant information, and attach to cable ends using cable ties.

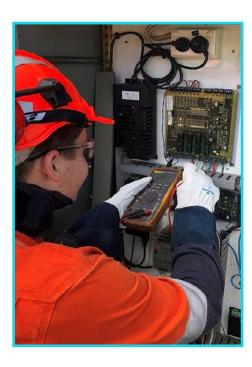
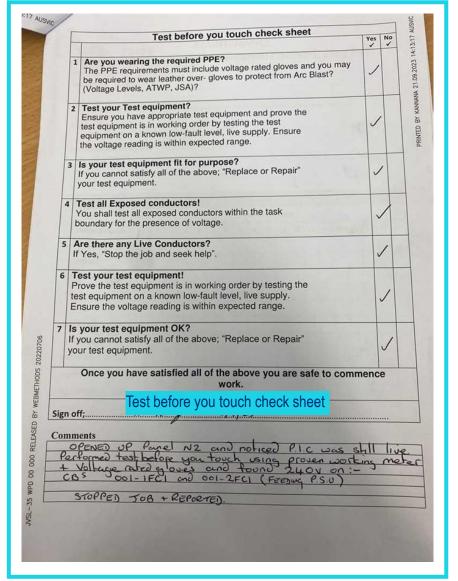
- Before commencing maintenance on an electrical panel, an electrician performed a test before you touch process using their meter and detected an energised 240V AC circuit. The job was stopped, the incident reported, and an investigation began.
- It was found that due to recent wiring changes, the isolation for the task was now incorrect. At the time of the wiring mods, isolations were identified as needing review & updating. This one was not updated yet. Marked up drawings of the wiring changes were still being processed too.
- The Test Before You Touch process worked, and a potential hazard was identified.
- Steps in the change process were not complete yet.
- Temporary signage or drawings on modified equipment help highlight the changes to people working on them.
- Steps in the change process need to be reviewed to confirm they are completed correctly and in a timely manner.

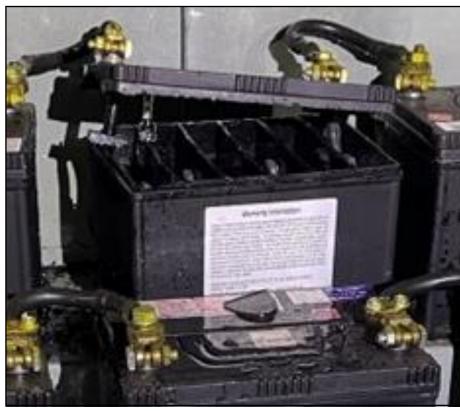
- A battery which formed part of a 110V DC closing supply for High Voltage Circuit Breakers failed under load, when a circuit breaker was being closed remotely. The brand of battery is only used at two locations, and they have been in service for 3 to 4 years but have recently started to fail. Newer replacement batteries of the same brand have failed also.
- Regular maintenance is done on the batteries and a root cause of these failures is yet to be determined.
- Key Learnings Even well maintained batteries have the potential to fail catastrophically (especially under load).
  - When switching HV circuit breakers, it is important to stand clear of the breaker as well as the closing supply battery enclosures.
- By ensuring battery enclosure doors are closed, we will limit exposure to these types of failures.

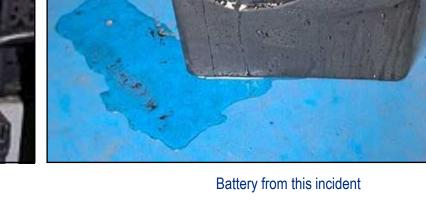
Same Battery type from another incident

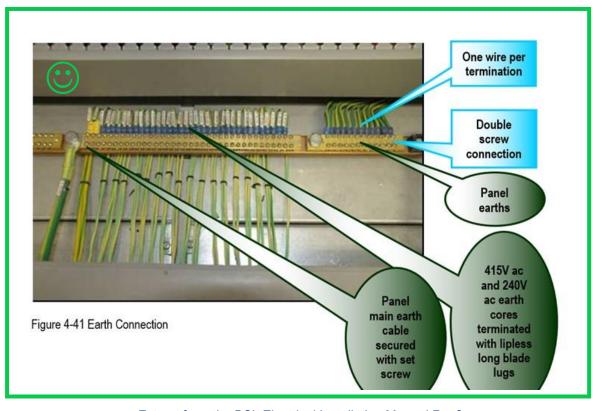
- During fault finding of a large industrial grinding machine, an electrician found the Main Earth Wire was loose in the Earth terminal that they were using as a test point for their meter. The Grinder had been in service for less than a year after commissioning.
- The DIN rail style earth terminal failed to maintain tension on the earth wire.
- The BlueScope Electrical Installation Manual (Rev3) states '4.7.6 Earth terminal strips should only be used for Extra Low Voltage applications and for terminating spare cores. All power distribution and multicore motor cable earth cores shall be terminated at panel earth bars.'
- This sort of incident could be avoided by ensuring
  we specify Double Screwed Earth Bars from our
  suppliers of new equipment, and retrofitting bars where
  we find Low Voltage Earth terminals in service.

Extract from the BSL Electrical Installation Manual Rev3 MA-ENG-INS-001 – showing correct use of panel earth bars

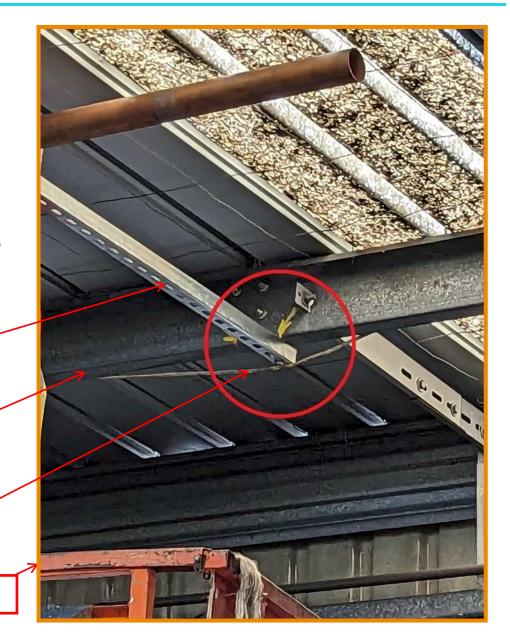
- Whilst installing brackets between roof purlins to support some copper pipes, a plumber has accidentally
  drilled into an electrical cable that powered the ceiling lights. They did not feel any electric shock, the drill was
  double insulated and the Elevated Work Platform they were in, had rubber tyres. It appears the circuit
  protection tripped due to the drill bit being a short circuit between the damaged cable and the building frame.

Support for copper pipe

Roof Purlin being drilled

Electrical Cable pulled out

**Elevated Work Platform**

- The initial JSEA for the job did not identify the possibility of electrical hazards.
- When planning all jobs, even non-electrical tasks, we need to consider the potential electrical hazards near or even hidden from view in the area we are working. Drilling into wall or ceiling cavities is another common task, where cables may be present but not clearly visible.

- A more thorough pre-inspection of the work area and seeking the advice of an electrician would have helped prevent this.

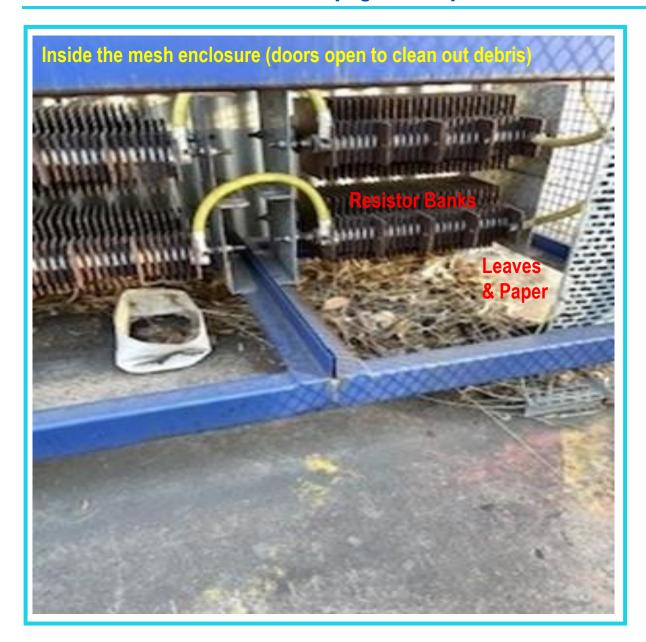
- While performing an audit on an Electric Motor Load Test Facility, it was noticed that
  there was a build-up of leaves & paper under some resistor banks outside of the
  Electrical Workshop. These resistor banks are installed outside and behind a wire
  mesh enclosure to dissipate the large amount of heat generated during motor tests.
   Recent heavy winds had blown the debris into this area, creating a potential fire
  hazard.
- The open design required for this enclosure has allowed debris to enter.
- We have many wire mesh enclosures around electrical equipment on site, especially for our High Voltage transformers.
- Regular auditing like this, will help us keep this hazard to a minimum.
