BlueScope

Electrical Incidents

Key Learnings

ASP Manufacturing

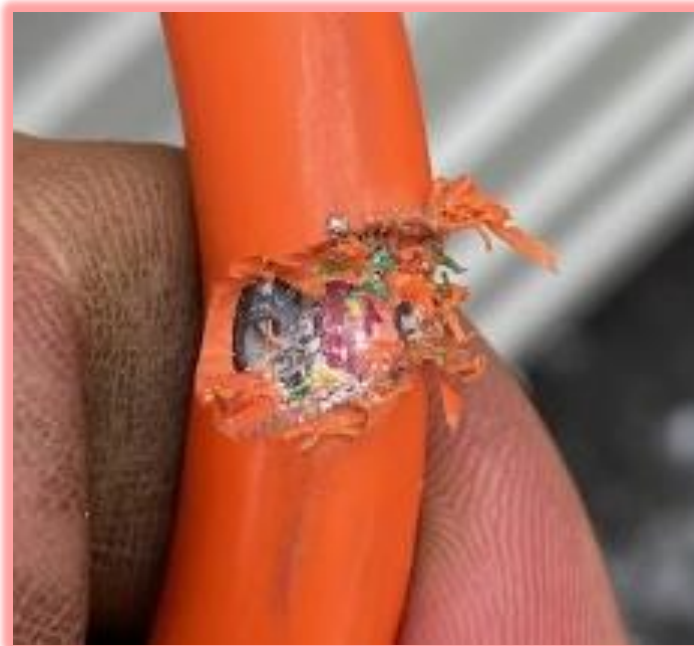
Internal cabling was damaged as a plumber drilled a hole into a recently installed demountable office building to install waste-water outlet piping. The JSEA included checks to confirm electrical supply had not been commissioned, with instruction to isolate otherwise. Electricians working under a separate SSW had supply to the construction village isolated and locked out. The plumber confirmed the supply was yet to be commissioned and worked without locking out.

The plumber had performed the same task on five previous installations, taking care to drill slowly and methodically. He was almost through the very last hole and stopped when he saw orange swarf. The mostly cut material was folded back, revealing the damaged cable. The rest of the hole was completed using tin snips.

Cable damaged by hole saw

There is a risk new installations may become live once supply cables are installed. The state of power supplies to new installations must be carefully managed in conjunction with work planning as part of the SSW process.

Electrical hazards must be considered when planning work, even non-electrical tasks. Work involving live electrical risks may only be performed following isolation and locking.

The Excavation and Penetration Procedure - DIV-ES-ADM-033 should be followed where there is a risk of contact or damage to embedded or hidden services. The location of services should be determined and marked prior to commencing penetration work. Work methods may need to be altered where the location of services cannot be positively determined.

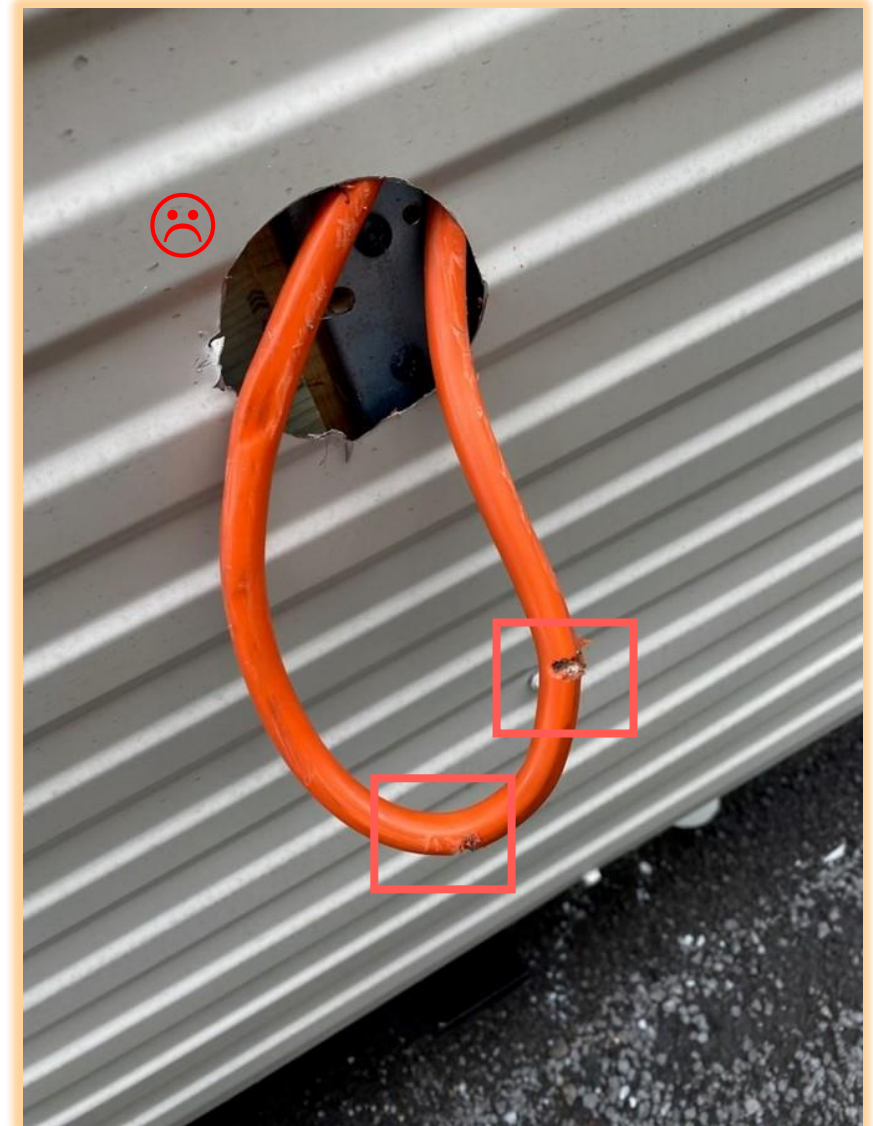
Hole drilled into steel cladding

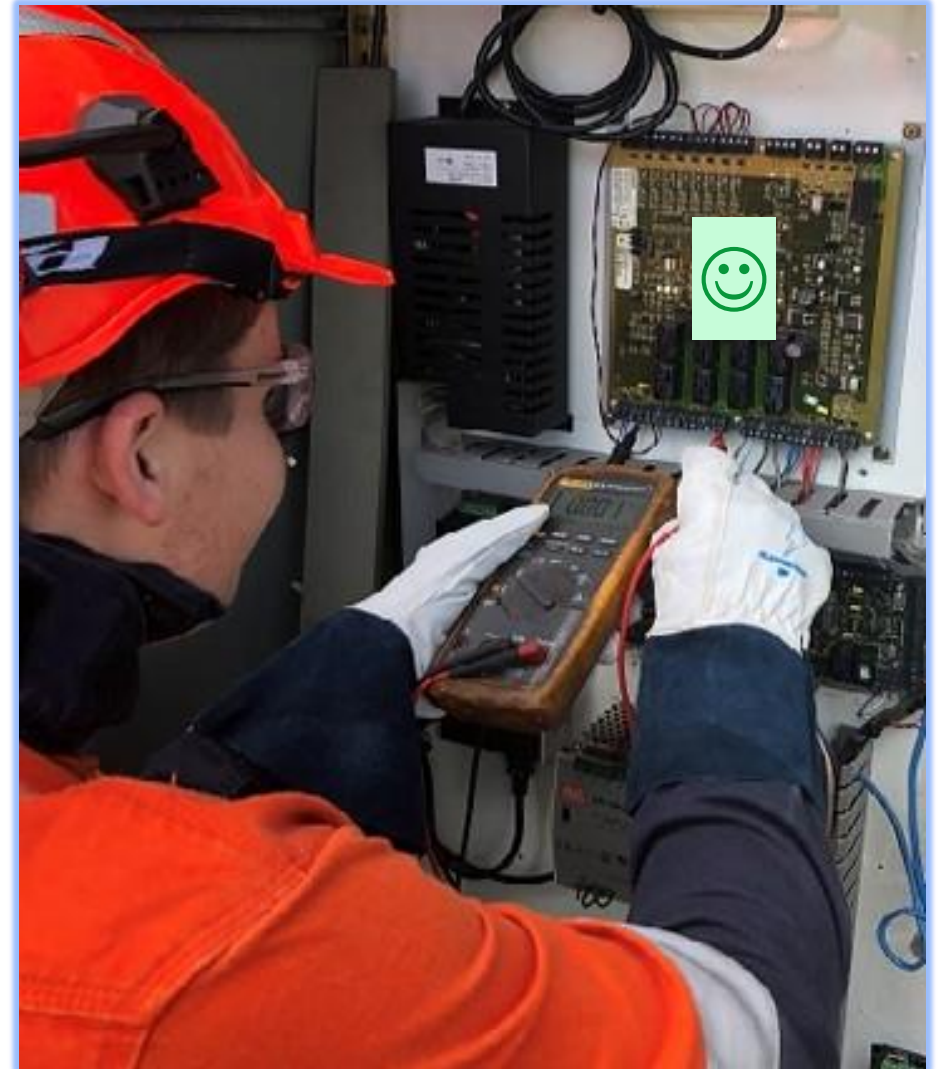
After isolation, the installation of scaffolding, and removal of guarding, the panel was accessed and a Test Before You Touch procedure was followed. This process detected 18 energised wires, all at 240 Vac.

A closer inspection of the termination panel found another power track cable, from a location 3 levels up was also terminated at the panel via other conduits & ducting. The source of the 240 Vac was confirmed, and an extra isolation point added to the procedure.

The issue - Limited access to equipment prevented pre-inspection to identify all sources of supply.

Example of Test Before You Touch being completed before working on an electrical panel.

Key Learning – Isolation procedures require careful verification, particularly when being used for the first time. Procedures should be prepared in advance and adequate time allowed to identify and verify all sources of supply. Schedule outages to verify procedures ahead of use where possible.

Drawings and equipment labels must provide adequate information to identify sources of supply.

It is essential that changes are managed, and drawings maintained to accurately reflect the installation in service.

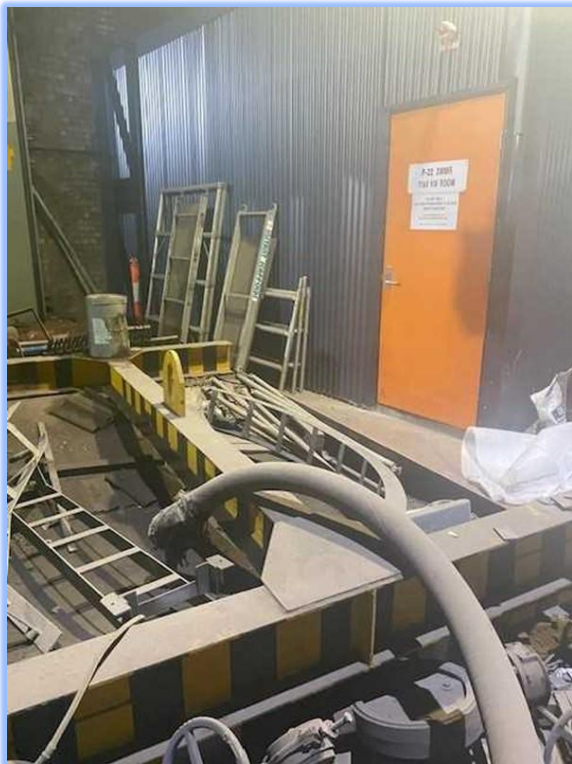
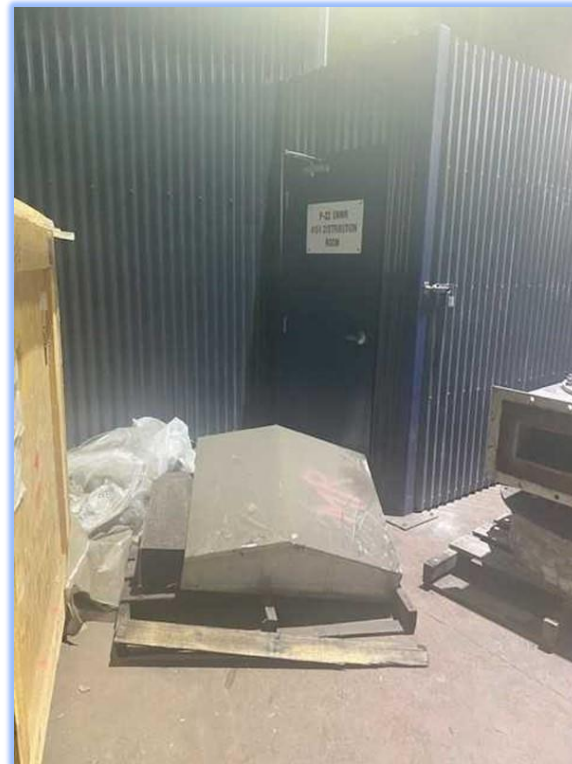
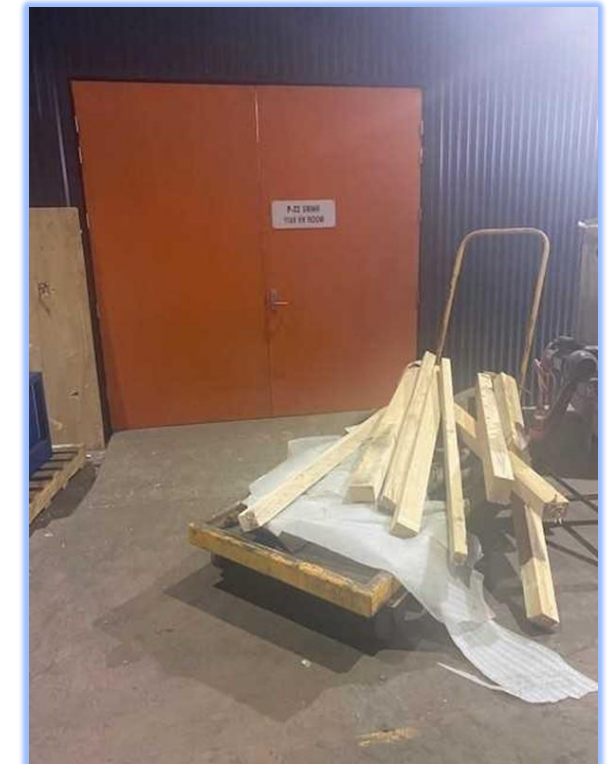
Whilst performing isolations, an electrician found access to switch room doors was impeded by the storage of spares and trash.

Poor management of spares and housekeeping failed to maintain clear access to doors and blocked several walkways used for emergency egress.

Compliance to AS/NZS 3000:2018, includes clause 2.10.2.2.2 for Switchboard Rooms – which requires doors to open in the direction of egress, have an unobstructed height of 2.0 m and an unobstructed width of not less than 0.9 m. The pathway should be clear for the whole route of the emergency egress.

Switch room doors blocked by spares & trash – restricting access and emergency egress.

Prominent signage and floor markings help remind people to keep clear of switch room doors. Housekeeping audits should identify similar issues.

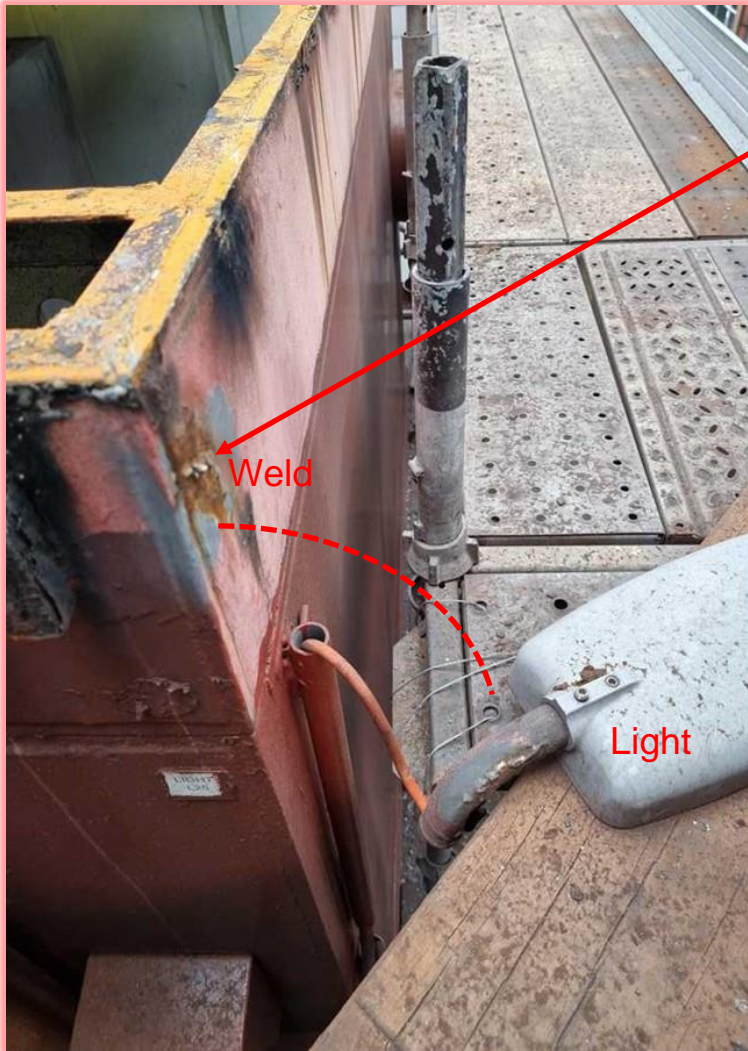
Light moved for scaffolding

An external building light had been removed to allow for scaffolding and it appears the electrical supply was not isolated before removal.

Electrical Hazards must be considered and correctly controlled when erecting scaffolding – Refer to Electrical Hazards Associated with Scaffolding DS.DIV-OHS-01-04.05.04

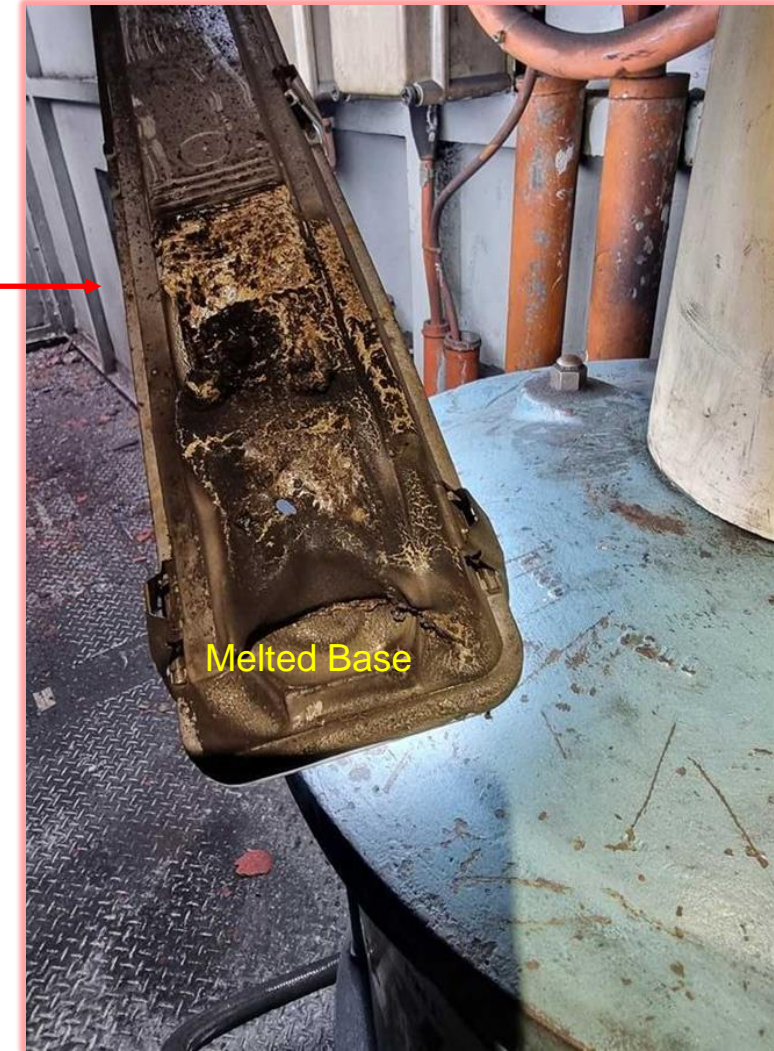
Two internal roof lights were also found damaged, one falling after melting.

There was no electrical sign-off when the scaffold was built, and the hot work controls for the job did not prevent damage to the roof lights.

Damaged roof light

Hot Work Permits should include controls to prevent damage to electrical equipment, conduits, and cabling in the area.

Refer to - Hot Work Procedure DIV-OHS-06-219, and Hot Work Checklist F.DIV-OHS-06-219-01.

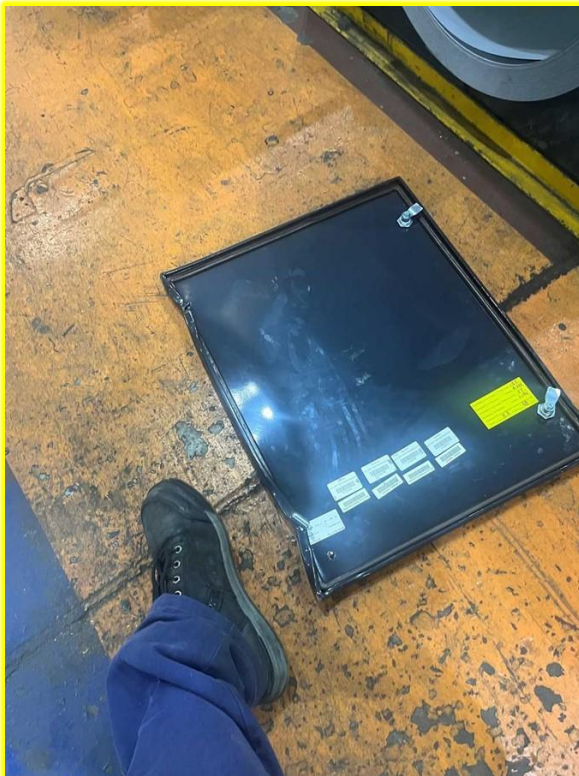
A jib crane electrical panel door fell approximately 5 meters to the ground. It appears the panel door was not closed and had contacted the crane structure during normal operation, tearing it off at the hinges.

The door latches had either opened with vibration, or they were not secured properly after maintenance.

Panel Door on floor

We need to consider the integrity of electrical panel door locking mechanisms on mobile equipment, especially where there are small clearances to structures.

Installation of vibration proof latches can prevent accidental opening.

Maintenance procedures with door security included in the final checks will remind us too.

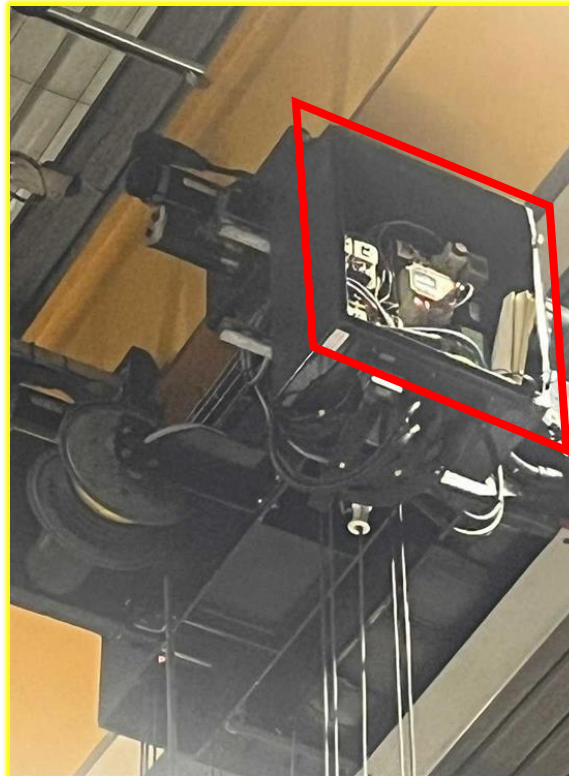
Panel (minus the door) on the crane

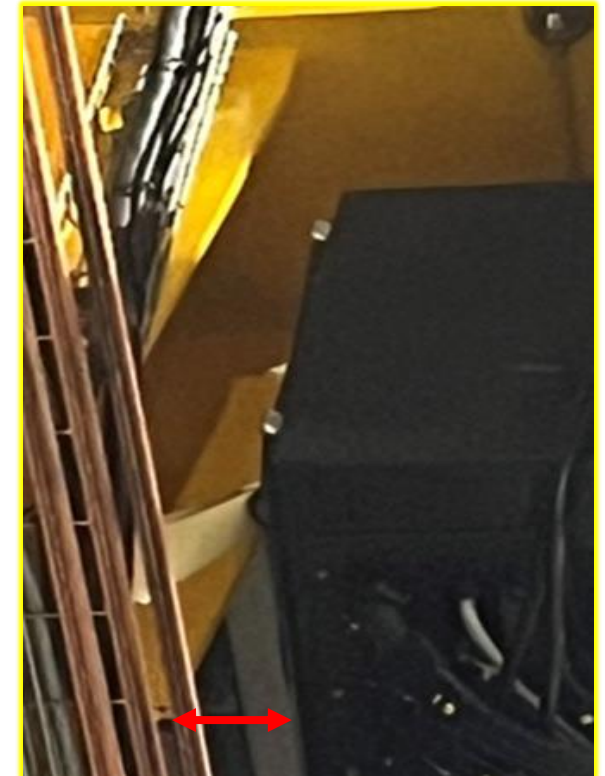
Tight clearances

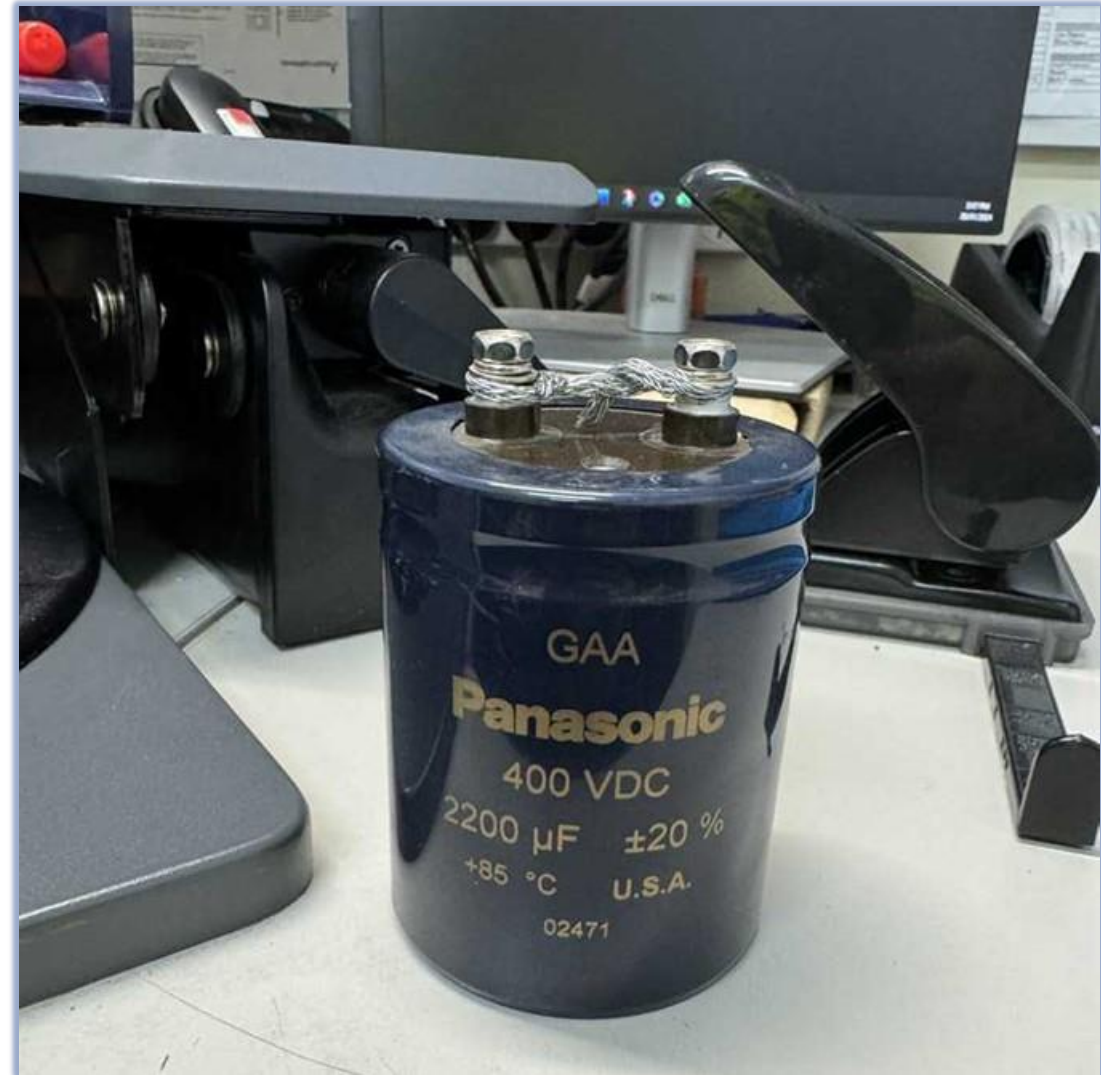
A large spare capacitor was found in a storage bin with the terminals exposed and not shorted together. This is an unsafe condition.

Capacitor with terminals shorted for storage

Power capacitors that are not in use should be individually short-circuited with a robust connection after discharging. Refer to manufacturer handling and storage recommendations and seek advice where you are unclear.
