Electrical Incidents

Key Learnings

ASP Manufacturing

2024 / 2

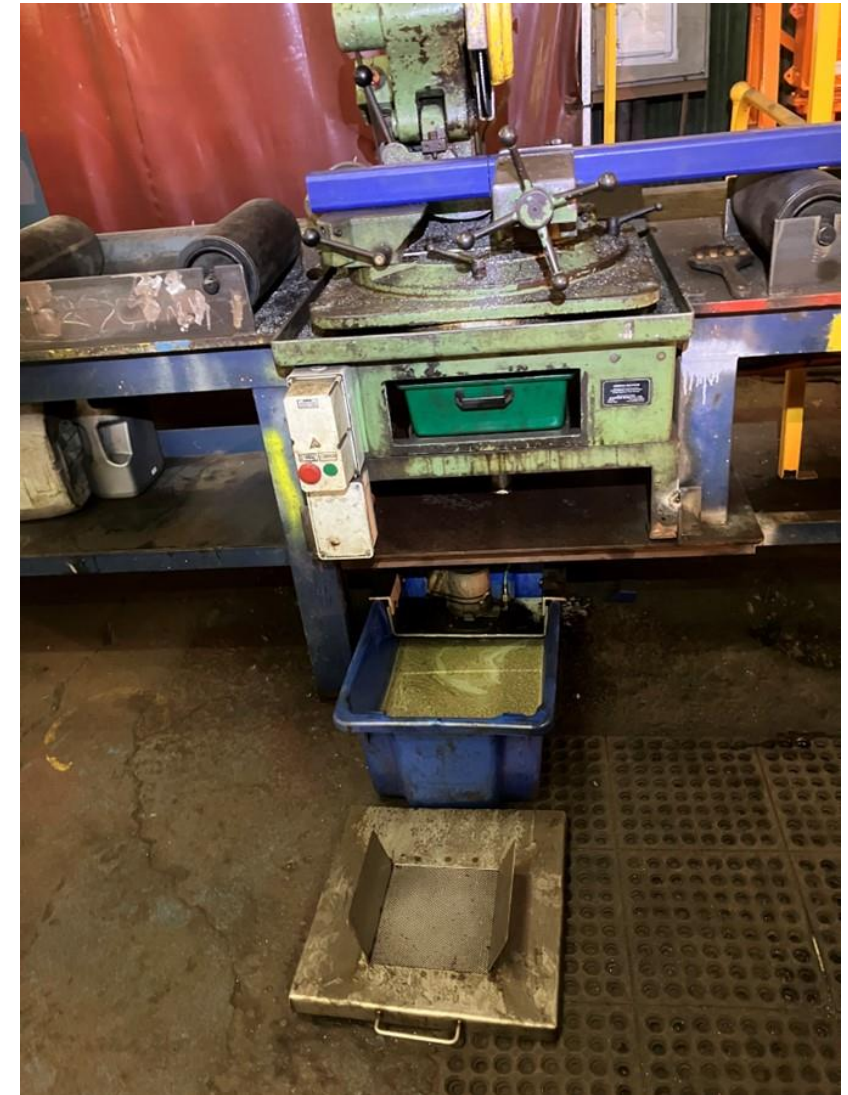
Whilst operating a cold saw a worker noticed the steel strainer on the coolant tub below was sticking out. When they reached down to move it, the strainer contacted the frame of the electric coolant pump behind it and the worker felt an electric shock between their arms.

Cold Saw (coolant tub below is forward of normal position)

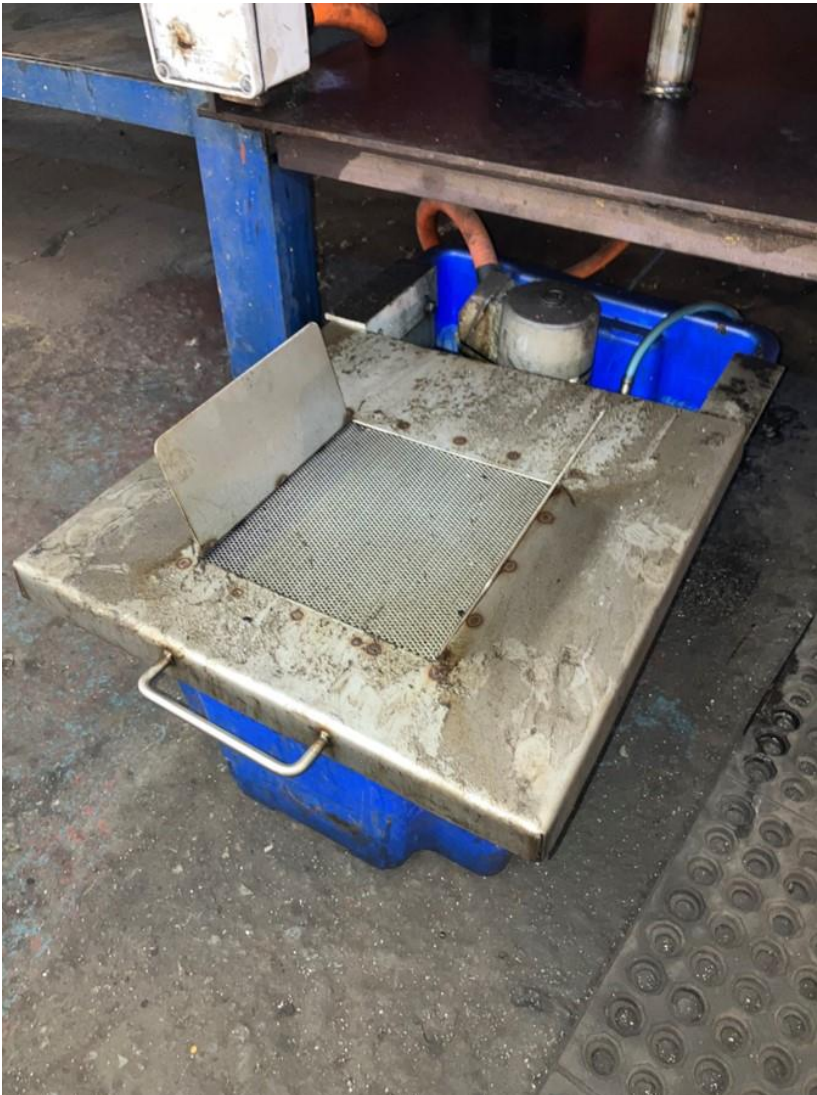
The coolant tub was a modification to the saw's original mechanical pump and faults were found with the electric pump motor –

Modifications - coolant tub, 415-volt pump, bracket & tray

Modifications to appliances and other equipment must comply with current standards.

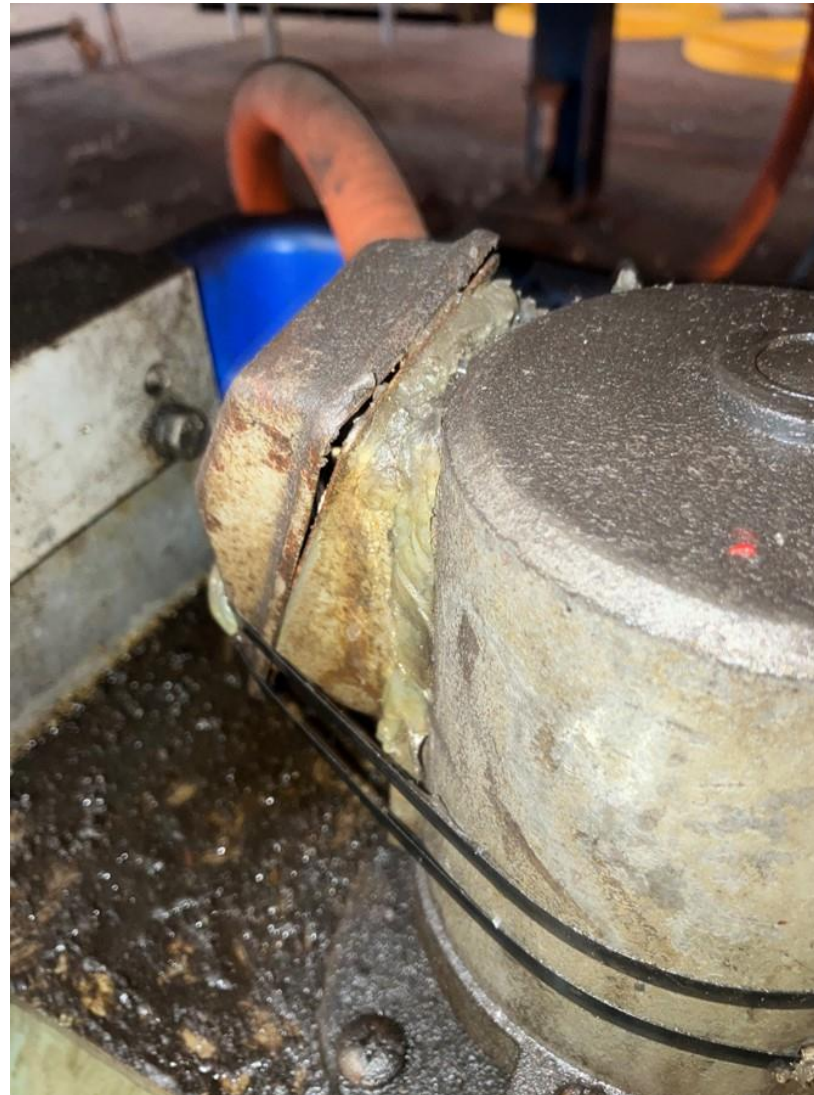
- It was not sealed effectively to stop coolant entering.
- The termination block was broken, energised terminals could move and contact the motor frame.
- The motor frame was not earthed. The supply cable was earthed at the supply end but found disconnected and taped up at the motor.

Motor terminal box IP rating insufficient for wet environment and cover not adequately secured

Equipment and protection must be suitable for the environment it is installed and the intended use.

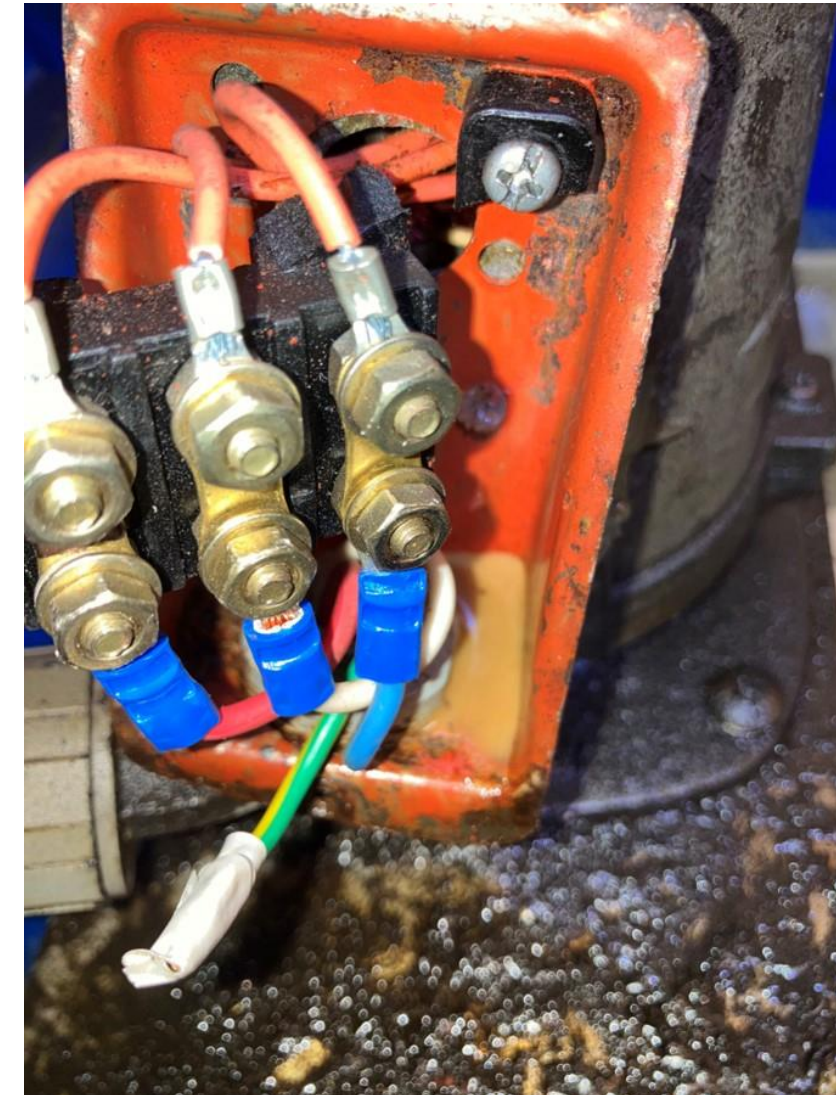
Motor terminal block base broken and loose.
(Motor frame not earthed)

Equipment must be adequately maintained to ensure live parts remain insulated and protect people from inadvertent contact. Periodic inspection procedures must ensure the integrity and safety of the whole electrical installation, with protective earthing confirmed on all accessible conductive parts.

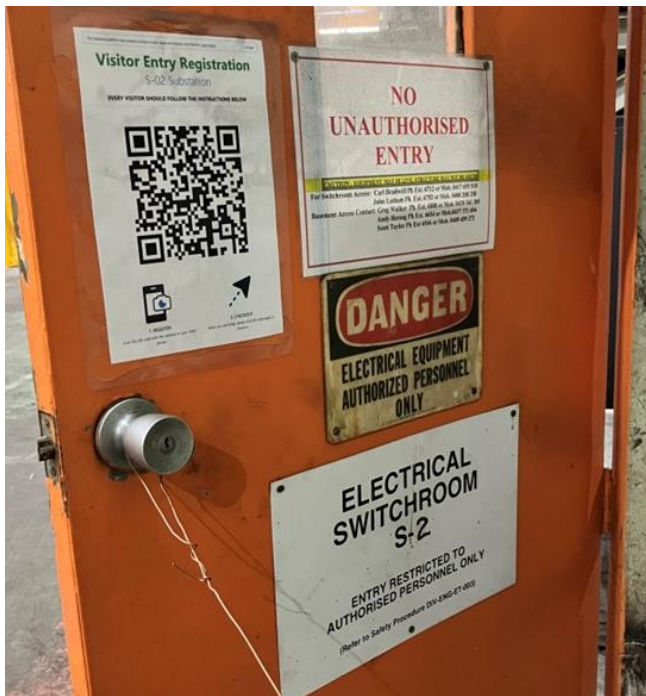
More than 10% of electrical incidents reported this month involved switchroom doors being left unlocked or held open by various means. These incidents mainly occurred during major shutdowns, resulting in more people than usual potentially being exposed to electrical hazards.

The normal restrictions that limit access to switch rooms failed or were intentionally bypassed.

Door tied open with electrical cable

Switchrooms or Electrical Stations must remain secured to restrict access to authorised persons due to the potential hazards present. Refer to DIV-ENG-ET-003 - Access To Electrical Stations. Electrical Station owners need to ensure all access control systems are working effectively and always maintained in good working order.

If planned work requires switch room doors to be left open (E.g., for ventilation, movement of equipment) then additional access controls need to be in place. A danger barricade in the immediate area or a designated safety watcher can help prevent unauthorized or accidental entry.

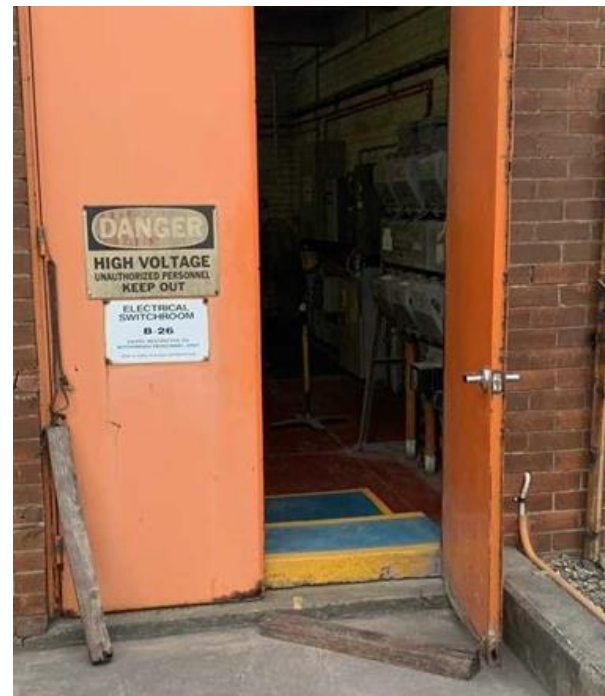
Door chocked open with timber

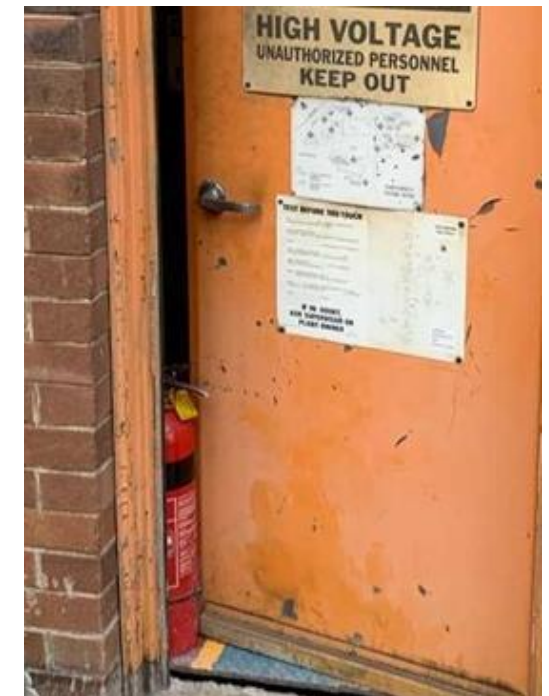
Door chocked with fire extinguisher

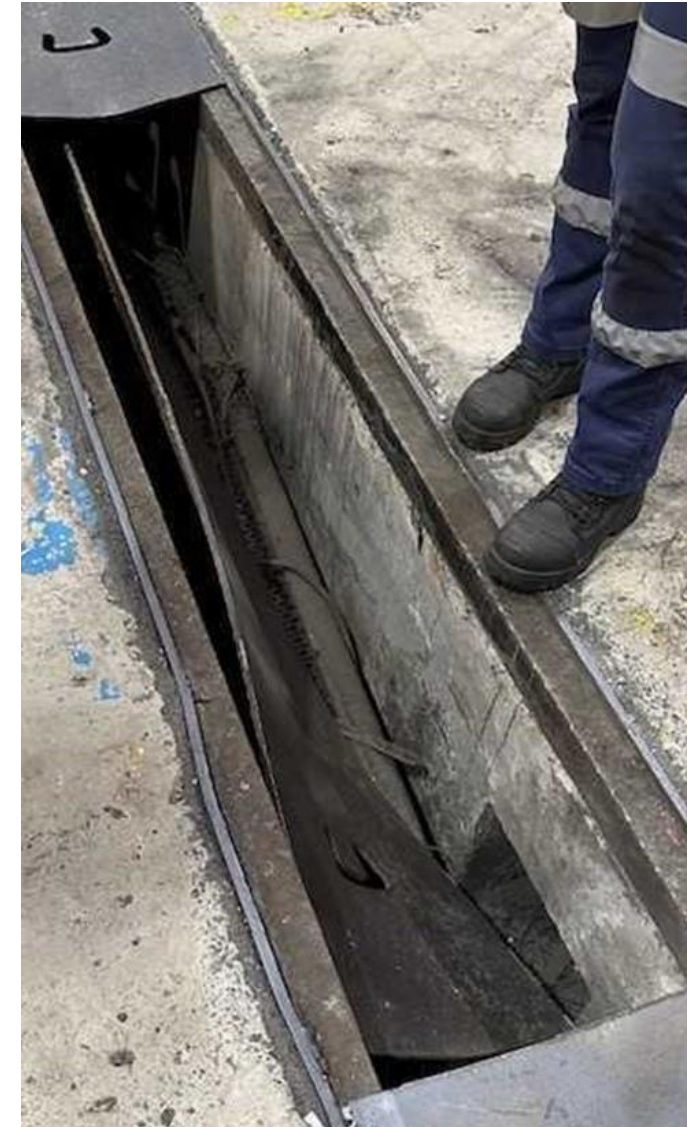
A steel cover for a cable trench was deformed and fell onto cables below after been driven over by a forklift.

The cable trenches were for old production lines in the area and had bracing underneath to prevent sideways movement but were not designed for the weight of a forklift. The production lines had been removed years ago, and the area repurposed as a warehouse, with the frequent use of forklifts to move heavy items around.

Modification control of the building usage failed to identify cable trench covers as being a potential hazard when driven over.

Damaged floor plate on cables

When areas of plant are repurposed, existing infrastructure and location of electrical services must be considered.

Cable trenches, racks, pipes and conduits may require additional mechanical protection.

An audit of repurposed areas like this can highlight these potential hazards.

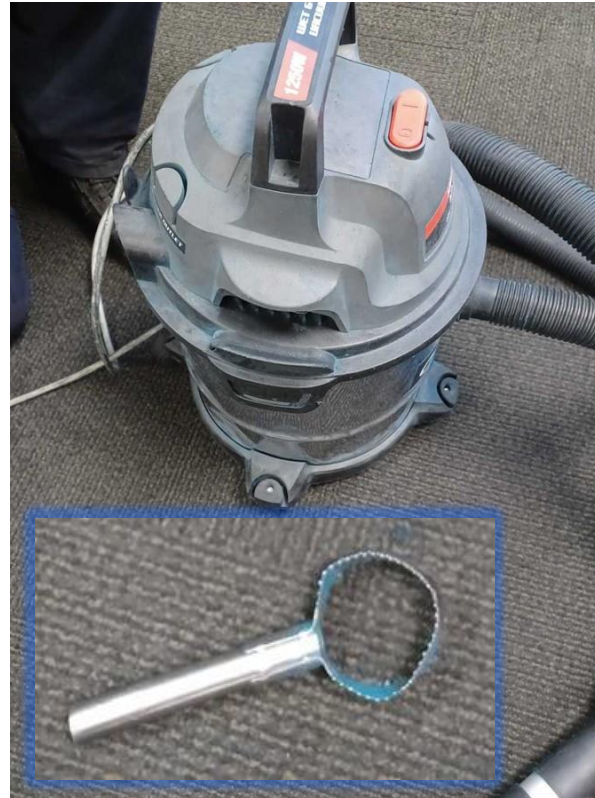
During cleaning of a process area, the energised power lead of a vacuum cleaner was cut when someone stepped onto it. The lead was on the floor, laying on top of a fish scaling tool that is used as a scraping device. The tools teeth punctured and shorted the power lead conductors, causing the supply circuit breaker to trip.

Vacuum Cleaner and Fish Scaling Tool

A designated storage location for the scaler and the use of insulated hooks to hang the lead safely above ground level would have prevented this.

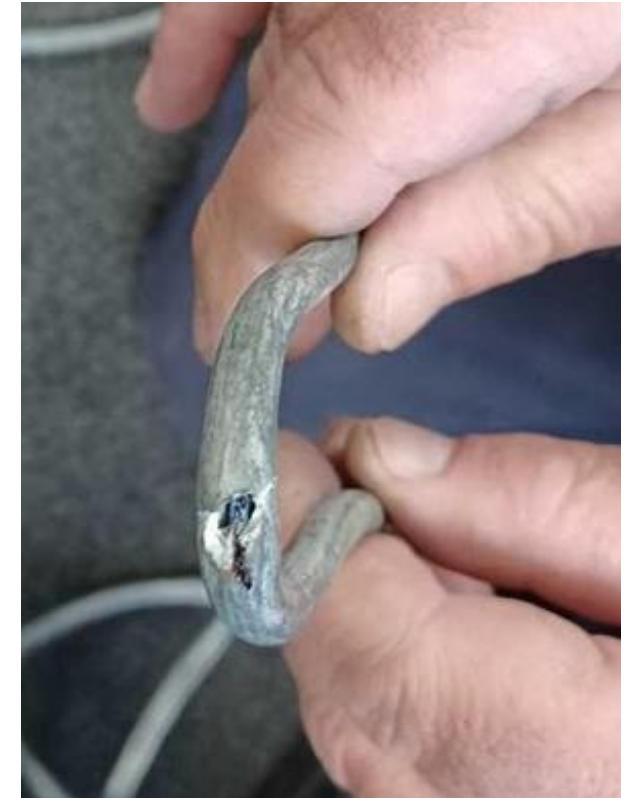
Housekeeping and management of appliance lead controls had failed.

Damaged Vacuum Power Lead

Storage of tools and equipment, and the location of leads needs to be considered when using powered appliances.

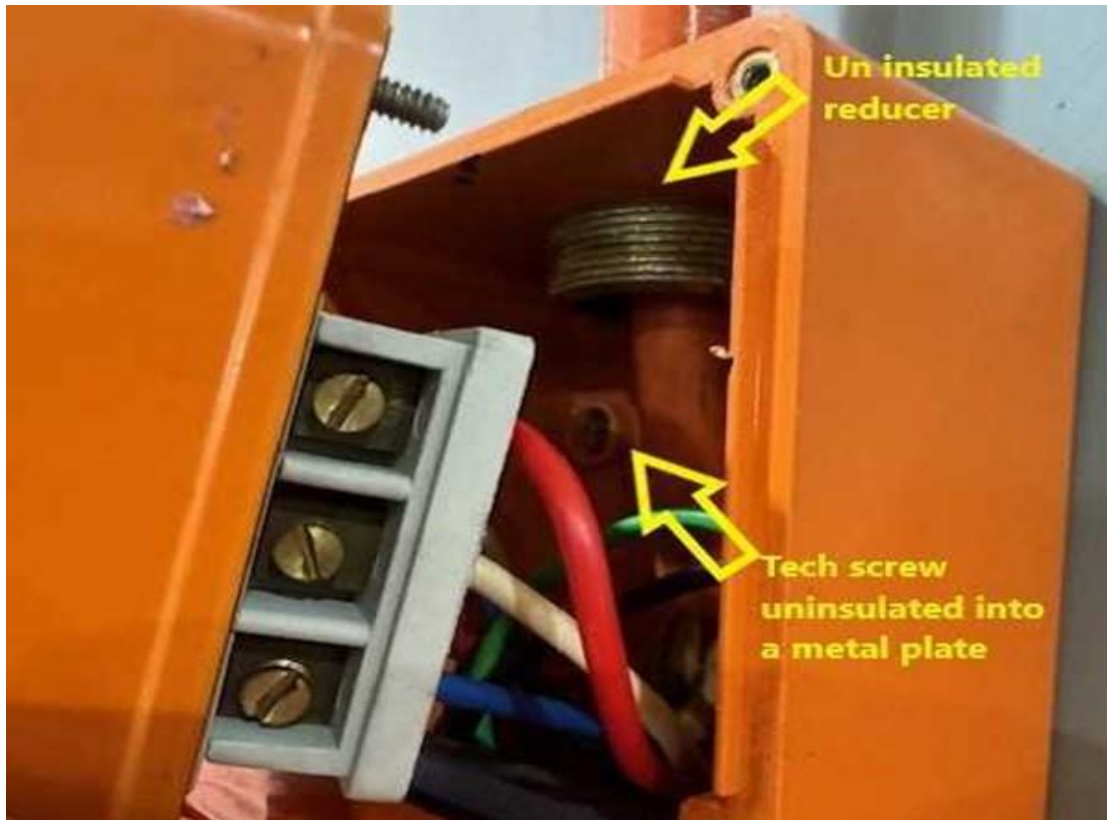
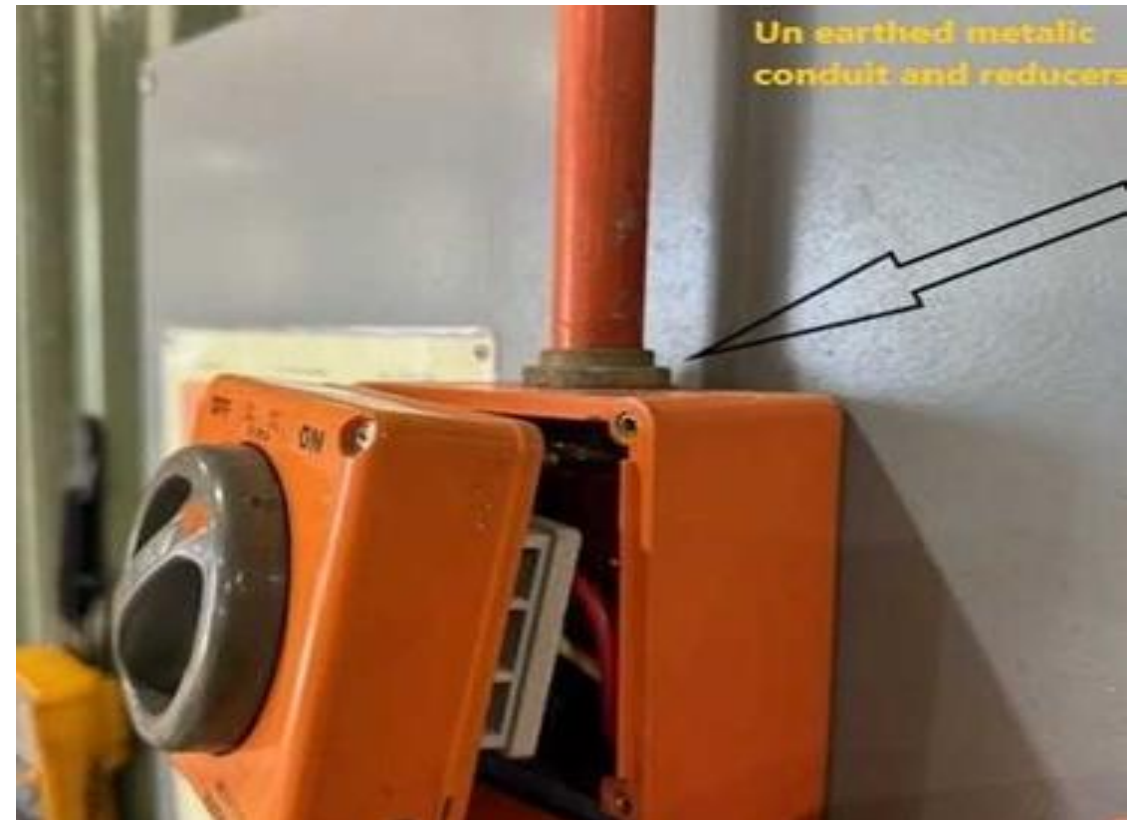
Metal conduit and reducers attached to PVC switch bases were found with no protective earth connection and the base mounting screws had no insulating plugs covering the screw heads. These were mounted on a steel backing plate.

This arrangement has the potential for metallic parts to become energised under fault conditions.

Earthing arrangements shall be selected and installed to enable automatic disconnection of the supply in the event of a short circuit to earth fault in the protected part of the installation (AS/NZS 3000:2018, Section 5). Reference to basic protection requirements such as insulation/barriers can be found in Section 1.5.4.

Refer to BSL Electrical Installation Manual MA-ENG-INS-001, Rev3, Figure 4-39 for an example of a conduit earthing ring installation.

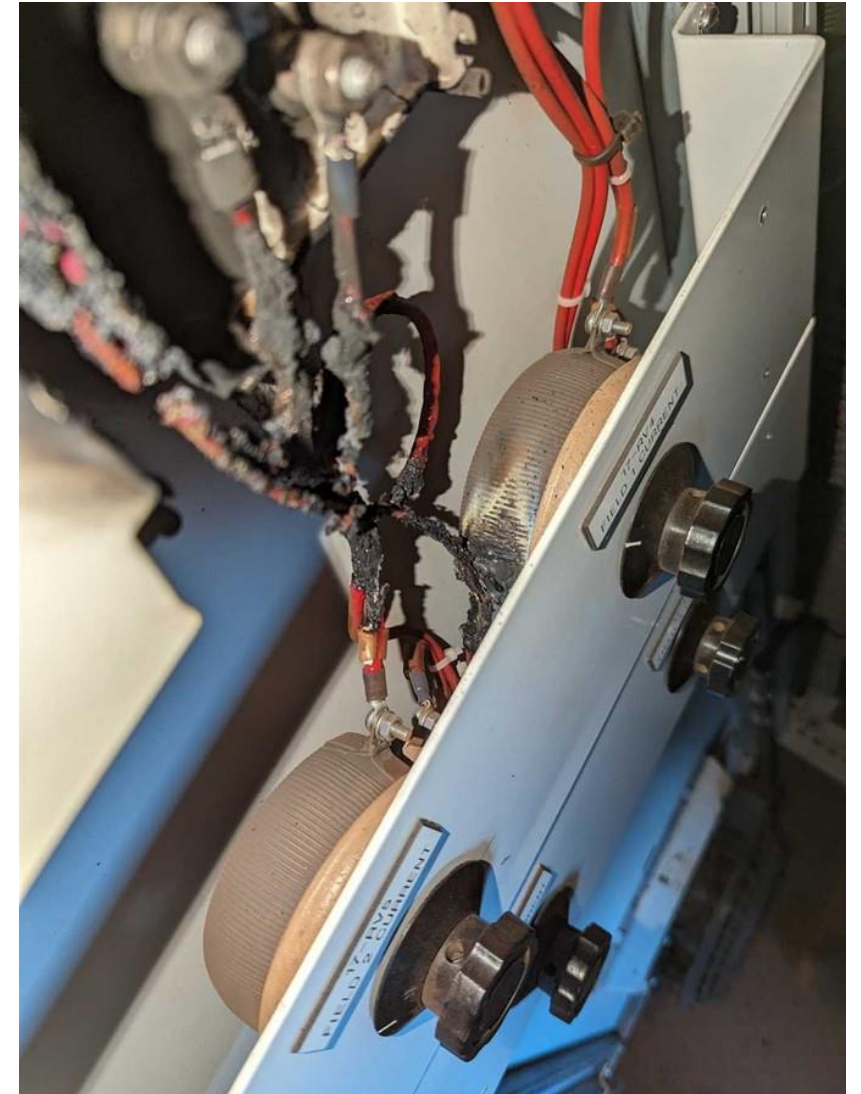
A Switchroom fire alarm was activated by smoke generated from a wiring fault in a convertor panel.

Over time, the insulation of the convertor wiring had broken down due to their proximity to rheostats which are warm during normal operations. The integrity of the wiring insulation failed, causing exposed copper to contact one of the windings of the rheostat, creating an arc fault that spread through adjacent wiring.

The installation did not allow for protection against the heat generated from the rheostats.

Rheostat Wiring

Extra precautions are required to prevent damage to adjacent wiring or equipment from the heat produced by some electrical equipment. Devices like high wattage rheostats, resistors, heatsinks etc. should be spaced to allow for adequate heat dissipation and cooling fans installed where required.

Wiring adjacent to these devices should also be adequately spaced, protected by heat shielding or be rated for the temperatures present.

An audit of similar installations will help identify heat affected wiring before it becomes a fire hazard.
