# MONTHLY ELECTRICAL INCIDENTS

**ASP Manufacturing**

**July 2022**

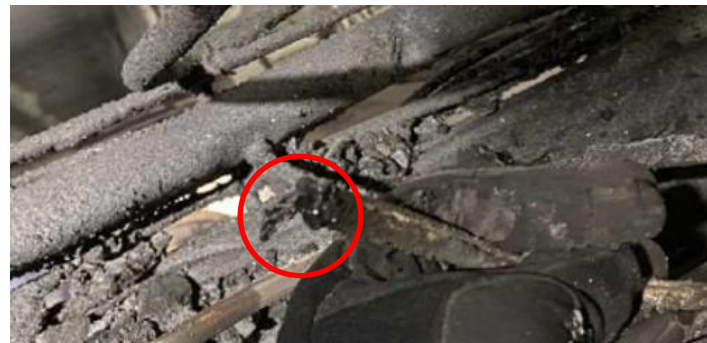
The other damaged control cable with outer sheath and inner insulation melted exposing conductors. Covered in Kish mud.
