MONTHLY ELECTRICAL INCIDENTS

ASP Manufacturing

September 2022

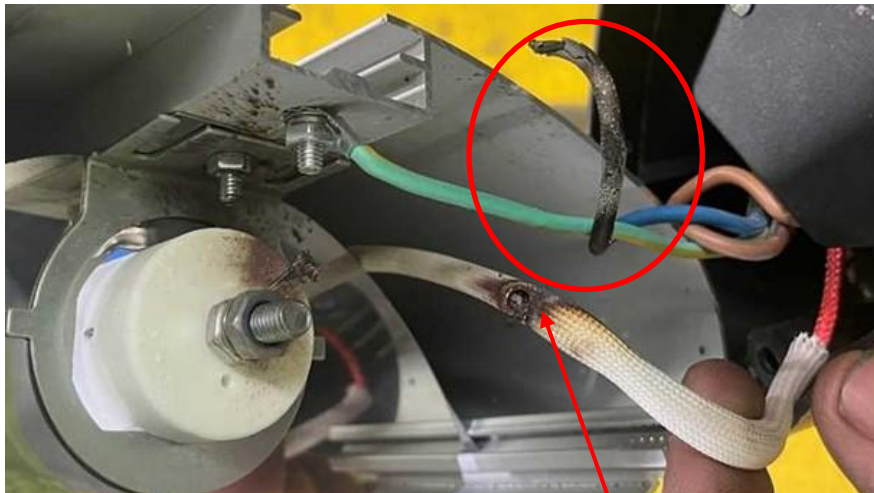
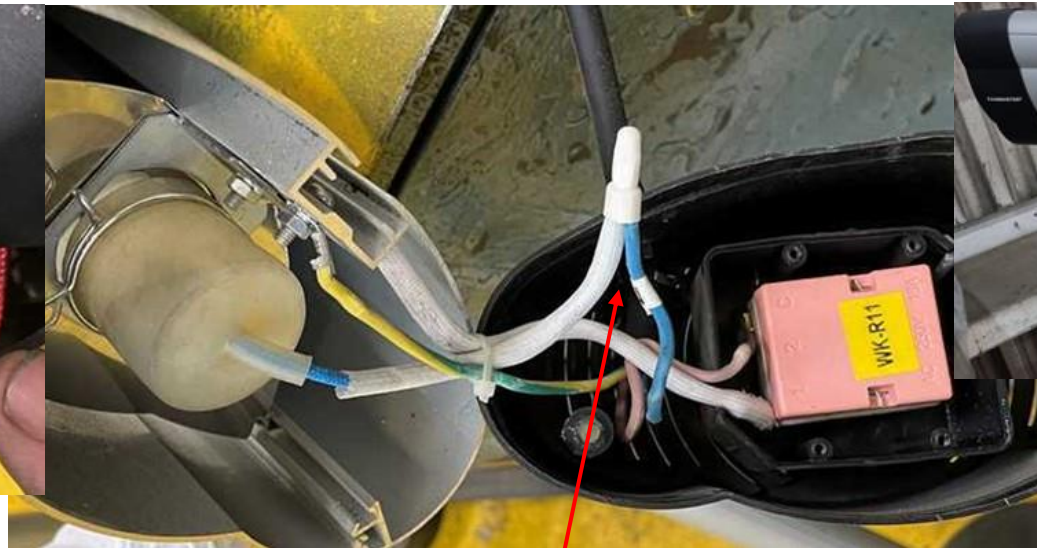
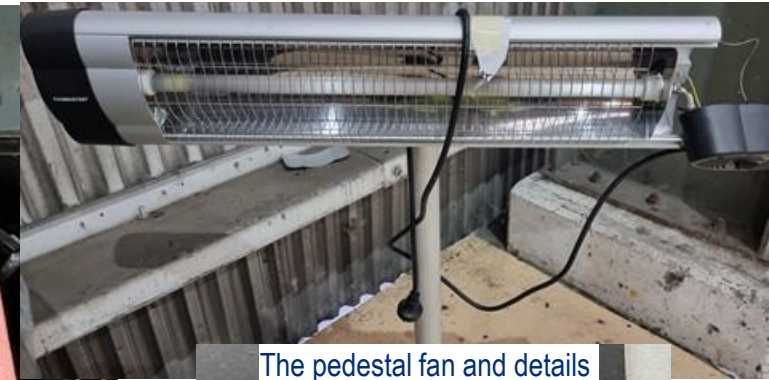
A follow up audit to incidents I2142440 and I2164101 identified two additional heaters with insufficiently rated or protected wiring for the internal operating temperature. One neutral had been completely burnt off, the second was in very poor condition. Three other units were found with high temperature wire and heat resistant sleeving installed on the active and neutral conductors. These modifications had been made either by the manufacturer or supplier, however a product recall notice has not been issued for the defective model. All units have now been removed from service at Western Port and the incident is being reviewed with the supplier (Blackwoods).

The pedestal fan and details

Anyone owning these heaters should either remove the unit from service or have it inspected by a licensed electrician to confirm if the unit is safe for use.
