Electrical Incidents

Key Learnings

ASP Manufacturing

2024 / 2

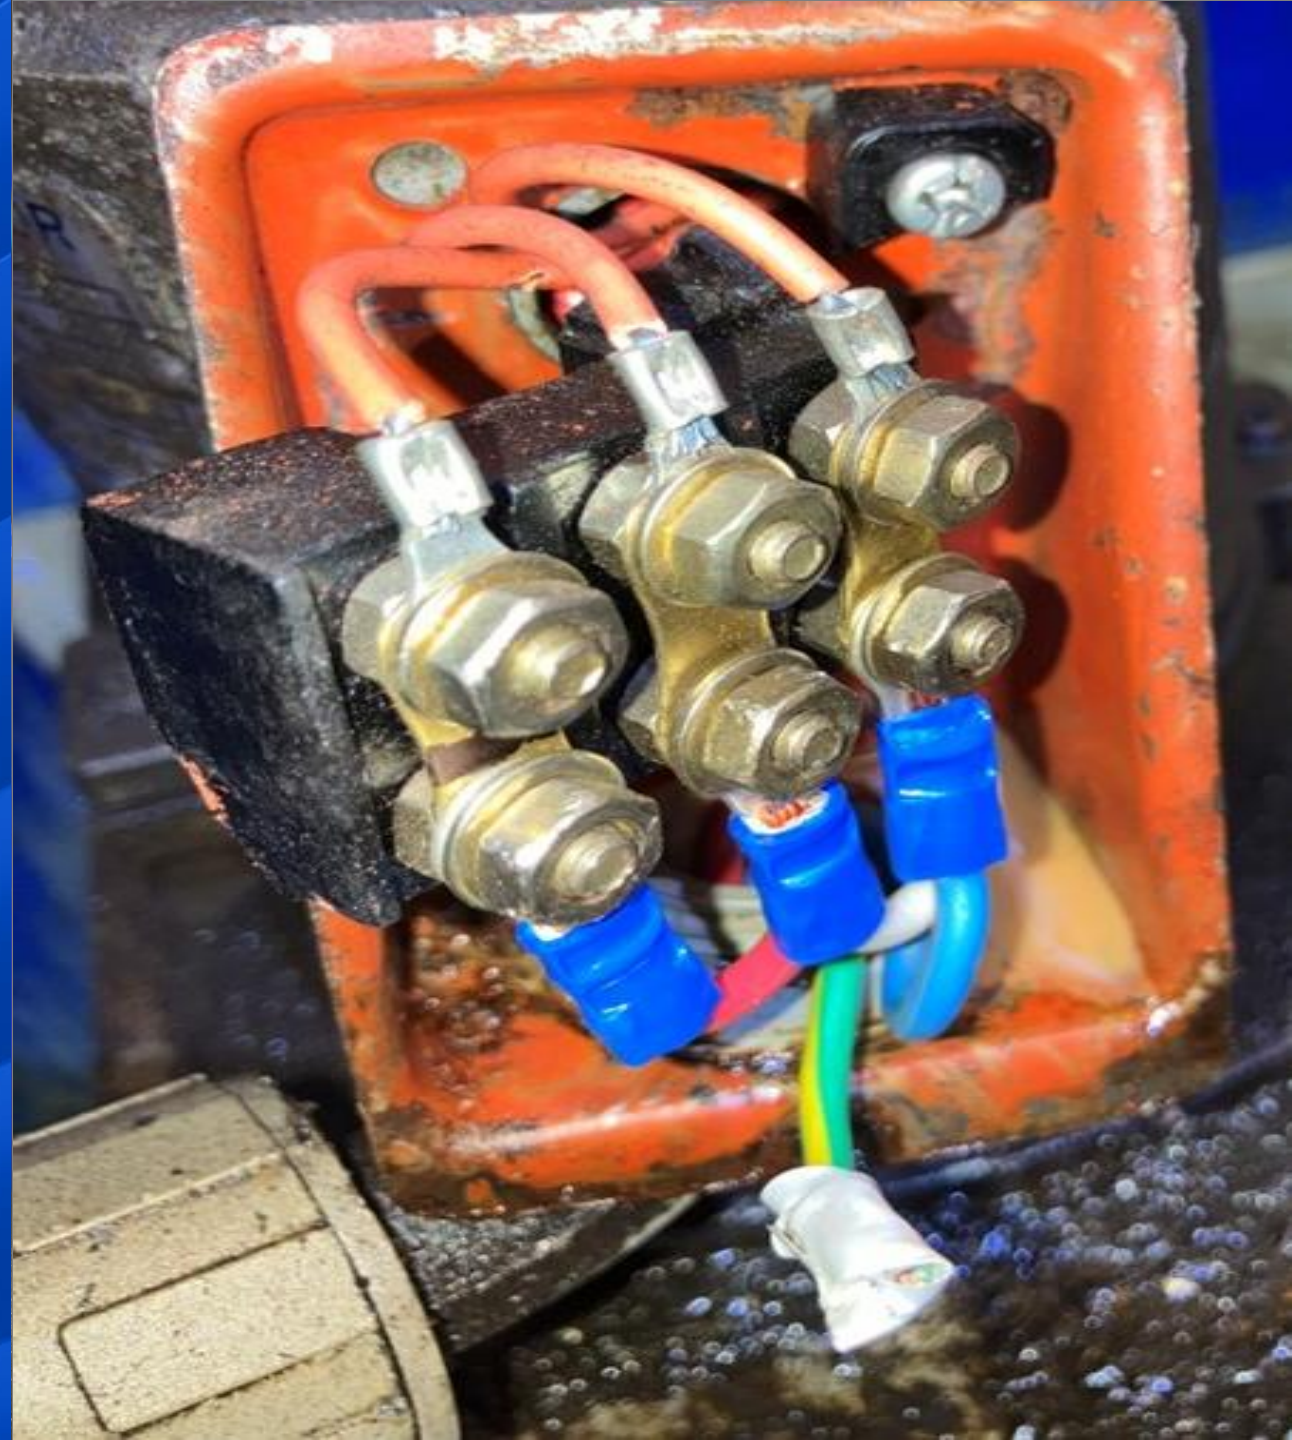
Whilst operating a cold saw a worker noticed the steel strainer on the coolant tub below was sticking out. When they reached down to move it, the strainer contacted the frame of the electric coolant pump behind it and the worker felt an electric shock between their arms.

The coolant tub was a modification to the saw's original mechanical pump and faults were found with the electric pump motor –

- It was not sealed effectively to stop coolant entering.
- The termination block was broken, energised terminals could move and contact the motor frame.
- The motor frame was not earthed. The supply cable was earthed at the supply end but found disconnected and taped up at the motor.

Modifications to appliances and other equipment must comply with current standards.

Equipment and protection must be suitable for the environment it is installed and the intended use.

Equipment must be adequately maintained to ensure live parts remain insulated and protect people from inadvertent contact. Periodic inspection procedures must ensure the integrity and safety of the whole electrical installation, with protective earthing confirmed on all accessible conductive parts.

Refer to AS 3019 Electrical installations - Periodic assessment, AS/NZ 3760 - In-service safety inspection and testing of electrical equipment and RCDs.

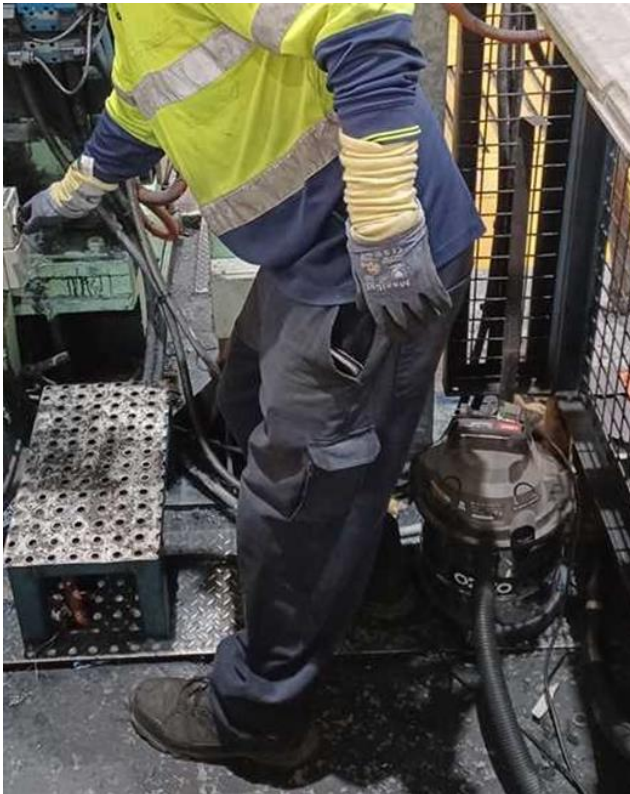
Work Area

Housekeeping and management of appliance lead controls had failed.

Storage of tools and equipment, and the location of leads needs to be considered when using powered appliances.

A designated storage location for the scaler and the use of insulated hooks to hang the lead safely above ground level would have prevented this.
